TECHNICAL INSTRUCTIONS
FOR
CUSTOMER SUPPORT PROGRAM 22TE09
HV FLOOR UNDER WIRE HARNESS AND REAR TRACTION MOTOR CABLE
CORROSION
CERTAIN 2019 –2022 MODEL YEAR RAV4 HYBRID AWD
(Amendment)

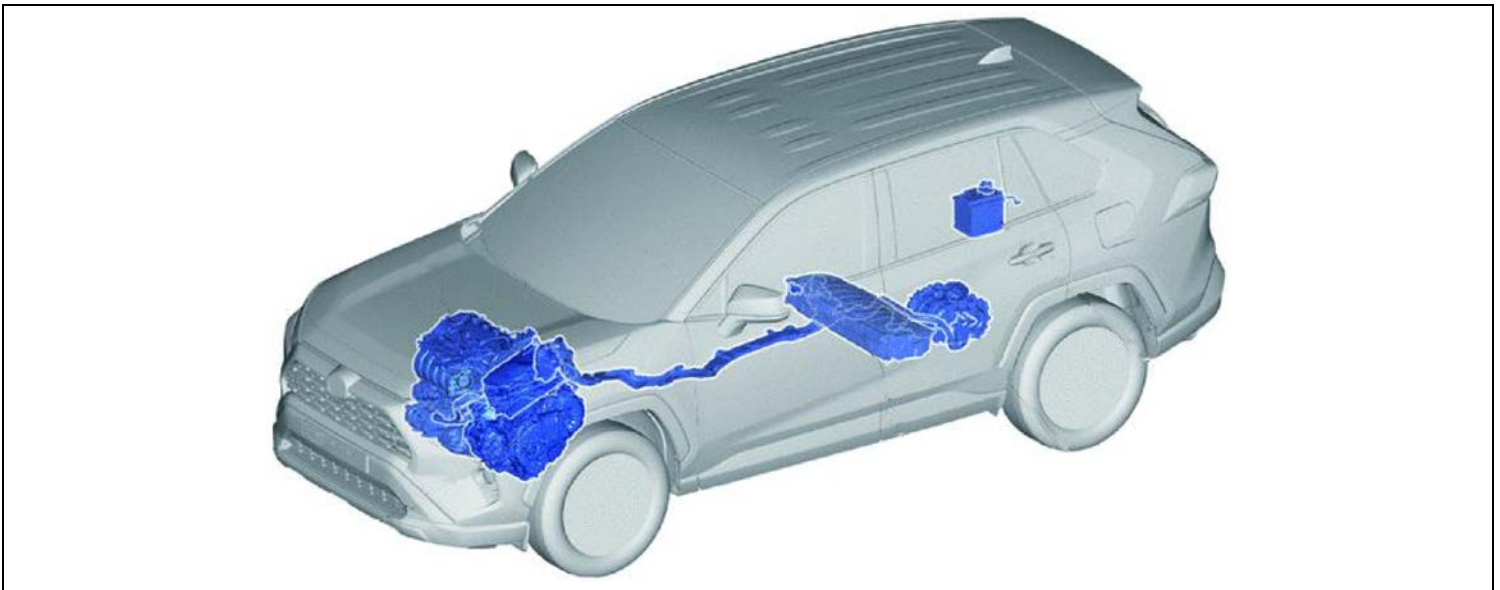
Although the HV Floor Under Wire Harness and Rear Traction Motor Cable is covered by Toyota's New Vehicle Limited Warranty for 3 years or 36,000 miles (whichever comes first), we at Toyota care about the customers' ownership experience. Toyota is providing coverage for repairs related to excessive corrosion to the wire harness connections at the Rear Motor Generator. Excessive corrosion can cause AM Radio Static during certain drive cycles or the vehicle may not start.

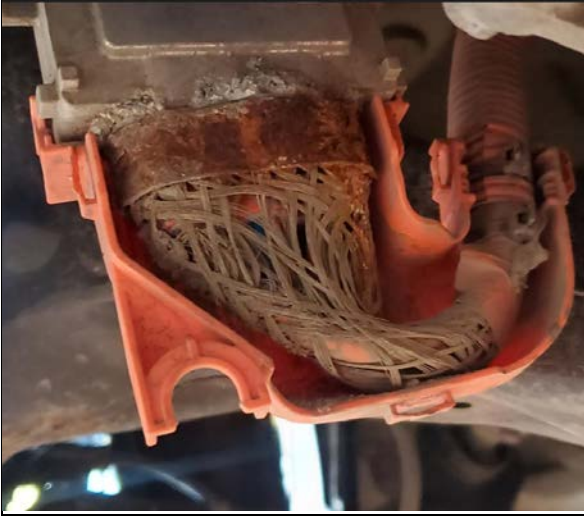
Y6 connector under vehicle at MGR

5) Inspect the Y6 connection for corrosion

- f) Disconnect the Y6 connector at the MGR and inspect for corrosion, dirt, or debris.

YES – Continue to Section VI

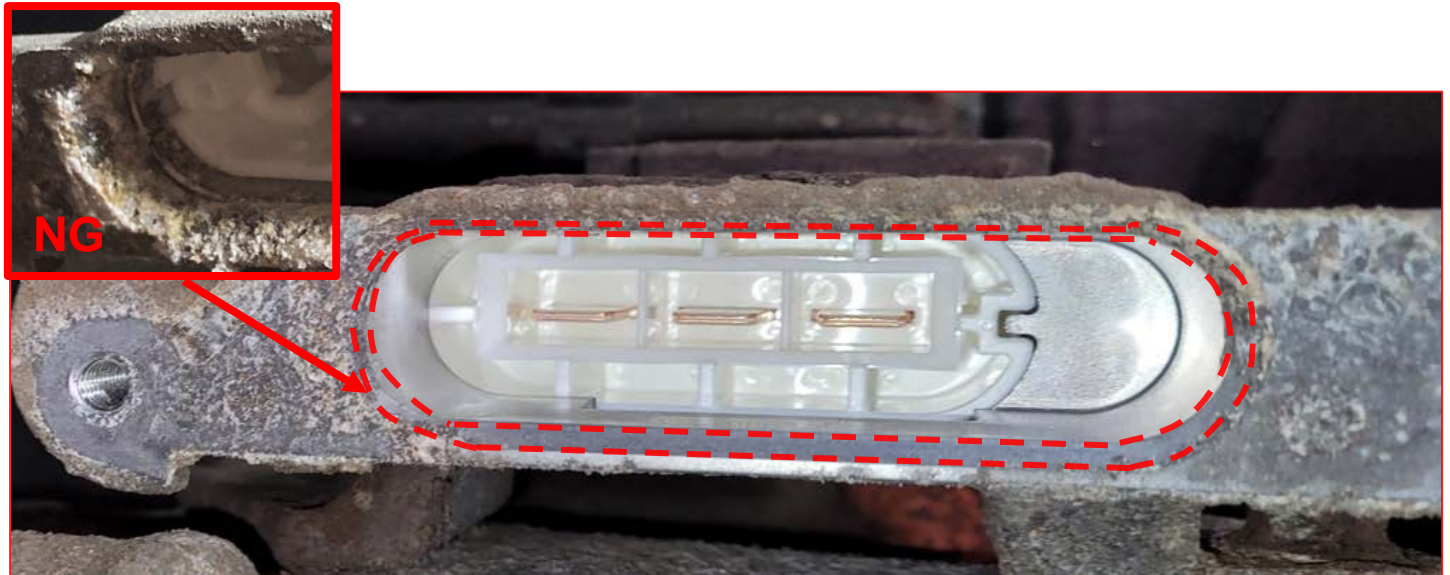
6) Inspect the connector housing of the MGR.

- a) Inspect the chamfer of the MGR connector housing for pitting and corrosion on the sealing surface. Corrosion in this area will cause the seal to leak. Is pitting and corrosion present?

YES – Rear Traction Motor Cable requires replacement continue to Section VI
