Service Bulletin

Bulletin No.: 23-NA-145

Subject: Radio Software Version 167.5

Brand:	Model:	Model Year:		Build Date:		Engine:	Transmission:
		from	to	from	to		
Buick	Encore GX	2024	2024	SOP	Built before July 6, 2023	—	—
	Envista			SOP	Built before July 5, 2023		
Chevrolet	Trailblazer	2024	2024	—	—		
	Trax			SOP	July 6, 2023

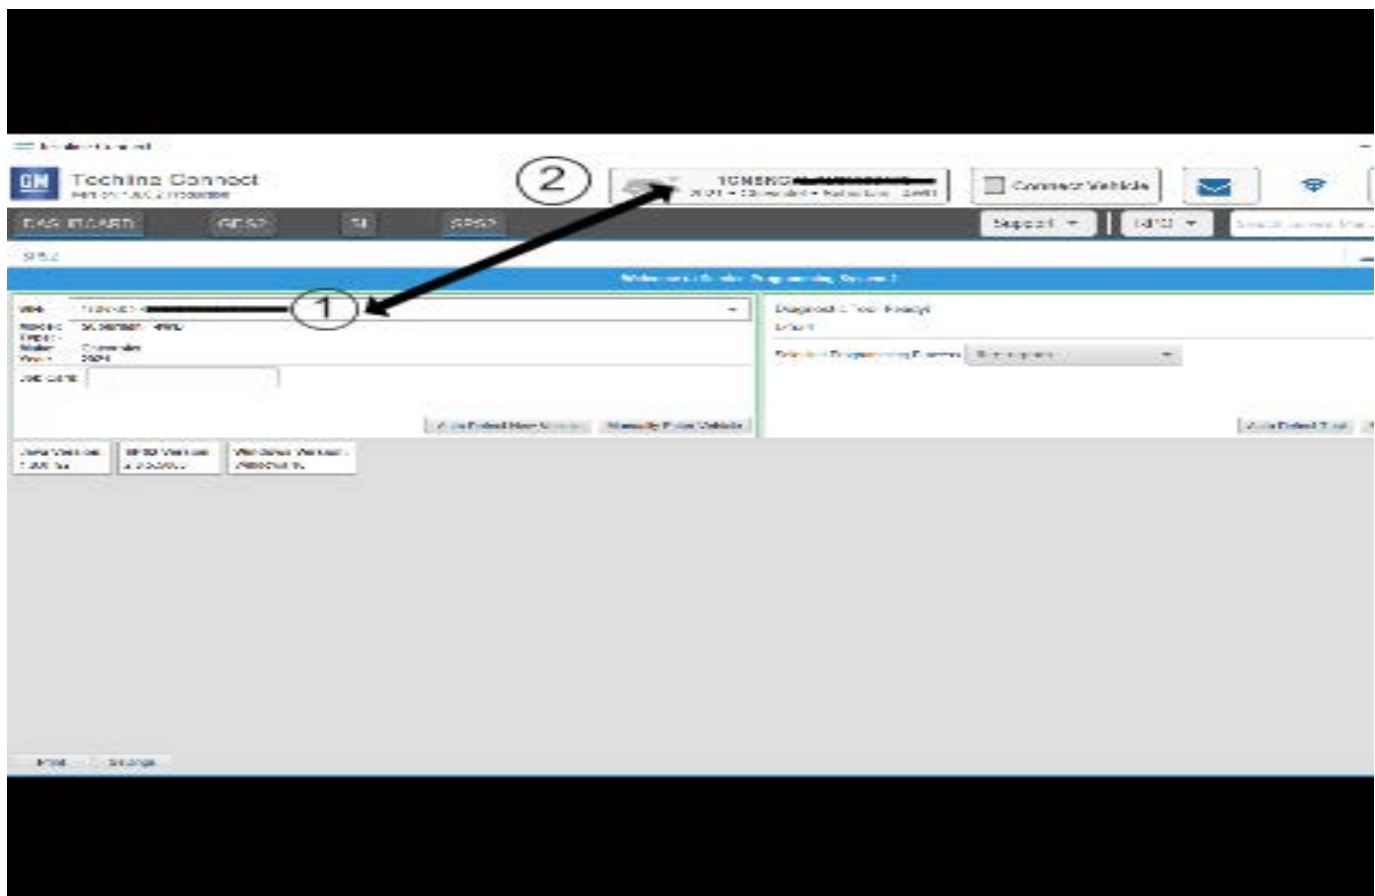
Caution: Be sure the VIN selected in the drop down menu (1) is the same as the vehicle connected (2) before beginning programming.

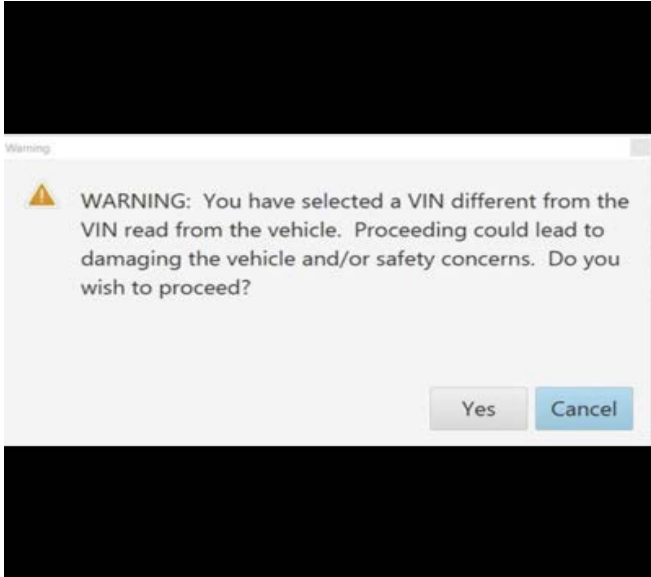
5877000

Important: If the vehicle VIN DOES NOT match, the message below will be shown.
