Service Bulletin

Bulletin No.: 23-NA-143

Subject: Radio Software Version Y169 – Multiple Updates for IOK

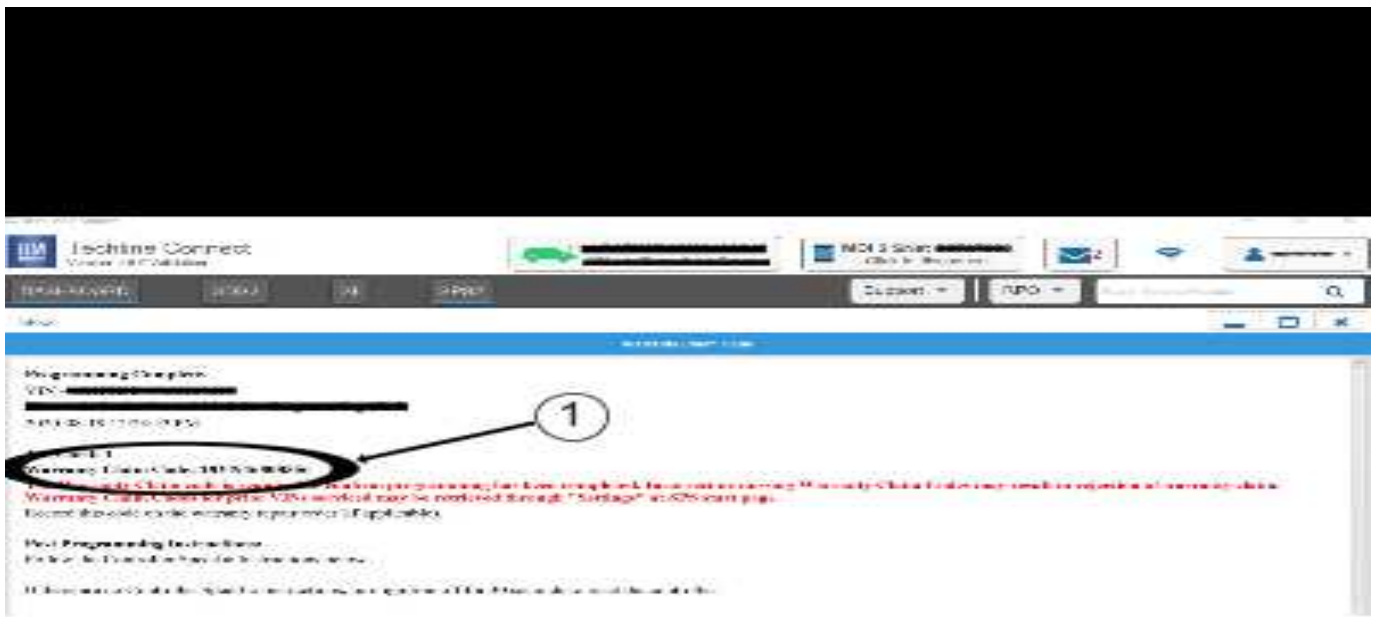
5644478

Important: To avoid warranty transaction rejections, you **MUST** record the warranty claim code provided on the Warranty Claim Code (WCC) screen shown above on the job card. Refer to callout 1 above for the location of the WCC on the screen.

3. Record SPS Warranty Claim Code on job card for warranty transaction submission.
