**SIB 54 04 21**

2023-10-18

GAP IN FRONT SUNROOF SEAL

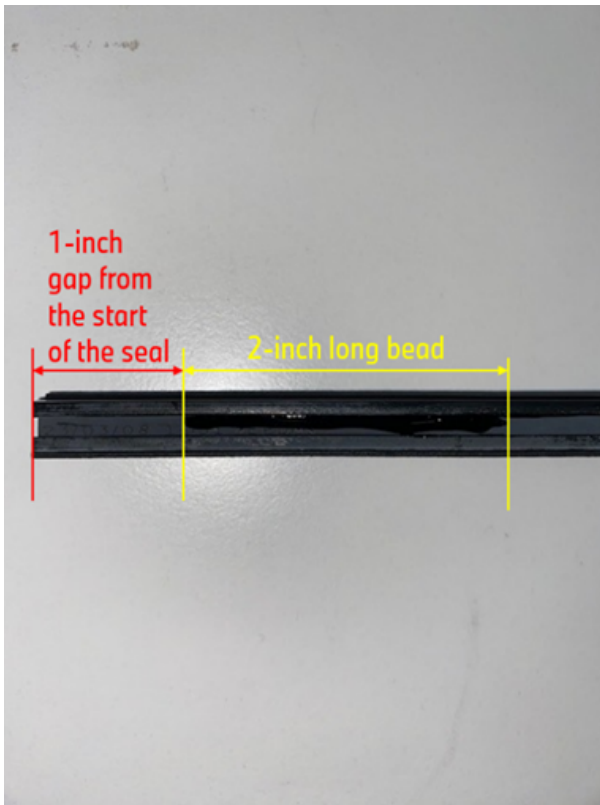
The front sunroof glass seal has shrunk, creating a gap which can cause wind noise or excess water entry.

2. Apply a 2 inch-long bead on both sides of the seal and bond the seal to the glass panel.

Note: Make sure to leave a 1 inch gap from the start of the seal before applying the adhesive.
