REFERENCE:	Nova Bus Manuals
SECTION:	16: Electrical System
RS N°:	MQR 7621-2357
EFFECTIVE IN PROD.:	N/A

SUBJECT:	Wiring Harness - Engine Compartment
JUSTIFICATION:	A bad connection at the ZF transmission connector may cause the transmission to jerk when shifting or show the fault code 188.

Service Instruction
QJ2357 : ZF Transmission Code 188

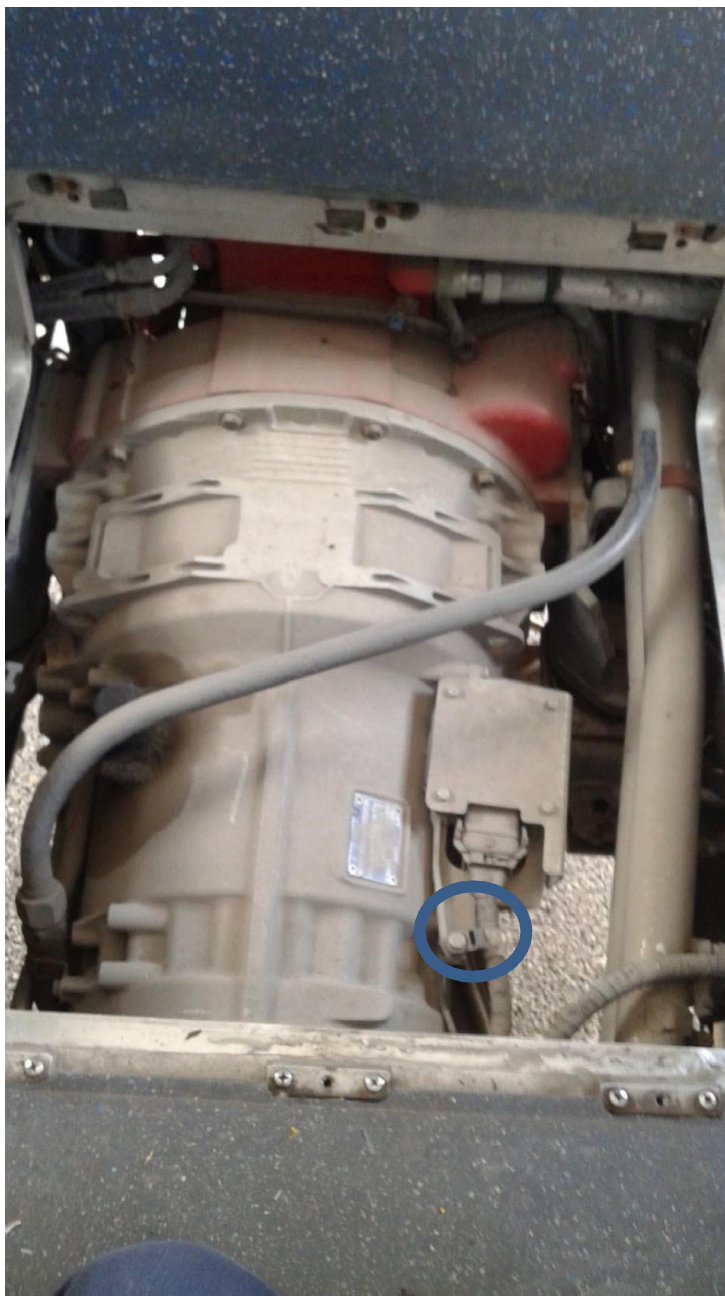
Step # 2:P-Clamp Presence

Description: Look if there is a P-Clamp around 4 inches from the Transmission Control Unit connector to secure the transmission harness. If the P-Clamp is missing, add a P-Clamp and replace terminals and connector

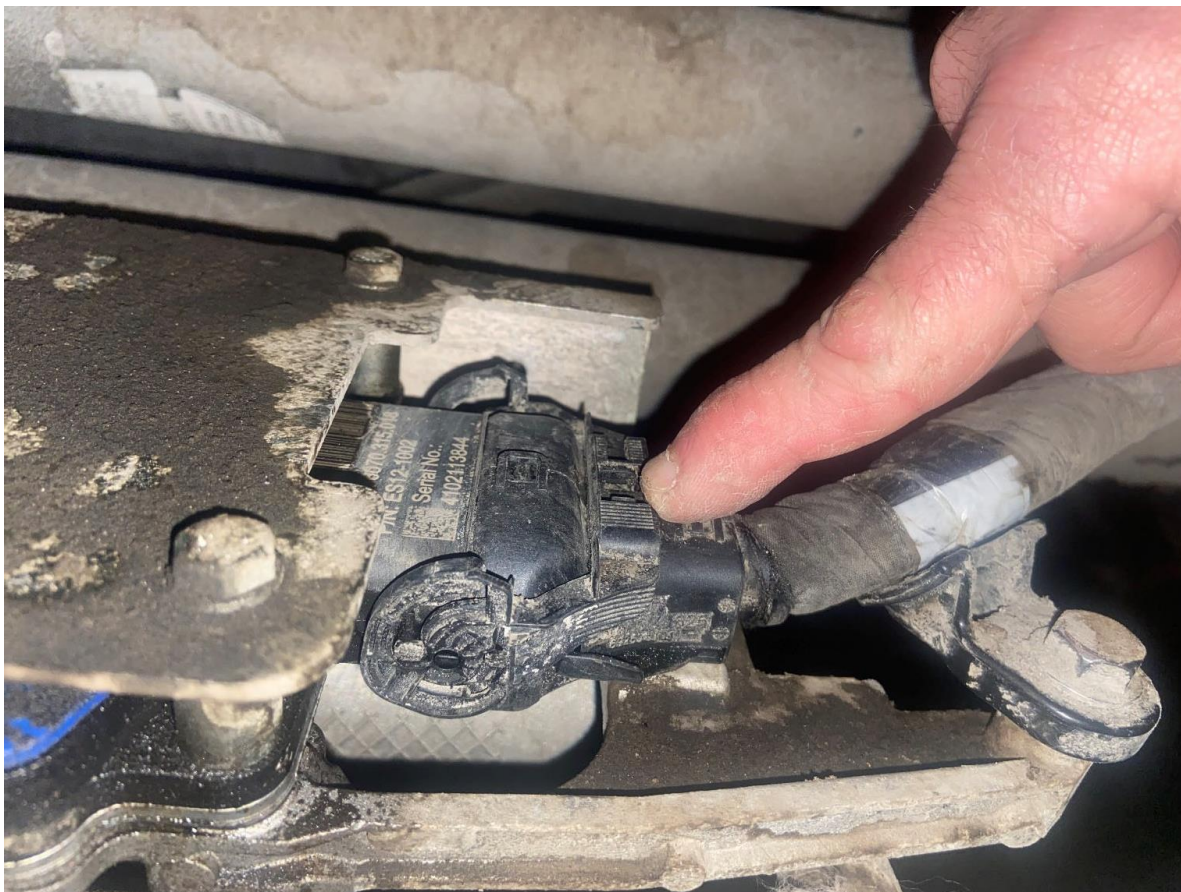
Step # 3: Locking tab on the TCU connector

Description: Look if the locking tab on the TCU connector is broken. If it is broken, replace terminals and connector

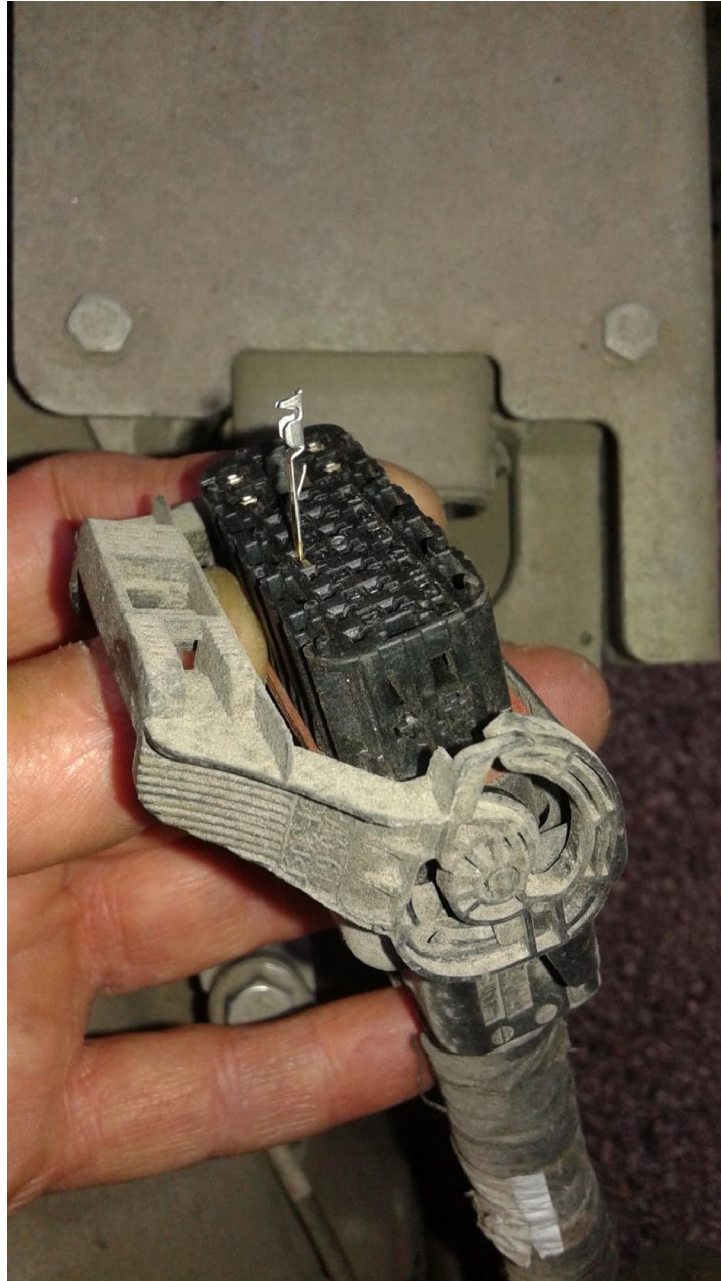
Description: Using a male terminal of the same size as the male connector of the ECU, check if the contact is well made and if there is no verdigris or oxidation on the pin. If it is the case, replace terminals.

One of the five smaller terminals to verify, MLK 1.2 terminals, pin 23

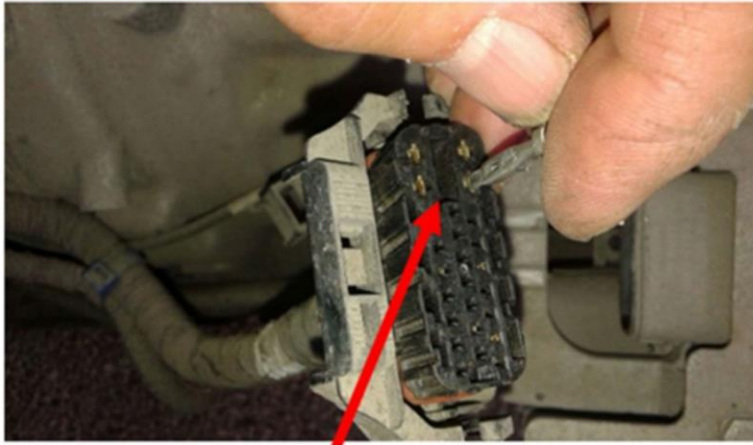
Description: Using a male terminal of the same size as the male connector of the ECU, check if the contact is well made and if there is no verdigris or oxidation on the pin. If it is the case, replace terminals.

Testing a SLK 2.8 terminal on pin 8.
