STAR ONLINE PUBLICATION

Case Number: S2319000007

Symptom/Vehicle Issue: Squeak Noise From Dash Area When Turning The Steering Wheel.

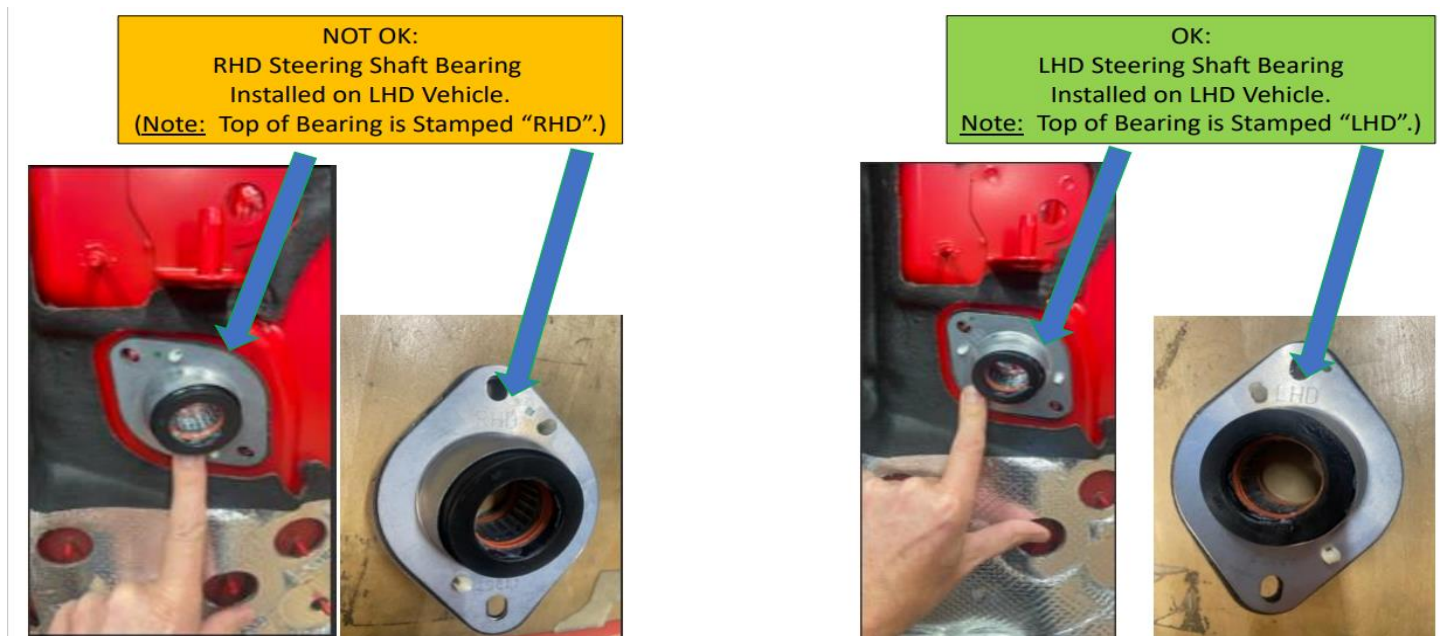
Discussion: Inspect the steering shaft bearing installed in the front bulkhead. The bearing is marked left-hand drive (LHD) or right-hand drive (RHD) to identify its application. If the bearing is not a correct match for the vehicle, a noise may result when turning the steering wheel. Replace the bearing if it does not match the application. See figures below.
