STAR ONLINE PUBLICATION

Case Number: S2318000010

Release Date: September 2023

Symptom/Vehicle Issue: Message in cluster for "Performance Limited Service Fuel System" with no DTC's

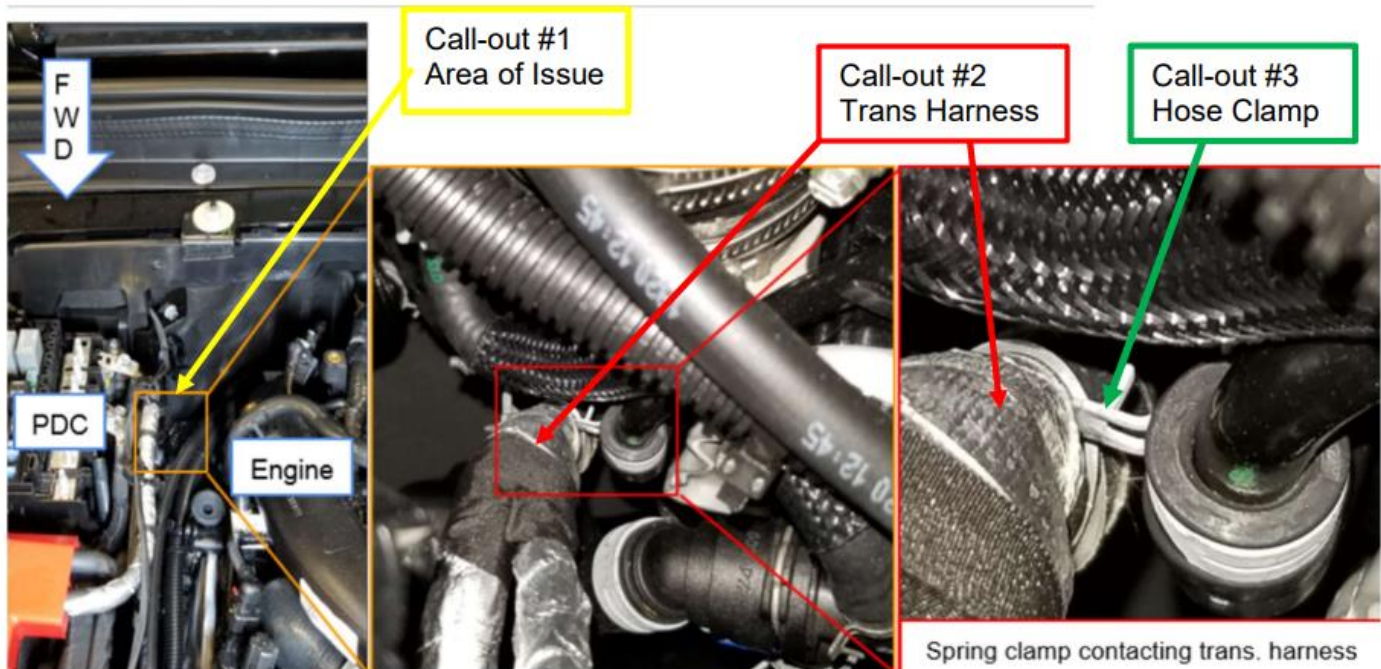
Picture 1

1. Remove the front right tire and wheel liner. Locate the transmission harness at the right rear outboard side of the engine below charge air duct (see picture 1, call-out #1 on page 2 of this document).
2. Check for interference between the hose clamp of the fuel evaporation intake hose (see picture 1, call-out #3 on page 2 of this document) and the transmission harness (see picture 1, call-out #2 on page 2 of this document).

3. If interference is observed, check harness for damage at the contact point between the harness and clamp. Repair circuits as necessary using published wiring repair procedures found in Service Library if damage is confirmed. If no damage is found or apparent, with the engine running manipulate the transmission harness in the suspect area to see if the condition can be duplicated. If it can the harness is suspect and should be replaced.

4. Rotate hose clamp away from harness and re-secure the harness back to original routing to ensure clearance.
