Technical Service Bulletin

01 MIL on, Whistling noise, leaking air Bank 2 - DTC P2ADF00, Engine Crankcase breather

01 23 87 2071318/3 October 23, 2023. Supersedes Technical Service Bulletin Group 01 number 23-78 dated September 20, 2023 for reasons listed below.

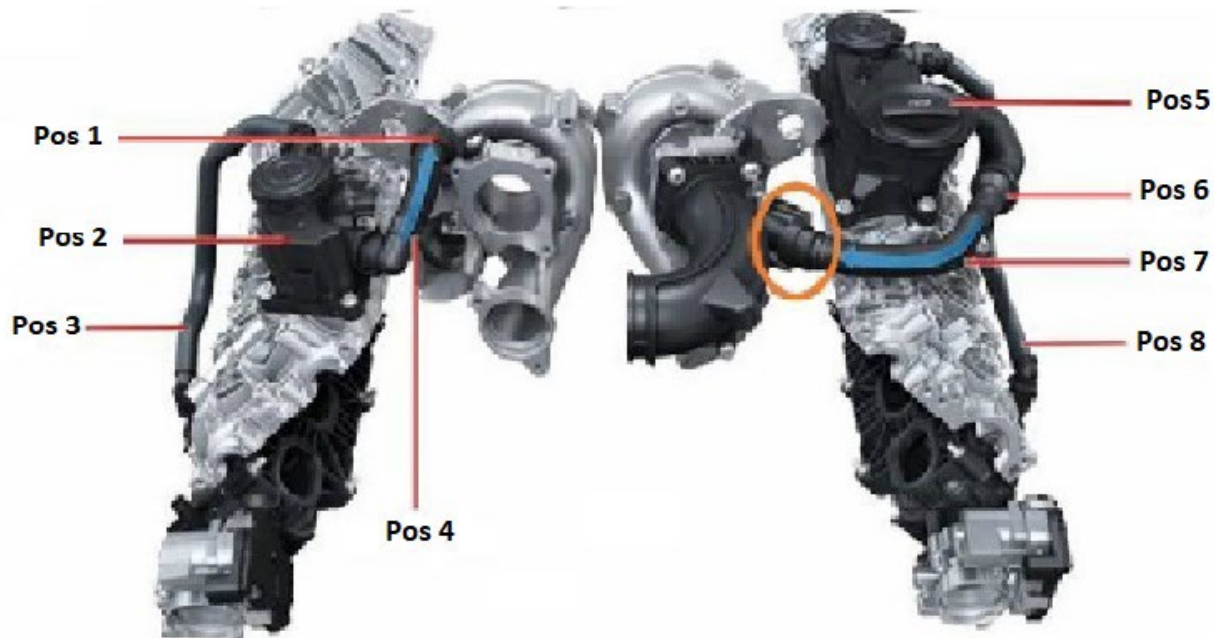
- Item 1: Non-return valve
- Item 2: Oil separator for bank 1
- Item 3 Part load breather line for bank 1
- Item 4: Full load breather line for bank 1
- Item 5: Oil separator for bank 2
- Item 6: Non-return valve
- **Item 7: Full load breather line for bank 2**
- Item 8: Part load breather line

In this case, replace the full load breather line for cylinder bank 2.

1. Do not replace the oil separator for bank 1 or bank 2 or the part load breather lines.
 - a. Please refer to image of the crankcase from the Self Study Program 920493 as a guide.
