Technical Service Bulletin

27 48V Reference: Charging 48V Battery with 12V Charger DTC P0A7D00

27 23 61 2067906/4 October 23, 2023. Supersedes Technical Service Bulletin Group 27 number 23-60 dated September 11, 2023 for reasons listed below.

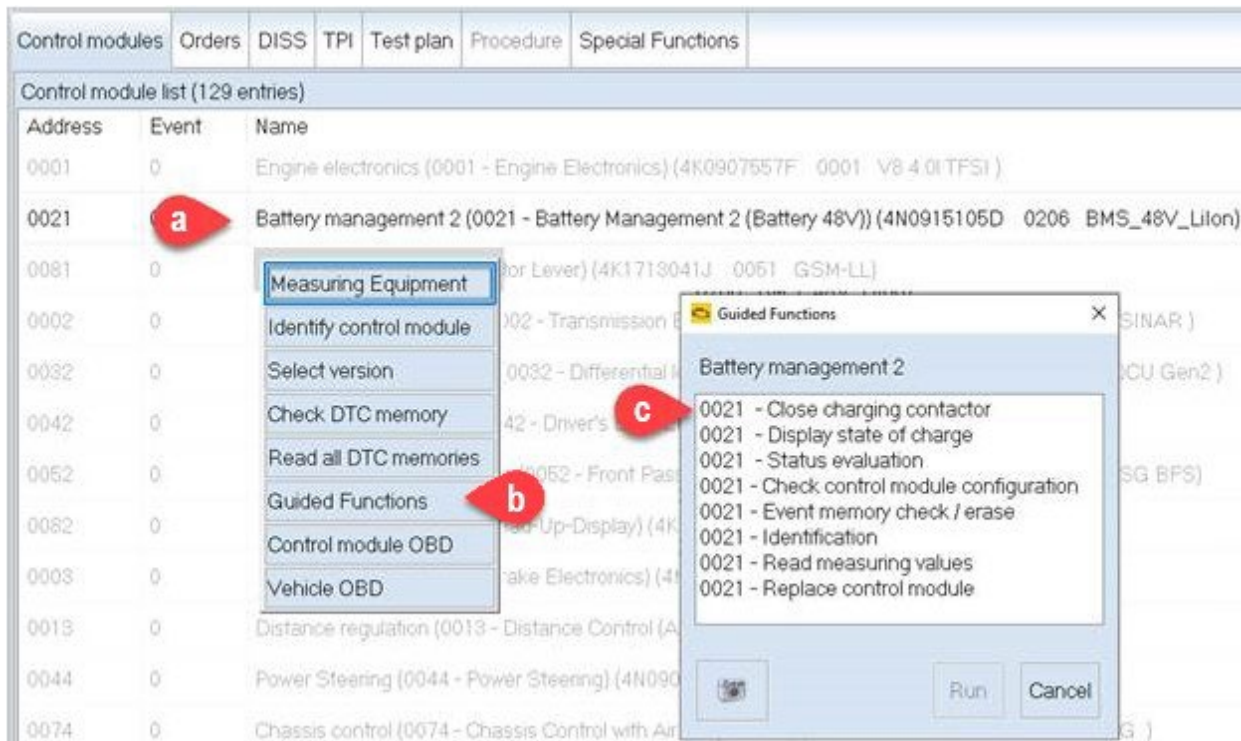
Figure 1: Use the steps below to access the test plan.

2. Shut off all non-essential electrical consumers in the vehicle.
3. In ODIS GFF run test plan “0021 – Close charging contactor” (Figure 1) to set the adaptation for protection relay closed, **do not exit the test plan** once the adaptation has been set.

- a. Right click on 0021 - Battery Management 2.
 - b. Select “Guided Functions”.
 - c. Select “0021 – close charging contactor”.
4. An automatic ignition cycle should be performed by the test plan. A clicking noise should be audible indicating that the battery contactors are closed.
