# Technical Service Bulletin

## 66 Exterior black optic trim is discolored

66 23 03 2060333/4 October 24, 2023. Supersedes Technical Service Bulletin Group 66 number 23-95 dated January 26, 2023 for reasons listed below.

Model(s)	Year	VIN Range	Vehicle-Specific Equipment
All Audi Vehicles	2018 – 2024	All	Black Optic Trim

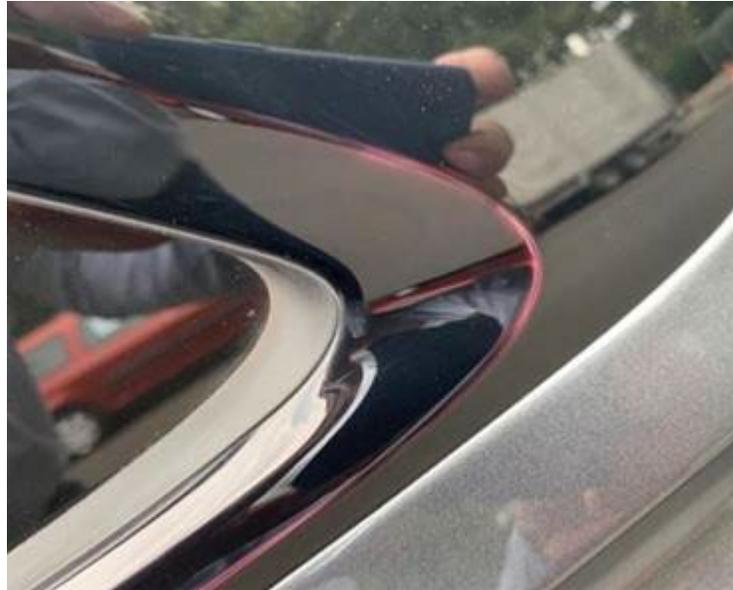
- The exterior trim on a vehicle with black optic package is discolored. It appears to take on a red or purple hue and, in some cases, may take on a grey or metallic appearance.

The ultraviolet radiation resistance in the trim coating was found to be insufficient.

**Figure 1.** The black optic trim takes on a red, purple, grey or metallic hue.

2. Should the symptom described in this TSB present as described, then replace the affected trim. Any other symptom on a black optic trim piece or an issue with a non-black optic trim piece may require AASM authorization as specified in the Warranty Policies and Procedures.

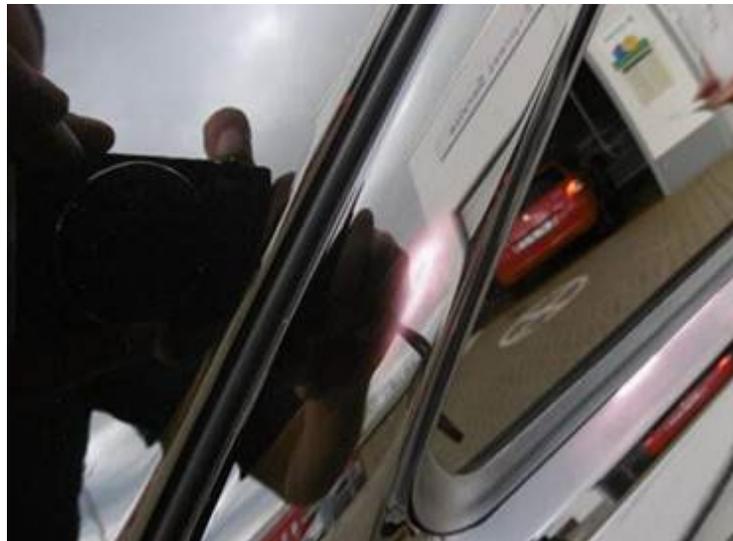
**Figure 2.** An additional example of the trim discoloration.

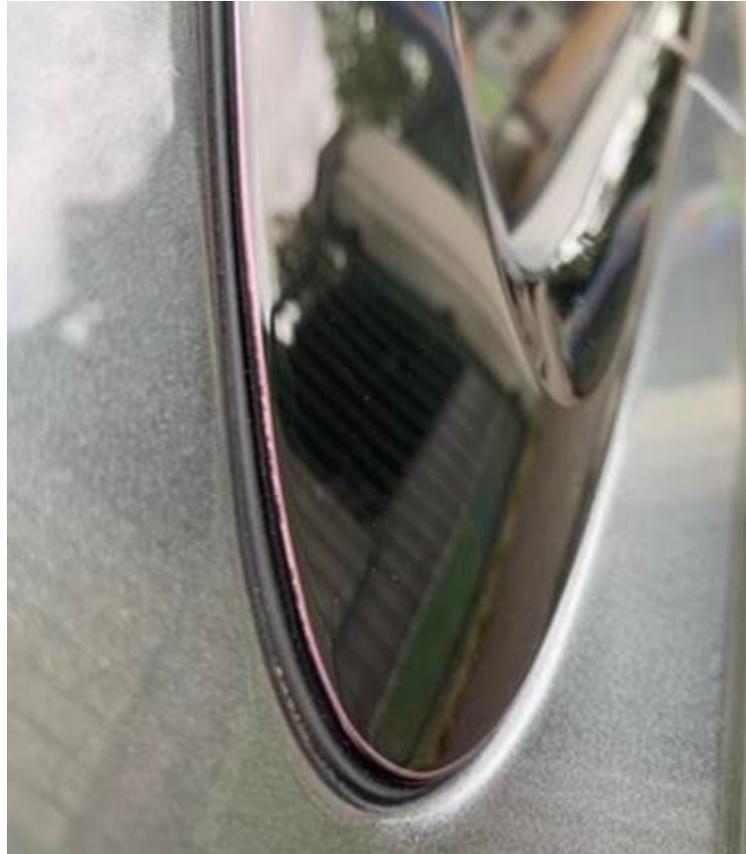
**Figure 3.** Discolored black optic trim around rear side window.
