Technical Service Bulletin

90 Instrument cluster: the Audi virtual cockpit displays a colorful line (pixel error)

90 23 45 2064983/6 October 16, 2023. Supersedes Technical Service Bulletin Group 90 number 22-84 dated December 1, 2022, for reasons listed below.

Model(s)	Year	VIN Range	Vehicle-Specific Equipment
All Audi Vehicles	2019 – 2024	All	With Virtual Cockpit Gen2+

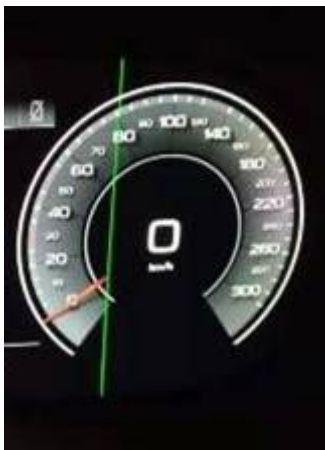
- A red, green, black or blue continuous line is displayed on the instrument cluster (pixel fault) (Figures 1-2).
- The line may be vertical or horizontal.

Figure 1. The vertical line through the instrument cluster display.

Pixel error in the virtual cockpit.

1. Read out the production date of the instrument cluster via ODIS. *Self diagnosis>> Address 17: instrument cluster>>Identification>>Production date*
 - a. If the cluster production date is **AFTER** September 30th 2023, submit a photo of the production date and image of the cluster to DOC-IT and the replace the cluster
 - b. If the production date is **BEFORE** September 30th 2023, no documentation is needed. Replace the cluster.
2. Replacement clusters received **BEFORE** the September 30th 2023 production may still be used.

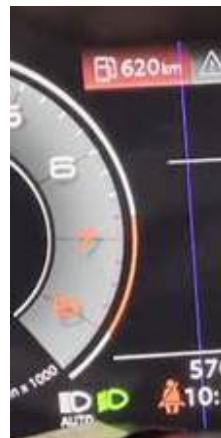
Figure 2. The vertical line through the instrument cluster display.
