# Service Alert

INDENTATION ON REAR OF FRONT SEAT

Service Alert No.: SA-072/23

2022-2023 MX-30

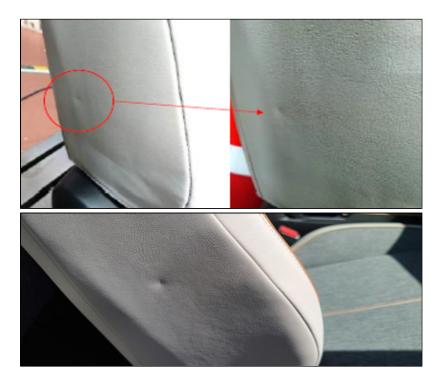
Some customers may report a dent at the side or rear of the front seat. This is caused by the seat belt buckle resting against the seat.

**Do not replace any parts**, this is a normal condition if the customer allows the seat belt to rest against the seat when retracted. If the buckle is moved away from the seat, the dent will go away after a day or two in the sun. The image below
