Technical Service Bulletin

00 Replacement control module is unable to be coded

00 23 80 2071338/3 October 31, 2023. Supersedes Technical Service Bulletin Group 00 number 23-77 dated October 16, 2023 for reasons listed below.

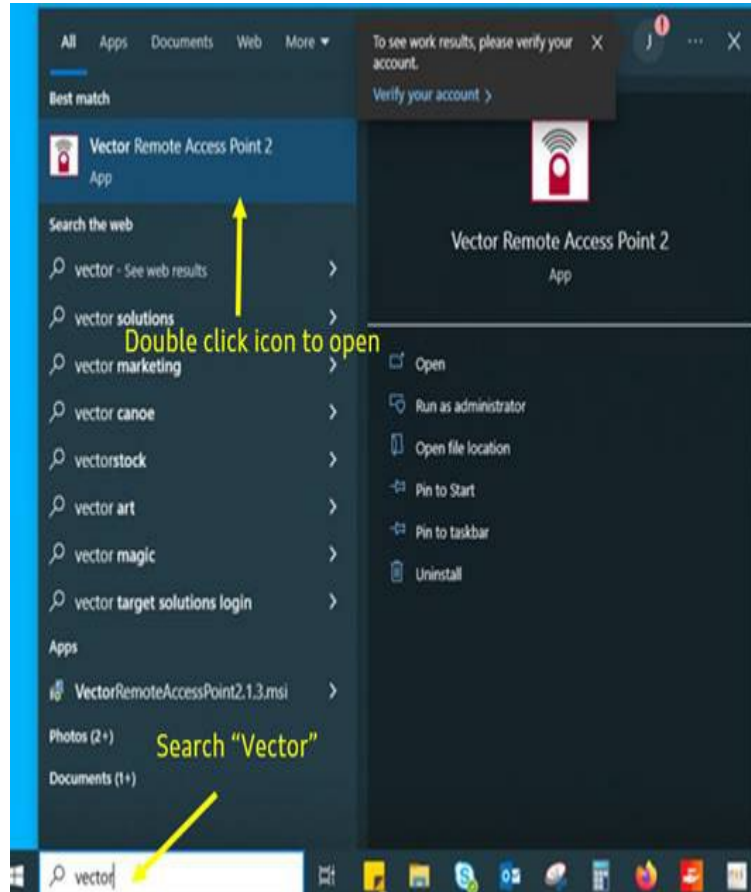
Figure 2: How to access Vector Remote Access Point.

- Search “vector” from the windows desktop search bar.
- Click the Vector icon and accept the prompt when the tool opens.

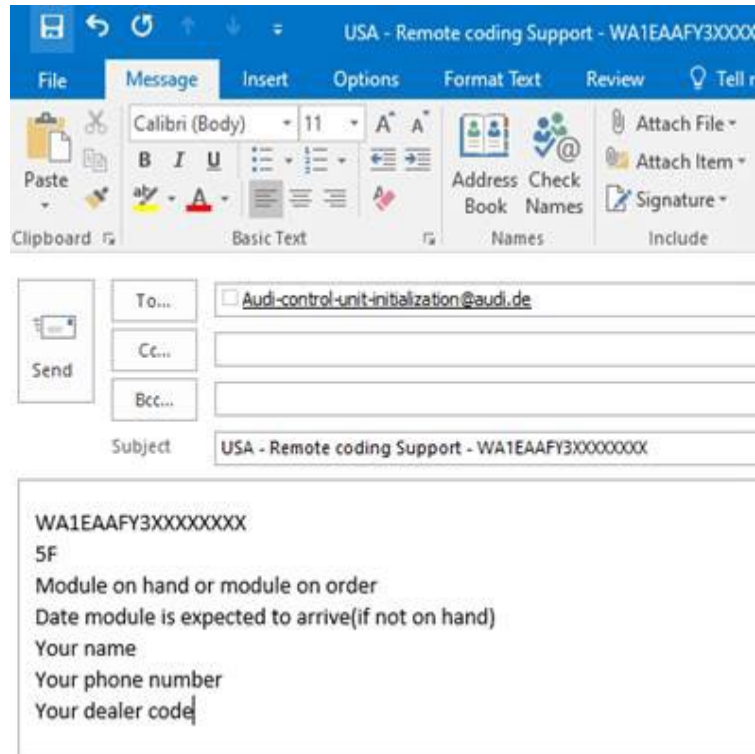
Figure 3: Example email, layout to be used.

1. Email the manufacturer at Audi-control-unit-initialization@audi.de
2. Compose email as follows (Figure 3):

- VIN
- Module address affected.
- Is module on hand?
- When is module going to arrive?
- Contact name and phone number for the individual working on car.
- Dealer code.

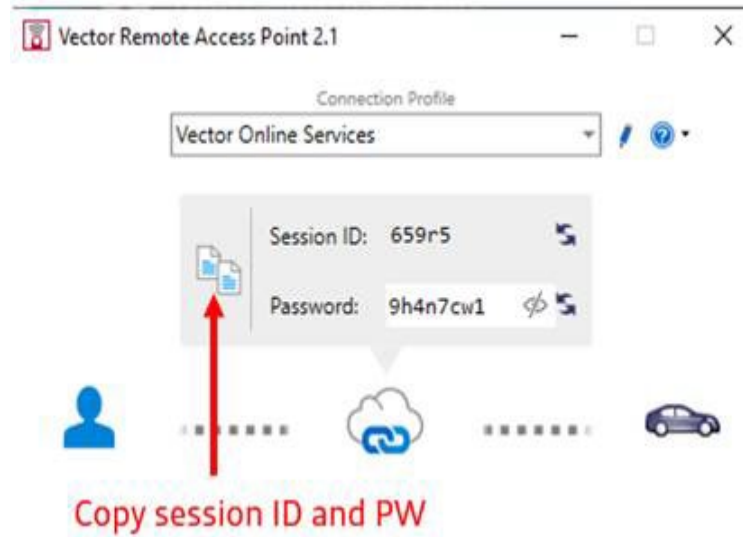
Figure 4: Use the copy button (red arrow) to copy the Session ID and PW.

1. Using the ODIS tester, connect to the Microsoft Teams session using the link from your email.
2. Start the Vector access point (see figure 2 above).
3. Copy/paste the Vector session ID and PW into teams chat window (red arrow figure 4).
4. Audi representative will carry out initial coding of the module using the Vector remote access point.
5. Once instructed, technician will start a new ODIS "Diagnosis" Session.
6. Work with the Audi representative throughout the coding process.
7. Once the remote coding session is complete, carry out any other subsequent work needed.
