# Technical Service Bulletin

## 94 Foreign objects inside a headlight or taillight

94 23 67 2071954/1 October 30, 2023.

Model(s)	Year	VIN Range	Vehicle-Specific Equipment
All Audi Models	2000 - 2025	All	Not Applicable

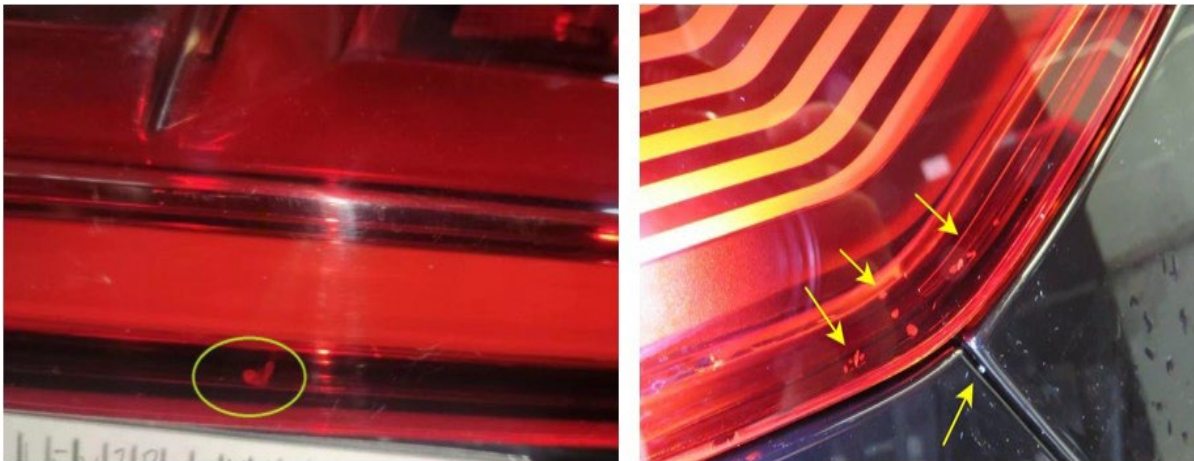
**Figure 1:** View of foreign objects (e.g. insects) inside of the tail light.

- Foreign object(s) are visible inside the lamp.
- No external application of force can be detected.

To ensure a temperature exchange can take place, as well as sufficient air circulation, the headlights and tail lights are designed as open systems. This requires ventilation openings in the housings; these openings are subject to continuous improvement processes which aim to ensure that foreign objects such as insects cannot get into the lights, or that it is at least very difficult to do so.

Such foreign objects have absolutely no effect on the condition, function and service life of headlights and tail lights.

Attempt to remove the foreign object(s) before replacing the affected lamp.

- Remove the tail light which is the subject of the complaint.
- Where possible, remove the dust caps on the tail light housing.
- Working with the utmost care, try using a vacuum cleaner or a pneumatic gun (oil-free compressed air is a mandatory requirement) to remove the foreign objects through the ventilation openings by suction or by blowing them out. Shaking the light slightly may help. If this is not possible, try to move the foreign objects to where they cannot be seen within the tail light.
