Technical product information

Topic	Bentley dynamic ride system warning - DTC P0B2500: Hybrid/EV Battery "A" Voltage low' stored (48 volt system)
Market area	Australia E04 Bentley rest Asia and Australia (6E04),China 723 Volkswagen (Anhui) Automotive CO (6723),China 796 VW Import Comp. Ltd (Vico), Beijing (6796),Germany E02 Bentley rest Europe (6E02),Japan E03 Bentley Japan (6E03),Korea, (South) E08 Bentley South Korea (6E08),United Arab Emirates E06 Bentley Middle East and Africa (6E06),United Kingdom E01 Bentley UK (6E01),United States E05 Bentley USA and rest America (6E05)
Brand	Bentley
Transaction No.	2068946/4
Level	EH
Status	Approval
Release date

Bentayga/New Continental GT/C and New Flying Spur

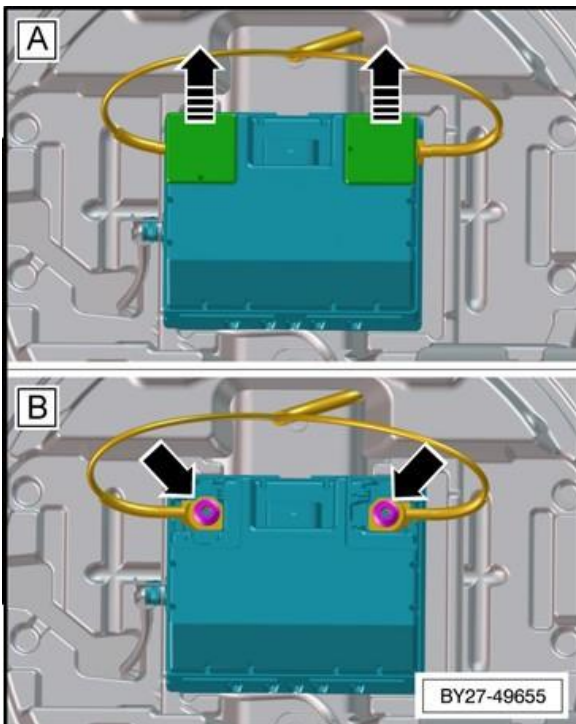
Figure 1

Possible internal fault with super capacitor

- Referring to Rep.Gr 27 - Deactivate the 48 volt system - Refer to 48 volt system - To activate and deactivate
- Referring to Rep.Gr 27 - Check the security of the super capacitor positive and negative terminals (Figure 1) as follows:
 - Remove the caps (A) from the terminals
 - Check the security of the positive and negative terminals
