Technical product information

Topic	Service info: body/equipment: front exterior lighting steamed up/leaks
Market area	Australia E04 Bentley rest Asia and Australia (6E04), China 723 Volkswagen (Anhui) Automotive CO (6723), China 796 VW Import Comp. Ltd (Vico), Beijing (6796), Germany E02 Bentley rest Europe (6E02), Japan E03 Bentley Japan (6E03), Korea, (South) E08 Bentley South Korea (6E08), United Arab Emirates E06 Bentley Middle East and Africa (6E06), United Kingdom E01 Bentley UK (6E01), United States E05 Bentley USA and rest America (6E05)
Brand	Bentley
Transaction No.	2050542/7
Level	EH
Status	Released for publishing
Release date	29-Sep-2023

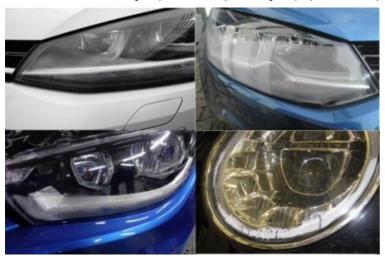
Illustration 1a (example for headlights)
Important: Observe accounting instructions.

1. The lenses of the headlights (illustration 1a) /front fog lamps (illustration 1b) are steamed up/damp from the inside with minor drips.
