Technical product information

Topic	W12 - Oil leak from engine
Market area	Australia E04 Bentley rest Asia and Australia (6E04),China 723 Volkswagen (Anhui) Automotive CO (6723),China 796 VW Import Comp. Ltd (Vico), Beijing (6796),Germany E02 Bentley rest Europe (6E02),Japan E03 Bentley Japan (6E03),Korea, (South) E08 Bentley South Korea (6E08),United Arab Emirates E06 Bentley Middle East and Africa (6E06),United Kingdom E01 Bentley UK (6E01),United States E05 Bentley USA and rest America (6E05)
Brand	Bentley
Transaction No.	2053350/5
Level	EH
Status	Released for publishing
Release date	26-Sep-2023

New Continental GT/C and New Flying Spur

Bentayga

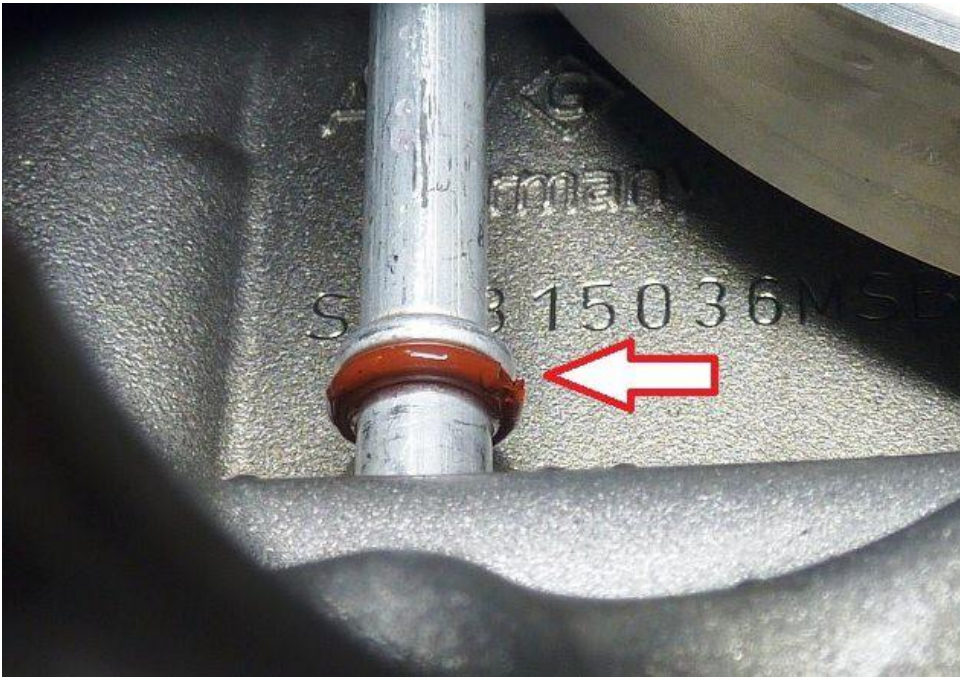
The breather return line and the oil dipstick tube O-rings can split causing an external oil leak.

This can be misdiagnosed as the engine sump leaking.

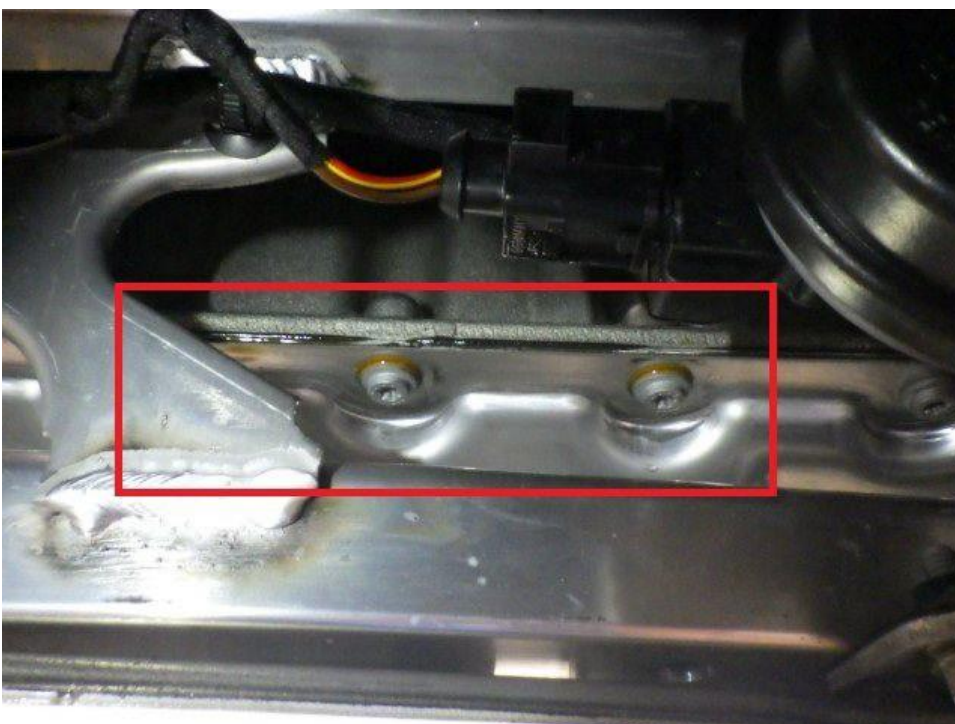
Figure 1

If an engine oil leak is found from the area shown in Figure 1, check the O-rings of both the breather return line and the dipstick tube for leakage. The oil can run down the engine and settle on the sump leading to misdiagnosis, Figure 1.

Should either of the O-rings be damaged or leaking replace according to ETKA.

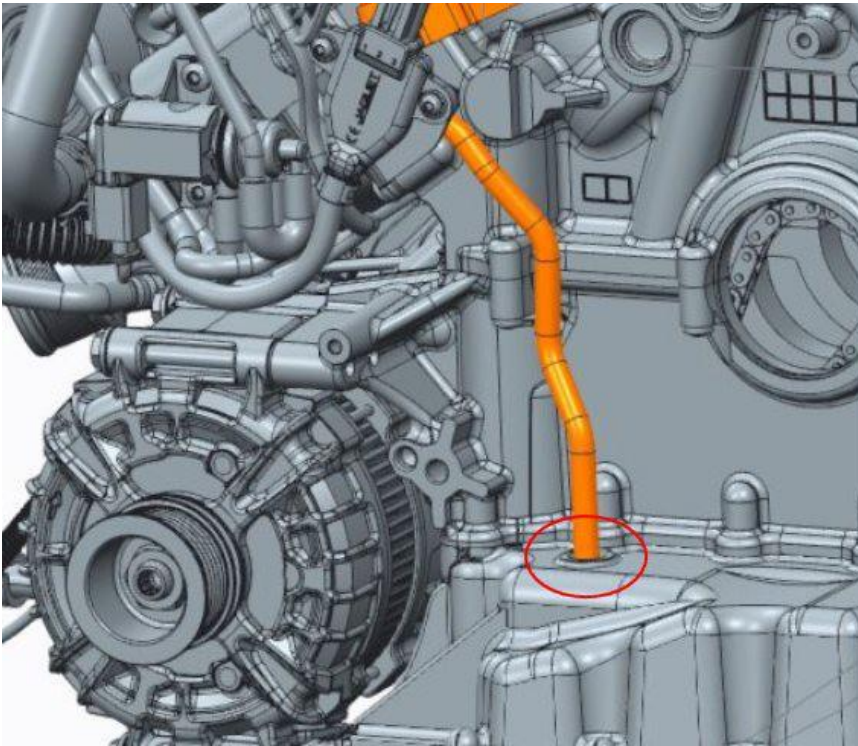
Figure 2

1. Firstly check the breather return line for signs an oil leak in area highlighted in Figure 2. Should a leak be evident, remove the tube and check the O-ring for damage.

Power unit → Engine lubrication → 6.0 L W12 TSI → Oil breather system return line – To remove and fit

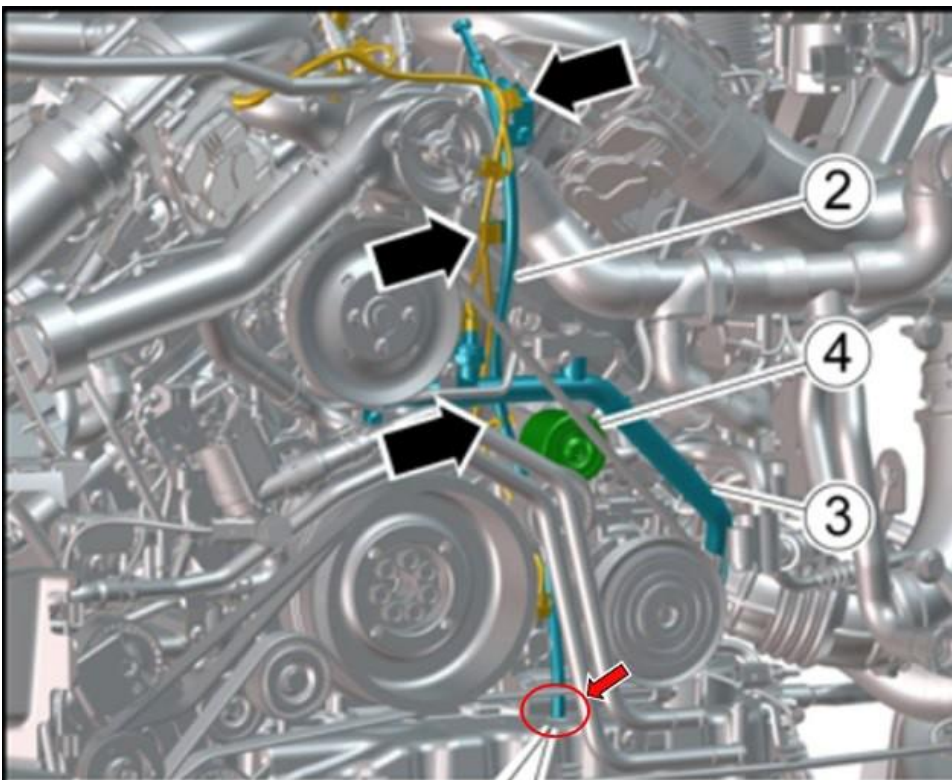
Figure 3

2. Check the dipstick tube for signs of an oil leak in area highlighted in Figure 3. Should a leak be evident, remove the dipstick tube and check the O-ring for damage.

Power unit → Engine lubrication → 6.0 L W12 TSI → Assembly dipstick and tube – To remove and fit
