Technical product information

Topic	Vibration noise from the powertrain when park or neutral is selected					
Market area	Australia E04 Bentley rest Asia and Australia (6E04), China 723 Volkswagen (Anhui) Automotive CO (6723), China 796 VW Import Comp. Ltd (Vico), Beijing (6796), Germany E02 Bentley rest Europe (6E02), Japan E03 Bentley Japan (6E03), Korea, (South) E08 Bentley South Korea (6E08), United Arab Emirates E06 Bentley Middle East and Africa (6E06), United Kingdom E01 Bentley UK (6E01), United States E05 Bentley USA and rest America (6E05)					
Brand	Bentley					
Transaction No.	2053428/7					
Level	EH					
Status	Released for publishing					
Release date	26-Sep-2023

New Continental GT and New Continental GTC - W12

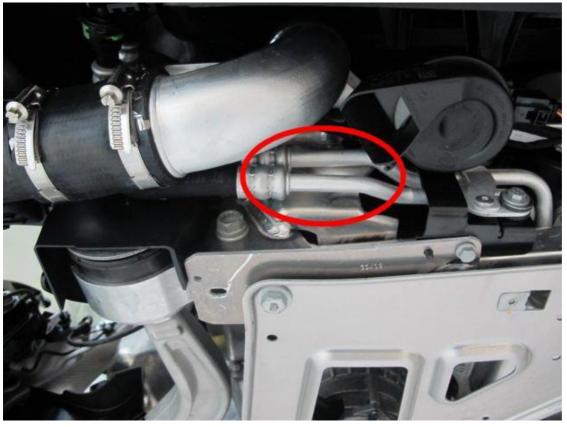
The noise is caused by contact between the transmission cooler pipes and the front subframe

- 1) Referring to Repair manual Rep.Gr 66 Remove the front undersheet
- 2) Referring to Figure 1 Locate the area (circled) at the front right hand side of the front subframe

- 3) Should contact be confirmed Taking care not to damage the pipes or securing points/brackets reposition the pipes ensuring clearance is maintained between the pipes and the subframe
- 4) Refit the front undersheet Refer to Repair manual Rep.Gr 66

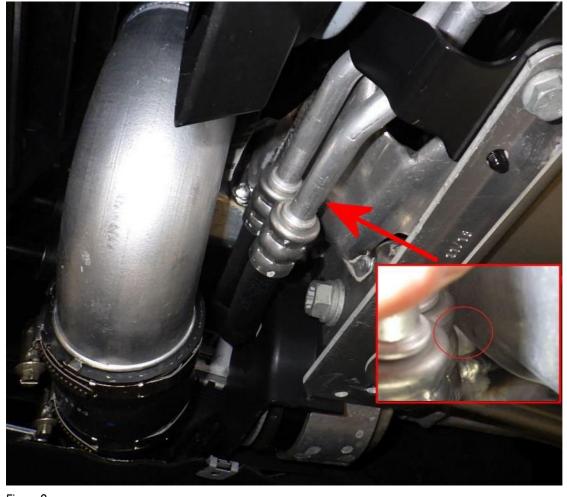
Figure 2

- Referring to Figure 2, Carry out a visual check of the transmission pipes to confirm the pipes are contacting the front subframe at the location shown
