Technical product information

Topic	Emission control system lamp illuminated - DTC P044100 evident
Market area	Australia E04 Bentley rest Asia and Australia (6E04),China 723 Volkswagen (Anhui) Automotive CO (6723),China 796 VW Import Comp. Ltd (Vico), Beijing (6796),Germany E02 Bentley rest Europe (6E02),Japan E03 Bentley Japan (6E03),Korea, (South) E08 Bentley South Korea (6E08),United Arab Emirates E06 Bentley Middle East and Africa (6E06),United Kingdom E01 Bentley UK (6E01),United States E05 Bentley USA and rest America (6E05)
Brand	Bentley
Transaction No.	2053429/6
Level	EH
Status	Released for publishing
Release date	26-Sep-2023

New Continental GT/C Bentayga, New Flying Spur W12

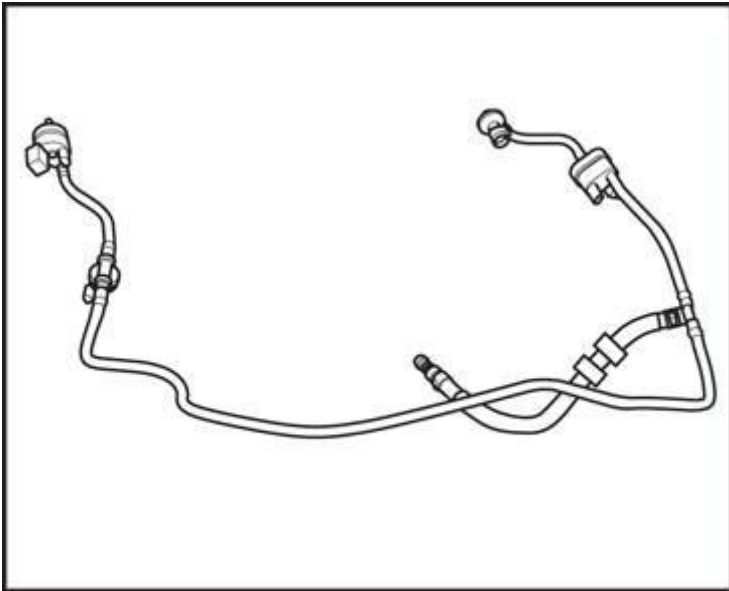
Figure 1

NOTE: The solenoid valves are connected together with a hose, and have to be replaced as a unit as these solenoid valves and hoses are not supplied separately

- 5) Replace the evaporative emission purge valve assembly (Figure 1) - Refer to repair manual Rep.Gr 20 - Evaporative emission purge valve - To remove and fit - pay attention to any debris/contamination falling from the ends of the line during disconnection, If contamination is found in the ends of the line or the engine ports please raise a DISS query

IMPORTANT: Please ensure the openings of the purge line assembly are fully sealed prior to returning back to Bentley Motors (Use the bungs which were fitted to new assembly for this purpose)
