TECHNICAL SERVICE BULLETIN

Front Seat Cushion Sagging - Built On Or Before 11-Feb-2021

23-2235

| Ford 2019-2021 Transit | Built on or before 11-Feb-2021 |

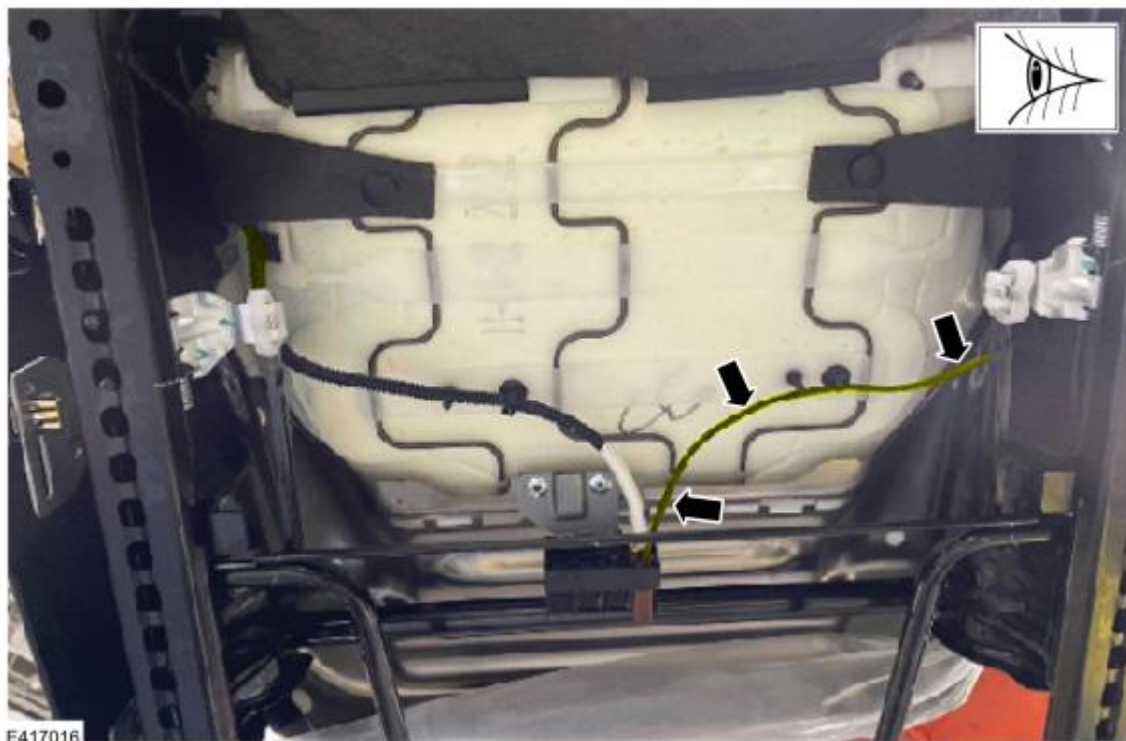
Figure 1

1. Remove the affected driver seat track. Refer to Workshop Manual (WSM), Section 501-10A, starting with Step 2.
2. Inspect the seat airbag deployment circuit for damage as shown in Figure 1. If damage is present, replace the seat airbag harness.

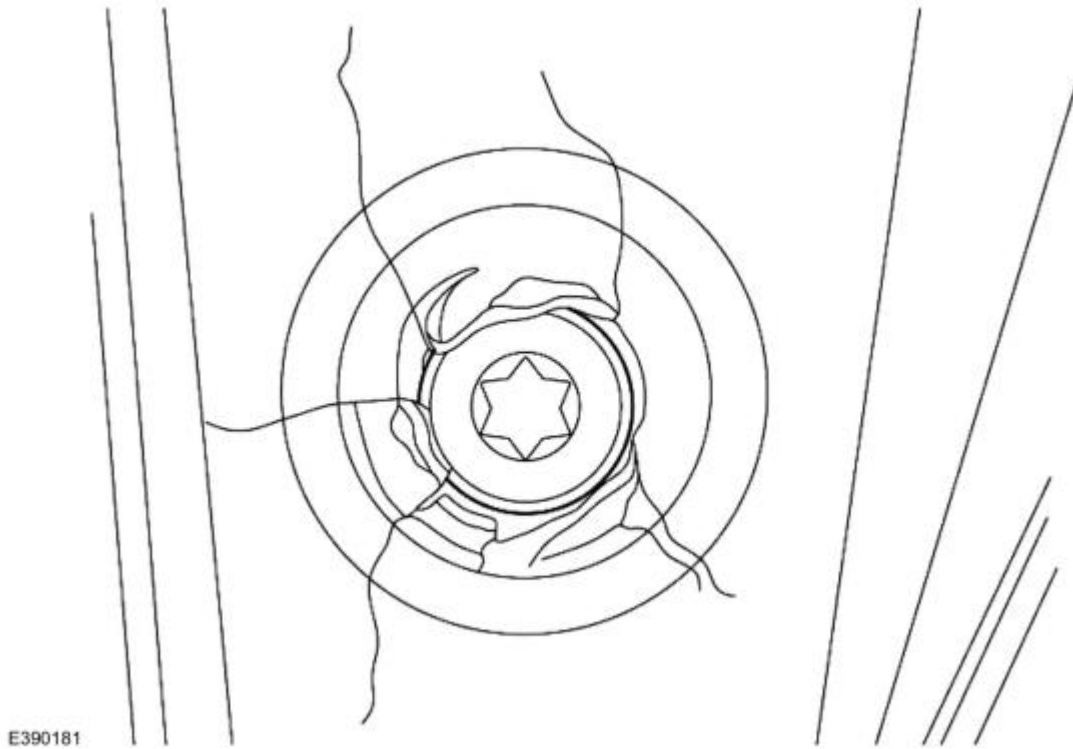
Figure 2

NOTE: Small cracks around the bolt are considered normal. (Figure 2)

(1). Yes - replace the seat track assembly. Refer to WSM, Section 501-10A Front Seats > Removal and Installation > Front Seat Track. Proceed to Step 5.
