Technical product information

Topic	Transmission communication DTC's (Numerous) - W12 engine
Market area	Australia E04 Bentley rest Asia and Australia (6E04),China 723 Volkswagen (Anhui) Automotive CO (6723),China 796 VW Import Comp. Ltd (Vico), Beijing (6796),Germany E02 Bentley rest Europe (6E02),Japan E03 Bentley Japan (6E03),Korea, (South) E08 Bentley South Korea (6E08),United Arab Emirates E06 Bentley Middle East and Africa (6E06),United Kingdom E01 Bentley UK (6E01),United States E05 Bentley USA and rest America (6E05)
Brand	Bentley
Transaction No.	2059068/6
Level	EH
Status	Released for publishing
Release date	03-Oct-2023

New Continental GT/C and New Flying Spur - W12 engine

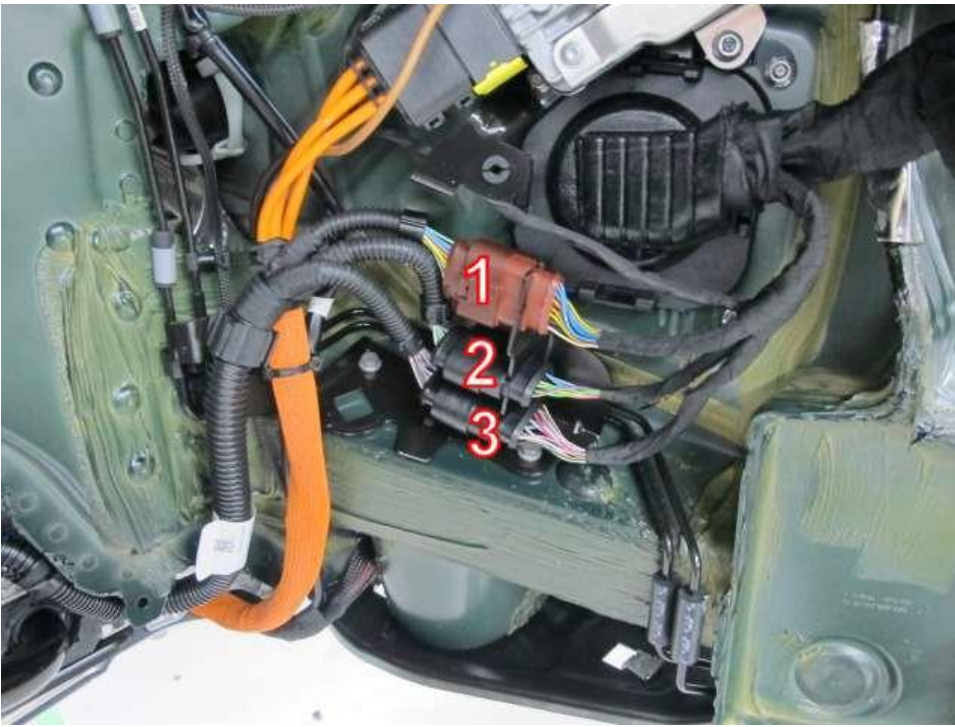
Loose pins within the transmission link harness to the Mechatronic unit for dual clutch gearbox -J743- connections can lead to various transmission communication and hardware based DTC's

- Referring to Figure 2 - Disconnect the three connectors shown

2) Once disconnected carry out pin/terminal grab checks on all three male and female connections

- In the event the main vehicle harness pins are not to specification the applicable pins should be replaced
- Should any issues be found with the transmission link harness and/or pins – the harness should be replaced
- In the event the pins are to specification or the applicable repairs have been done (for example – Harness replacement or pin replacement)
 - Reconnect all three connectors
