Technical product information

Topic	Bentayga - PDC system not working or PDC system false detection
Market area	Australia E04 Bentley rest Asia and Australia (6E04),China 723 Volkswagen (Anhui) Automotive CO (6723),China 796 VW Import Comp. Ltd (Vico), Beijing (6796),Germany E02 Bentley rest Europe (6E02),Japan E03 Bentley Japan (6E03),Korea, (South) E08 Bentley South Korea (6E08),United Arab Emirates E06 Bentley Middle East and Africa (6E06),United Kingdom E01 Bentley UK (6E01),United States E05 Bentley USA and rest America (6E05)
Brand	Bentley
Transaction No.	2059392/4
Level	EH
Status	Released for publishing
Release date	28-Sep-2023

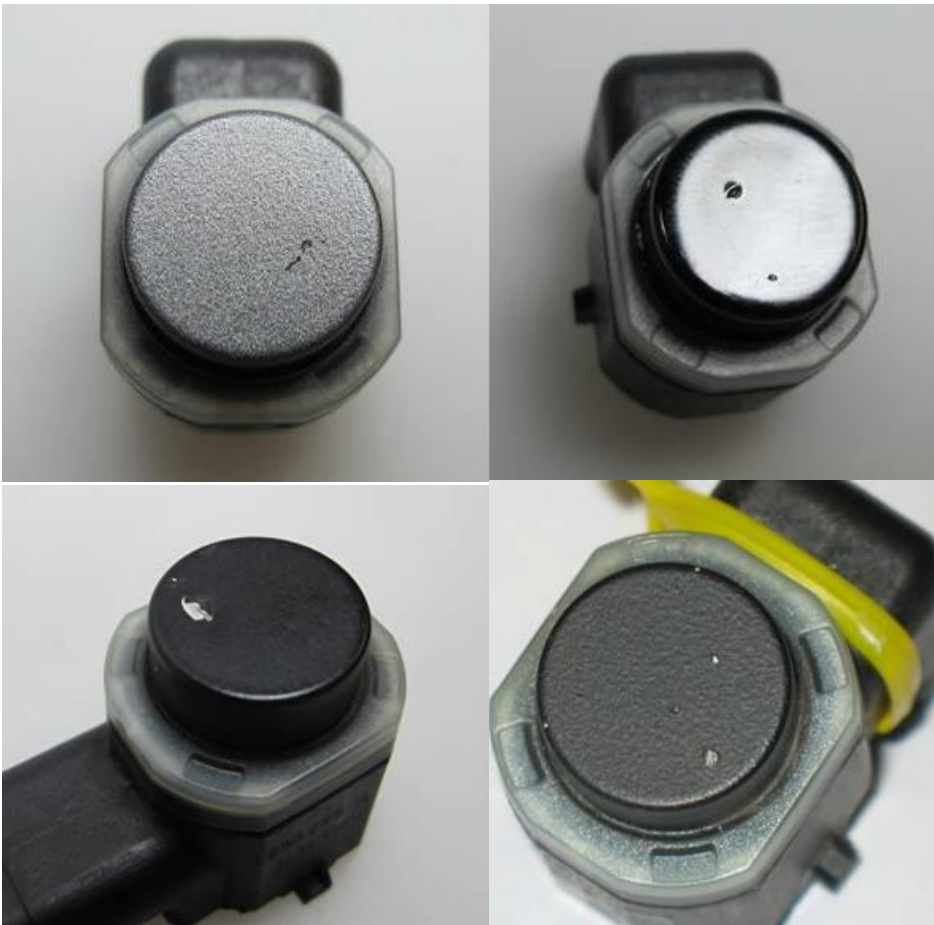
IMPORTANT: With the following examples stone chips led to the failure of the sensor:

Stone chips and scratches are not complaints in the sense of warranty. Therefore dirty sensors should be cleaned and not replaced

Any sensors which are replaced for stone chips, scratches or any other type of damage will not be approved for warranty payment

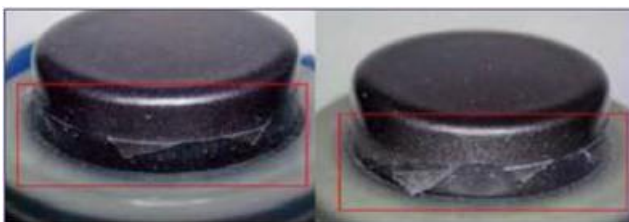
Paint overspray

9. when painting sensors ensure to paint within area specifications, removable layers of paint on the membrane can lead to false signals
