## Rear Spoiler Sporadically Nonfunctional with Fault Message in Instrument Cluster

Topic number	LI77.25-P-073749
Version	5
Function group	77.25 - Wind deflector (spoiler)
Date	10/18/23
Validity	All X290 as of beginning of production without code U99/ U94
Reason for change	Remedy added

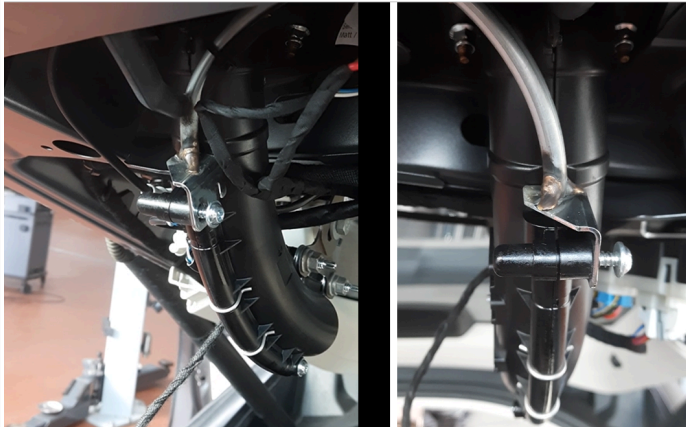
Attachment 1 - Screws

If still NOK: Check screw connection of rear spoiler adjuster (see "Attachment 1") for tight seating (correct any smaller deviations as necessary; SPECIFIED torque ~ 4.5 Nm).

\*The looseness of screws does not compromise integrity of spoilers attachment to vehicle. Screw does not allow for standard operation of spoiler when driving.\*

- If screws are tight: Subject the vehicle to a final inspection/test drive and hand it back to the customer. Work on a software remedy for this fault profile is currently in progress (see below for SW release timeframe based on production date). At commencement of travel, the spoiler can be completely extended manually via the button in the vehicle interior, in order to deactivate the automatic mode for this driving cycle and avoid an additional fault message in the instrument cluster.

- If screws are loose: Create a TIPS case with the following information:
  1. When exactly does the fault message appear (at which speed, when accelerating or braking, automatic mode, etc.)?

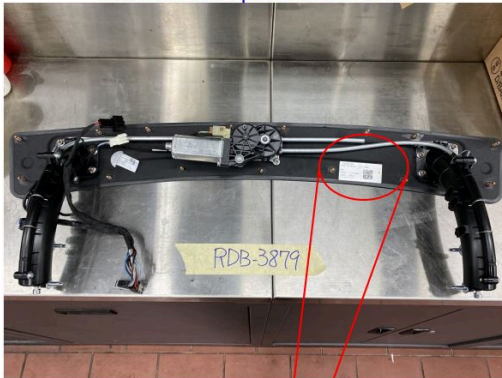
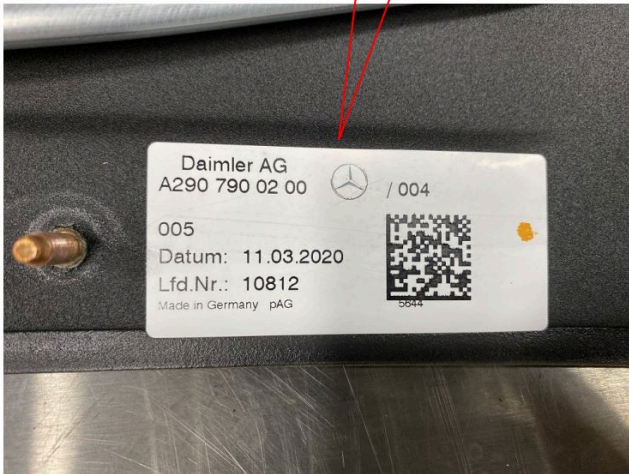
Attachment 2 - Rear Spoiler Production Date

12. Photo of the label on the rear spoiler drive (IMPORTANT: Production/manufacturing date of the rear spoiler must be easily readable) (For an example, see "Attachment 2")
