GLOBAL SAFETY FIELD INVESTIGATIONS  
DCS6704  
URGENT - DISTRIBUTE IMMEDIATELY

Subject: REVISION: N222375790-09 - Customer Satisfaction Program  
Park Assist Retrofit  
Final VINs

# Customer Satisfaction Program

## N222375790 Park Assist Retrofit

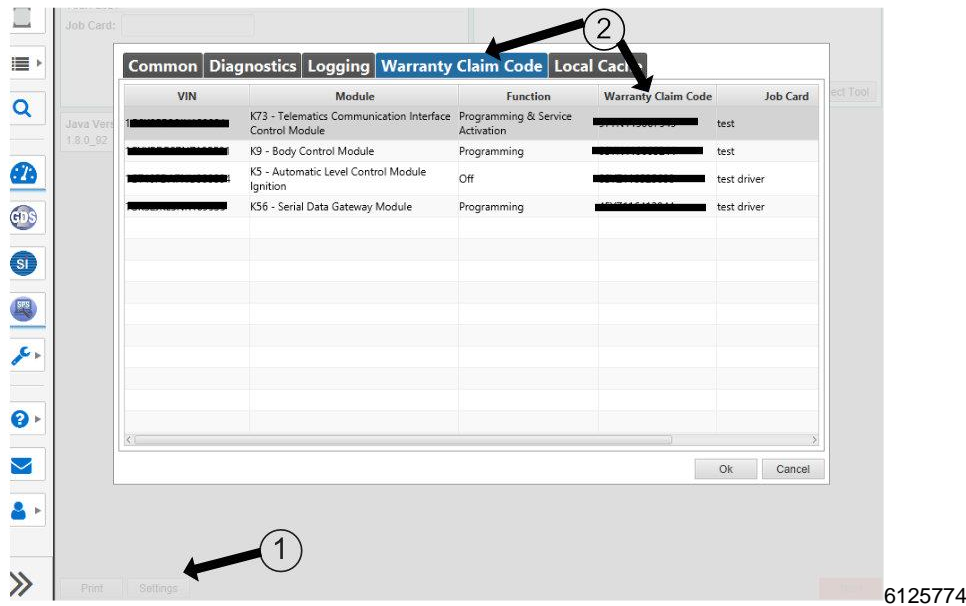
**Warranty Claim Code Information Retrieval**

If the Warranty Claim Code was not recorded on the Job Card, the code can be retrieved in the SPS2 system as follows:

- Open TLC on the computer used to program the vehicle.
- Select and start SPS2.
- Select Settings (1).
- Select the Warranty Claim Code tab (2).

The VIN, Warranty Claim Code and Date/Time will be listed on a roster of recent programming events. If the code is retrievable, dealers should resubmit the transaction making sure to include the code in the SPS Warranty Claim Code field.

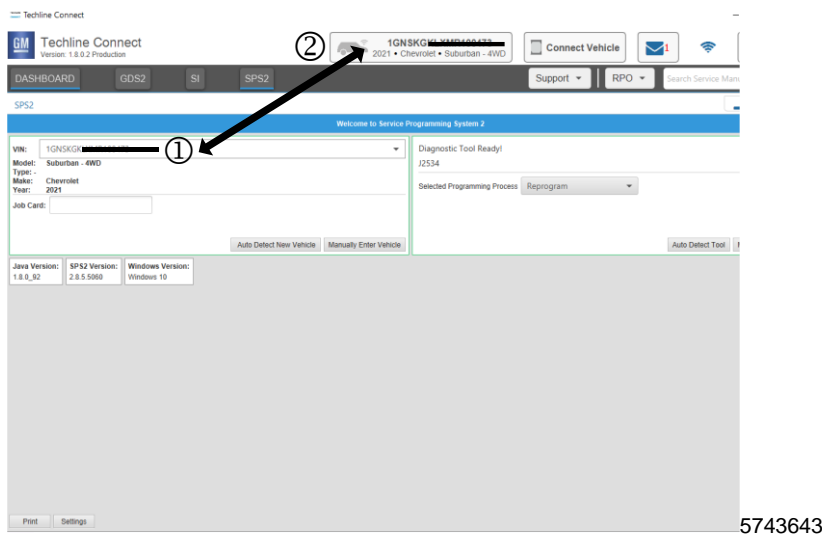
**Caution:** Be sure the VIN selected in the drop down menu (1) is the same as the vehicle connected (2) before beginning programming.

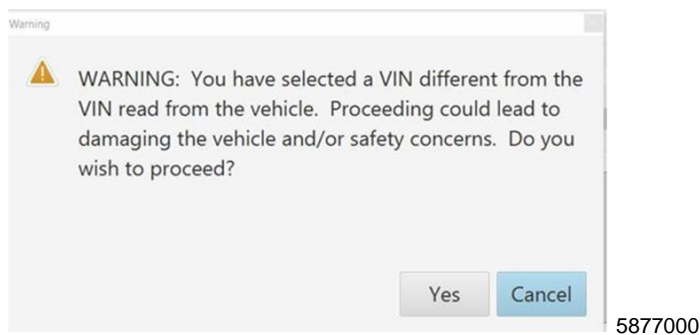
**Important:** If the vehicle VIN DOES NOT match, the message below will be shown.
