## X167 GLS600 Maybach - CCR tablet cannot be connected to the MBUX

Topic number	LI82.60-P-076966
Version	1
Function group	82.60 - Radio, audio, video systems
Date	10/9/23
Validity	Mercedes-Maybach GLS 600 with code 447
Reason for change

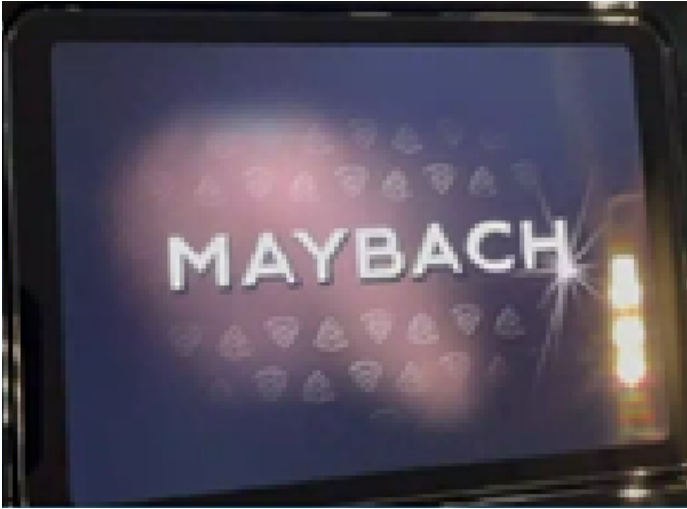
Attachments	
File	Description
<a href="#">correct SCN.PNG</a>	View with correct coding

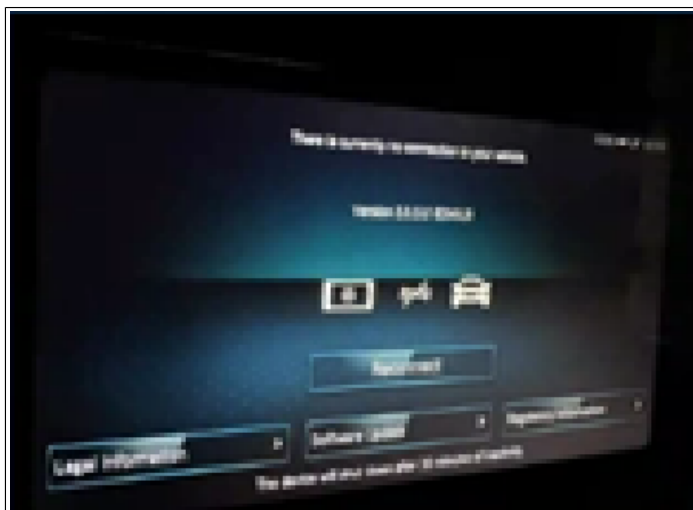
<a href="#">wrong SCN.PNG</a>	View with incorrect coding

SCN Coding in tablet cradle A105/6 (TAS)

Perform scn coding in the tablet cradle A105/6 (TAS)
