ID # CBR-995

Mack Chassis - Telematics Gateway (TGW, MID 142) Losing Communication With The Instrument Cluster (IC) - Counts Of Fault Code (FC) MID 140 PSID 239 FMI 12 Data Link, MID 142 Faulty Device or Component Logging, Possibly Following Engine Start

TGW Possibly Missing From Product Information In Premium Tech Tool (PTT) - OBD13 Through OBD16 Emissions With TGW1 Or TGW2

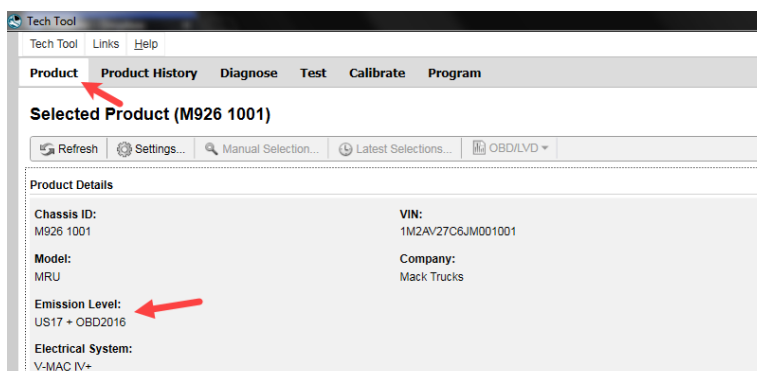
Verify the chassis emissions level first.

- Details can be found in the Product Details box on the Product tab in PTT as seen below:

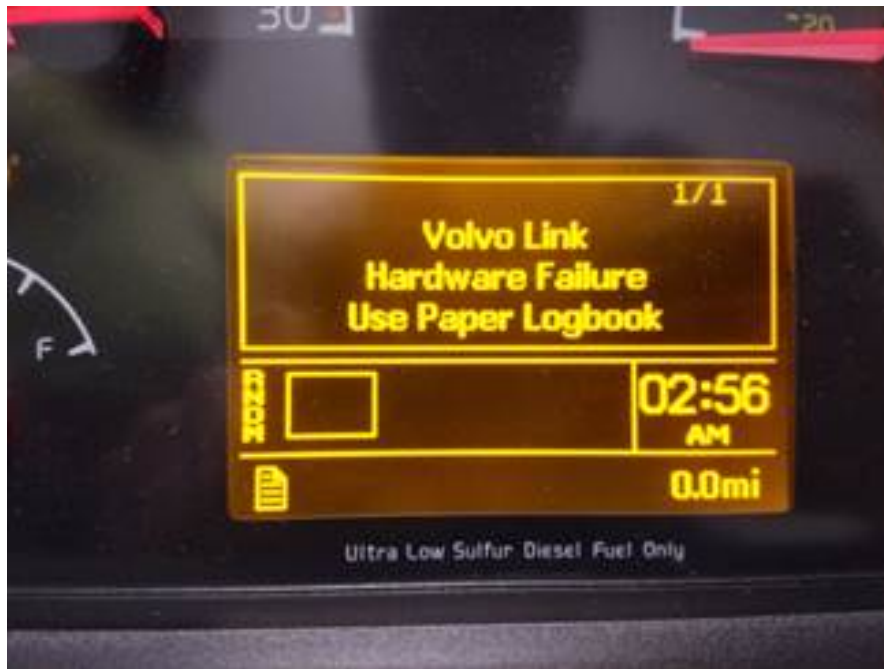
This message occurs when the Telematics Gateway (TGW) is not being detected on the J1587 datalink to the Instrument Cluster. This Message only appears on the Volvo DID. Mack vehicles will not show any dash message. Tech Tool will be the source of indications for the Mack vehicle. Both will have a high count of MID 140 PSID 239 FMI 12 in the inactive faults for Telematics Gateway ECU.

- **Behavior:** Sometimes (randomly) at TGW2.1 startup the 3G modem fails to start. If this happens, the TGW2.1 will go into a situation to constantly restarting itself (instead of a controlled retry to restart the modem), resulting in loss of all TGW2.1 functionality until power is cut.
- **Root cause:** Management of failed modem restart missing in the SW
- **Failure recovery:** Cut battery power, restart
- **Impacted vehicles:** All vehicles with TGW2.1 3G HW and 23035402 SW

- **Corrective action:** Reprogram with previous 22957679 SW
- The TGW is not defective and can be corrected with new software programming.
- With this condition, any Uptime services or Partnered services will not report as designed.
