Service Bulletin

Bulletin No.: 22-NA-081

Subject: Paint Peeling or Chipping on Front Fascia at Headlamp or Fender Seam

Brand:	Model:	Model Year:		VIN:		Engine:	Transmission:
		from	to	from	to		
Chevrolet	Corvette	2020	2024	—	—	All	All

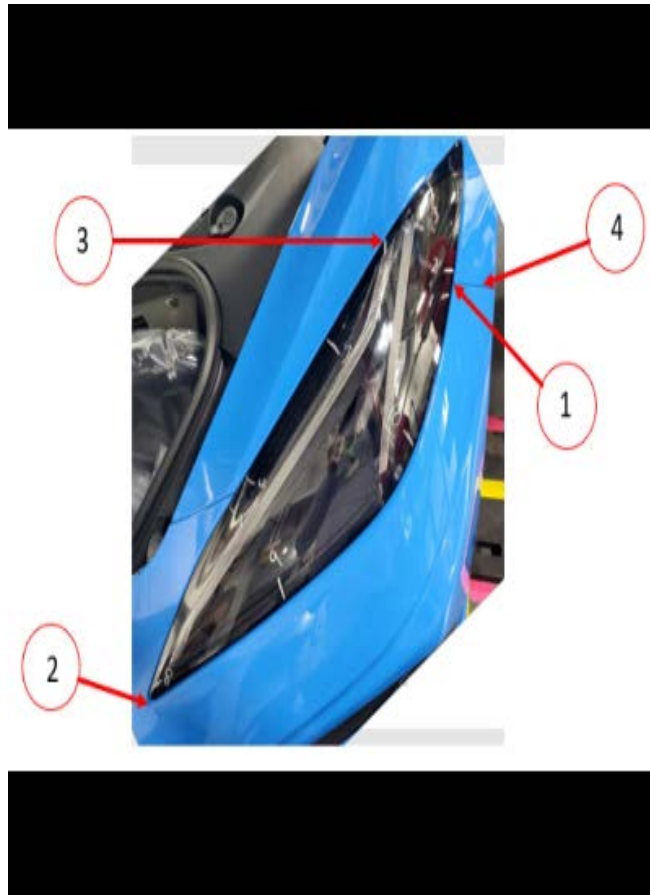
6041596

- There are four potential high contact areas where the paint may chip or peel:
1. Fender/fascia under headlamp (see Service Bulletin # 20-NA-124: Small Front Fascia Paint Chip Below Headlamp).
 2. Front corner of headlamp to the fascia.
 3. Head lamp tight to fender.
 4. Front fascia to fender.

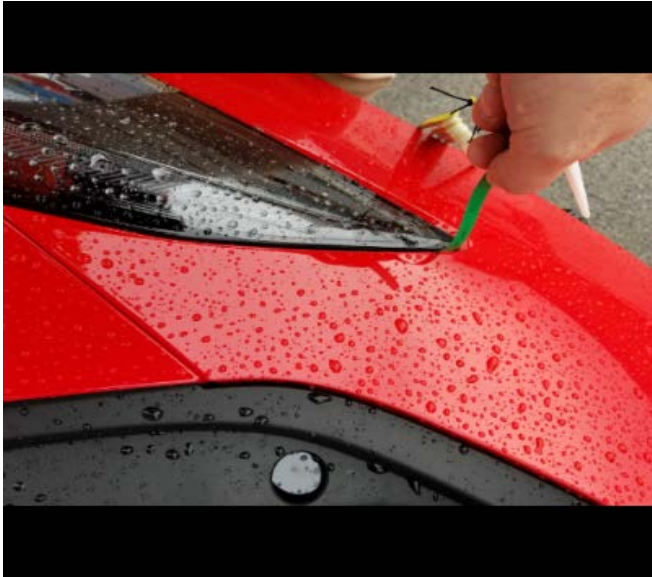
6041601

2. Check for a tight gap at area # 2.

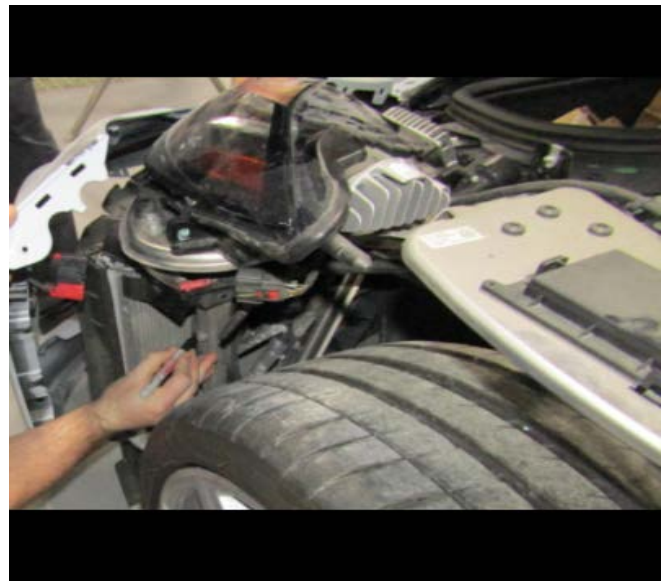
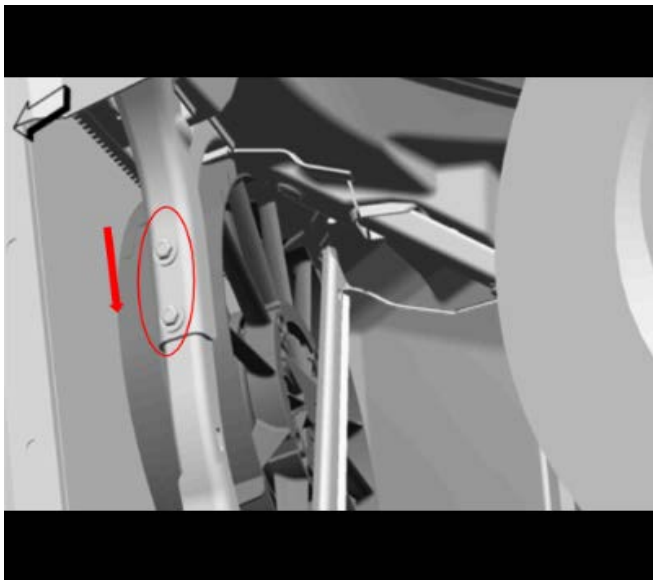
6041609

8. If a tight gap is noted at area #3, mark the location of the 2 cobra bracket bolts on each side of the vehicle and adjust the brackets:

- 8.1. Loosen the cobra bracket bolts.
- 8.2. Lowering the bracket will create a larger gap between the headlamp lens and the fender.
- 8.3. Install a 0.5 mm feeler gauge between the headlamp and fender gap. Tighten the cobra bolts with the gauge in place.

Tighten the bolts to 9 N•m (80 lb in).
