Technical product information

Topic	Keyless door entry does not work - Front Outside Door Handle(s) - Touch Sensor DTC B147613 present
Market area	Australia E04 Bentley rest Asia and Australia (6E04),China 723 Volkswagen (Anhui) Automotive CO (6723),China 796 VW Import Comp. Ltd (Vico), Beijing (6796),Germany E02 Bentley rest Europe (6E02),Japan E03 Bentley Japan (6E03),Korea, (South) E08 Bentley South Korea (6E08),United Arab Emirates E06 Bentley Middle East and Africa (6E06),United Kingdom E01 Bentley UK (6E01),United States E05 Bentley USA and rest America (6E05)
Brand	Bentley
Transaction No.	2062257/5
Level	EH
Status	Released for publishing
Release date	29-Sep-2023

New Continental GT/GTC and New Flying Spur including Hybrid

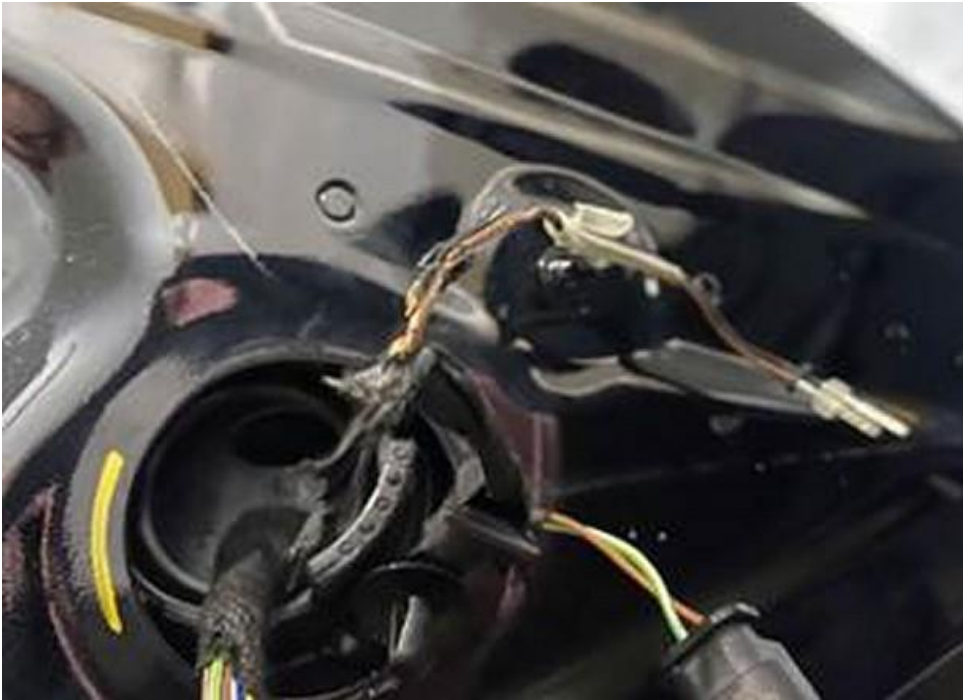
Figure 1

- Referring to Figures 1 and 2 - Perform a check of the wiring that is routed through the exterior door handle (from the convenience control module), including the wiring inside the clear heat shrink or insulating tape
- In the event that any wires show damage or signs of chaffing/breaks continue with the suggested repair as detailed in Step 3

3) Repair the broken or damaged wires as per Rep.Gr 97

TIP: Where possible, extend the length of the wires by 10mm

- Ensure the wiring does not clash with and components in particular the window mechanism
