**Lightweight Glass Panes Cracked – Identification and Possible Causes**

Models	Model Year	Model Type	VIN Range	Vehicle-Specific Equipment
911	2021 - 2024	992110 992120 991130 992140 992150 992410 992420 992430 992440 992450 992460 992810 992820 992850	n/a	+VW4

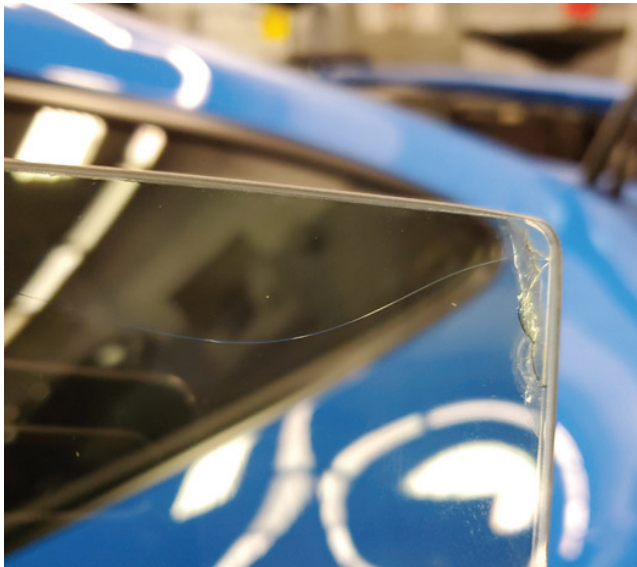
**Figure 1 - Door glass: cracks in the top corner**

There are two main causes for this condition:

- > The door glass is misaligned, which can cause contact between the door glass and the rear quarter glass, or
- > Force applied to the glass (i.e., instead of the door sill) throughout the door closing process can bend the glass enough to cause contact with the rear quarter glass, despite a proper window alignment with no force applied.

Updated lightweight door glass parts have been developed to address this complaint. Please see the *Door glass: cracks in the top corner* section of the Service Information for repair instructions.

Please replace the affected glass pane(s) with the updated parts (index "H"), as instructed in *WM 644019 – Removing and installing door window glass*.

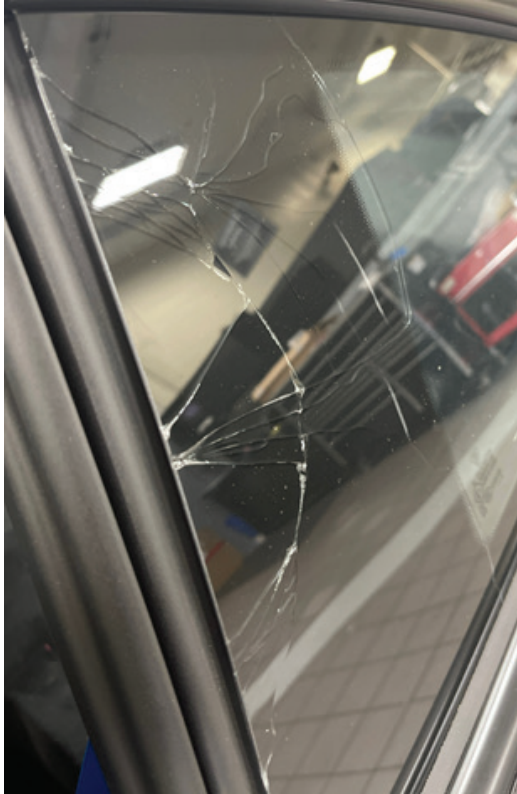
**Figure 2 - Rear quarter glass (side window pane): cracks near front edge**

There are two main causes for this condition:

- > The door glass is misaligned, which can cause contact between the door glass and the rear quarter glass, or
- > The quarter glass mounting nuts are over-torqued

This condition is possible on both the driver and passenger sides of the vehicle.

Please replace the affected glass pane(s) as instructed in *WM 647519 – Removing and installing side window (Coupe)*.

Please exercise additional caution when tightening the fastening nuts for the glass pane. Applying too much torque to the fastening nuts may cause the glass pane to crack.

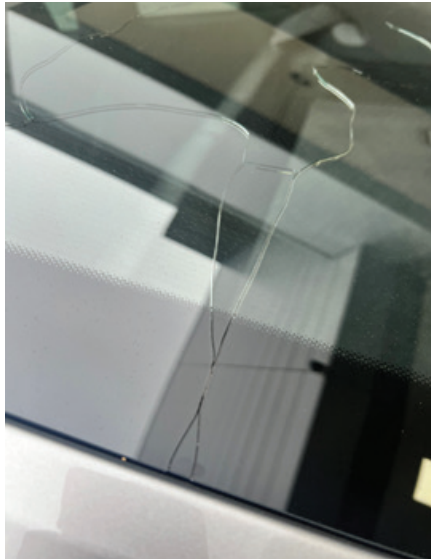
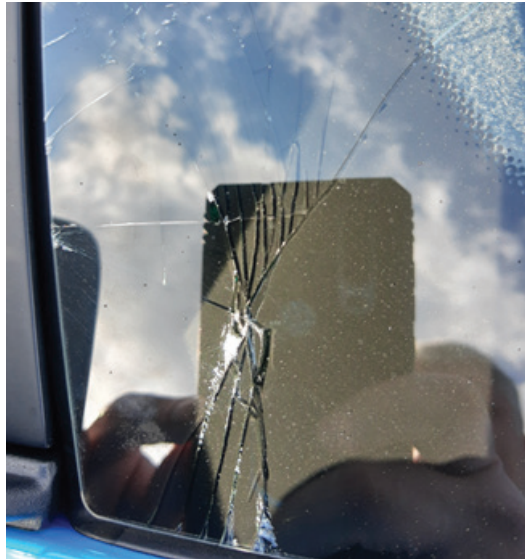
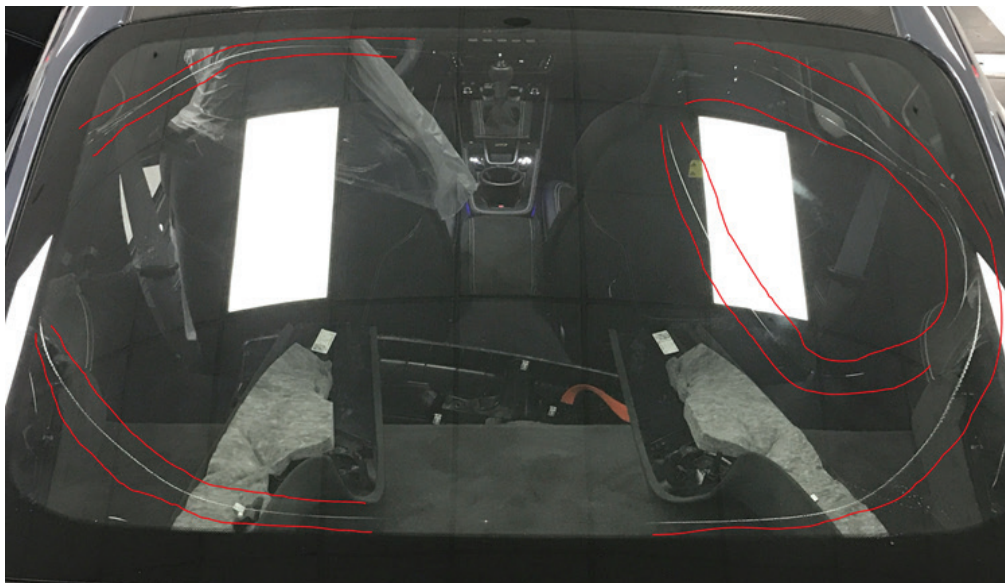
**Figure 3 - Rear window glass: various cracks**

Stress cracks in the rear window glass are currently being analyzed by Porsche. The root causes for the different kinds of stress cracks are unknown at the time of publication of this document.

Please replace the rear window glass as instructed in *WM 648619 – Removing and installing rear window*.
