# UPDATE PRIOR TO SALE NOTICE

Global Service Action  
Number: N819 UPS3623-2

<b>Subject:</b>  <b>Battery Heater Coolant Hose</b>	Publication No.: N819 UPS3623-2
	Model: Range Rover (LK)
	Model Year: 2023
	Model: Range Rover Sport (L1)
	Model Year: 2023
	Date of Issue: 13 October 2023
	Expiry Date: 13 October 2024

# SERVICE INSTRUCTION - N819 UPS3623-2

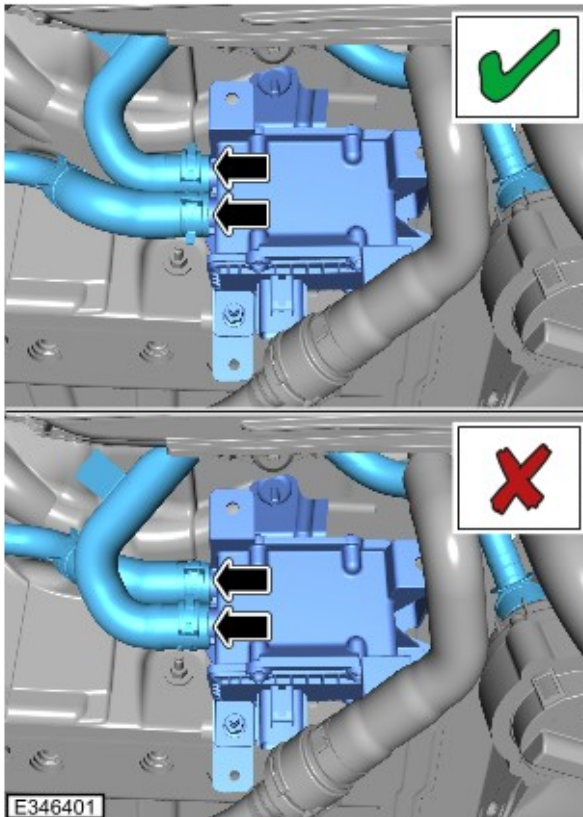
2. Inspect the installed position of the battery heater coolant hoses.

- If the battery heater coolant hose are installed in the position shown in the image with a **GREEN '✓'**, the vehicle has **PASSED** the inspection. **Reverse step 1 and release the vehicle.**
- If the battery heater coolant hose are installed in the position shown in the image with a **RED 'X'**, the vehicle has **FAILED** the inspection. **Continue to step 3.**

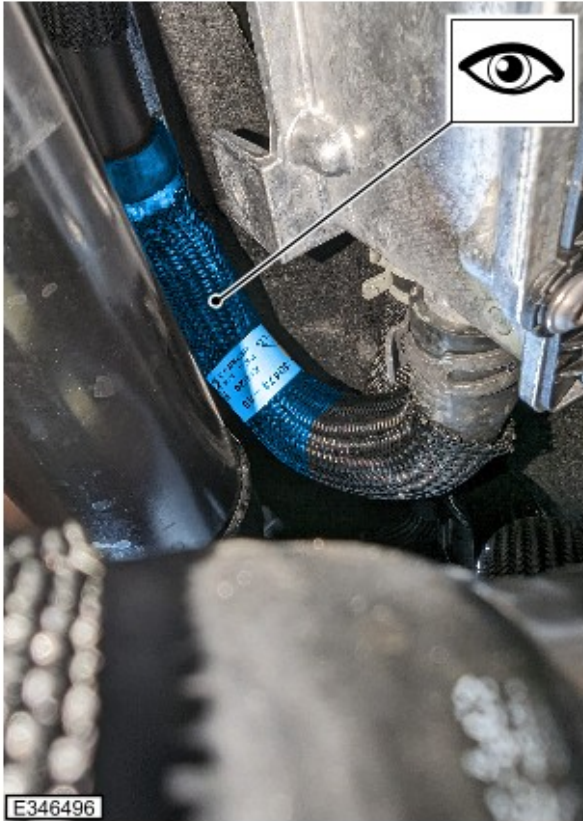
2. Inspect the battery heater to battery coolant pump hose for signs of damage, to contact with the front driveshaft.

- If the battery heater to battery coolant pump hose **DOES NOT** have signs of damage, **continue to Service Instruction 1.**
- If the battery heater to battery coolant pump hose **DOES** have signs of damage, **continue to Service Instruction 2.**
