## Technical product information

<b>Topic</b>	Air suspension warning light within the DIP - DTC's P089200 - C104707 - C103B13 - Evident within Address 74
<b>Market area</b>	Australia E04 Bentley rest Asia and Australia (6E04),China 723 Volkswagen (Anhui) Automotive CO (6723),China 796 VW Import Comp. Ltd (Vico), Beijing (6796),Germany E02 Bentley rest Europe (6E02),Japan E03 Bentley Japan (6E03),Korea, (South) E08 Bentley South Korea (6E08),United Arab Emirates E06 Bentley Middle East and Africa (6E06),United Kingdom E01 Bentley UK (6E01),United States E05 Bentley USA and rest America (6E05)
<b>Brand</b>	Bentley
<b>Transaction No.</b>	2062259/6
<b>Level</b>	EH
<b>Status</b>	Released for publishing
<b>Release date</b>	03-Oct-2023

### New Continental GT / GTC & New Flying Spur

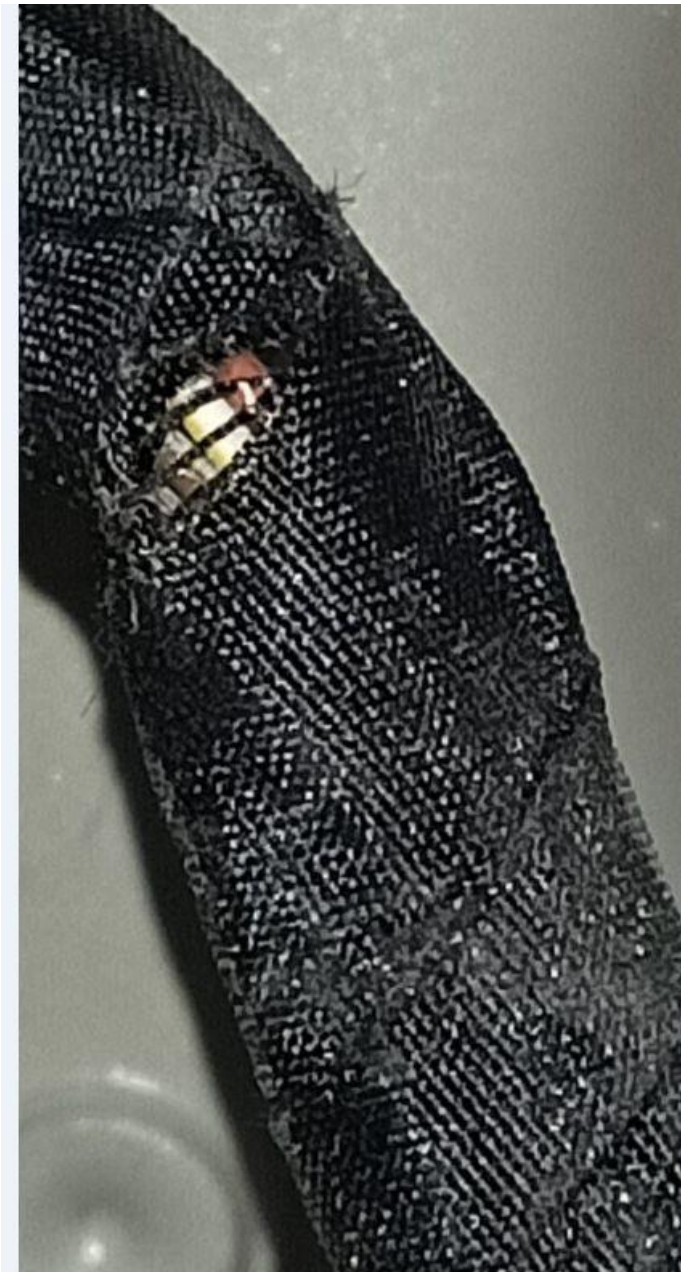
- Broken wires
- Kinked wiring
- Pin/s missing
- Pin/s broken
- Pin/s loose

NOTE: Refer to the example shown in Figure 1 of a damaged wiring harness

2) Repair any broken or damaged wires as per Rep.Gr 97
