Technical product information

| Topic | Road wheel inspection procedure |
| Brand | Bentley |
| Transaction No. | 2063017/3 |

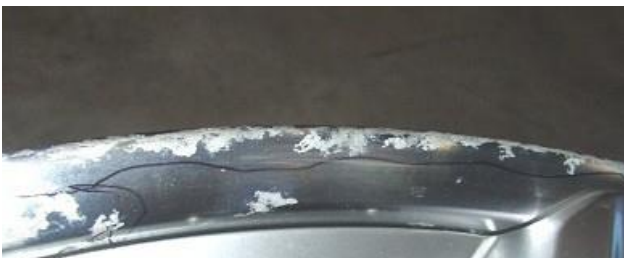
Filiform corrosion in the middle of the rim initially caused by impact damage to the lacquer coat, such as stone chips

- Both Figure 1 and Figure 2 **do not** show a manufacturing defect

and are not claimable under warranty

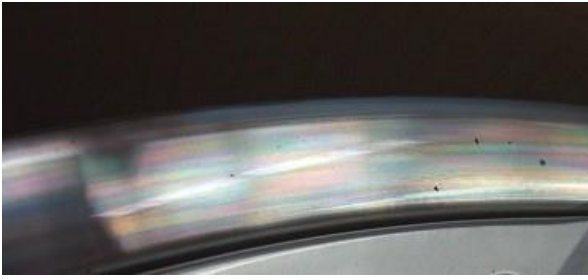
Figure 3

The original wheel finish has a prismatic effect (Figure 3)

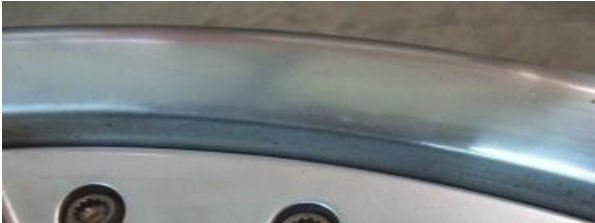
Figure 4 shows the tell tale sign of re-work as the finish is duller and no prismatic effect is visible. Re-worked wheels that show signs of corrosion or defects cannot be claimed under warranty

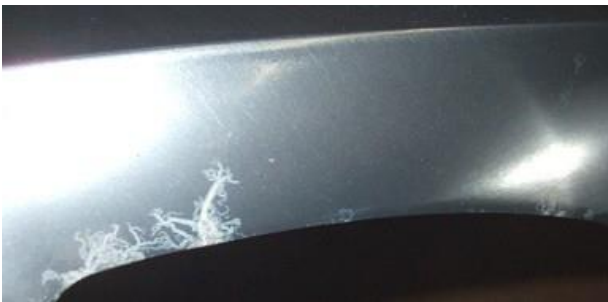
Figure 5

Filiform corrosion coming from sharp edge on the spoke. In this area it is difficult for the supplier to get the specified lacquer coverage

- Both of these could be classed as a manufacturing defect and are claimable under warranty

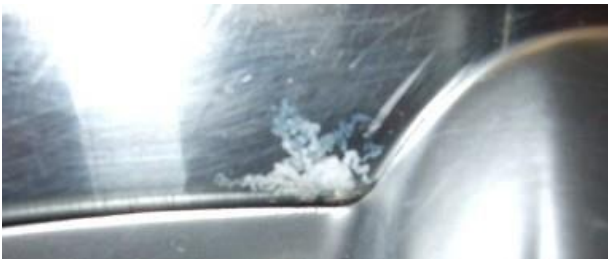
Figure 6

Filiform corrosion coming from behind the inner wheel piece is highly unlikely to be caused by impact damage. It is therefore more likely due to low lacquer coverage

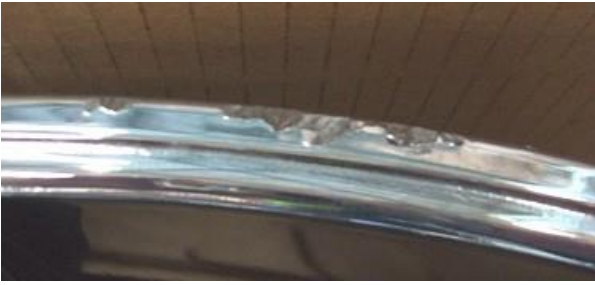
Marks on the rim due to curbing

- Both Figure 7 and Figure 8 **do not** show a manufacturing defect and are not claimable under warranty

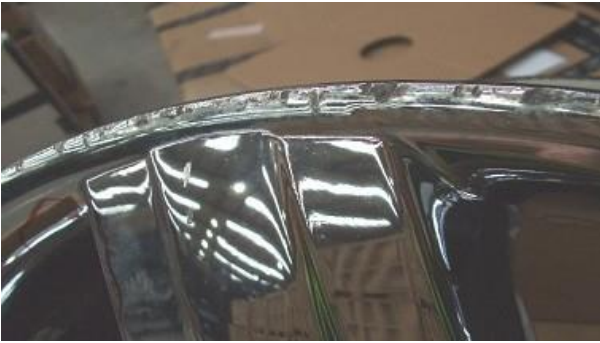
Figure 8

Damage to the rim due to curbing but also damage to the spoke caused by impact damage, such as stone chips

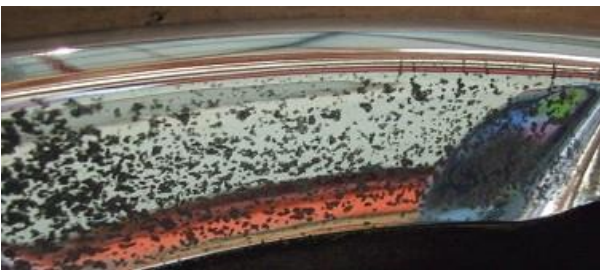
Figure 9

- Pitting is not a manufacturing defect and cannot be claimed under Warranty (Figure 9)

- When cleaning chrome wheels, they have to be wiped down and not just sprayed with water as there is still a film of dirt that can remain on the wheels
- There are a number of variables that contribute to pitted wheels, such as brake dust, salt, dust/dirt, ice/snow melting chemicals
- Chrome wheels should never be washed while still hot from driving as they could warp or pit

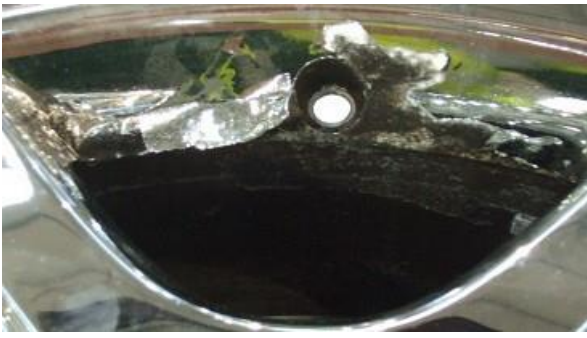
Figure 10

- Aluminium alloy wheels are one of the most difficult substrates to reliably plate
- Peeling almost always comes from improper preparation and plating, not environmental exposure (Figure 10)

- Peeling is classed as a manufacturing defect and is claimable under warranty
