Technical product information

Topic	Tyre tread/sidewall crack(s)
Market area	Australia E04 Bentley rest Asia and Australia (6E04),China 723 Volkswagen (Anhui) Automotive CO (6723),China 796 VW Import Comp. Ltd (Vico), Beijing (6796),Germany E02 Bentley rest Europe (6E02),Japan E03 Bentley Japan (6E03),Korea, (South) E08 Bentley South Korea (6E08),United Arab Emirates E06 Bentley Middle East and Africa (6E06),United Kingdom E01 Bentley UK (6E01),United States E05 Bentley USA and rest America (6E05)
Brand	Bentley
Transaction No.	2063651/3
Level	EH
Status	Released for publishing
Release date	28-Sep-2023

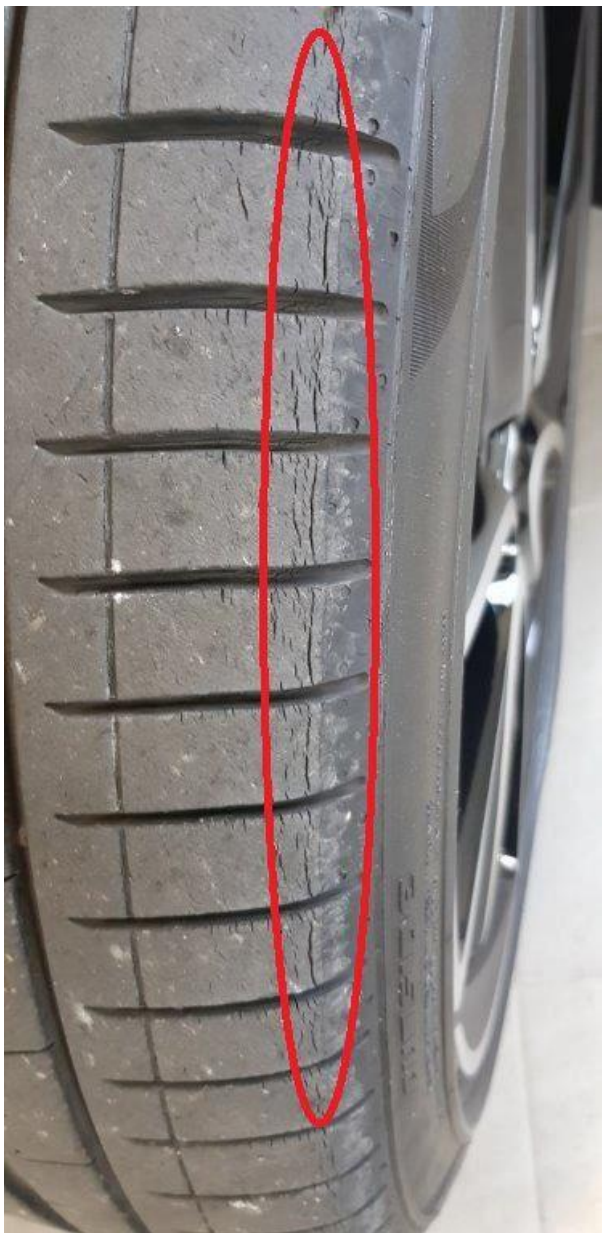
Figure 1

Cracks evident in the sidewall and/or tread pattern (See the examples in Figures 1 and 2 showing cracks within the tread pattern)

The issue is mainly evident on vehicles with very low usage

This is a result of the tyre compound hardening due to the following:

- Tyre age
- Tyre pressure not adjusted to specification
- Low mileage/vehicle usage
- Vehicle storage conditions

When cars are found to be at low mileage or have not been used regularly for an extended period of time, the oils and compound of the rubber can dry up due to a lack of repeated compression, this can lead to compound separation.

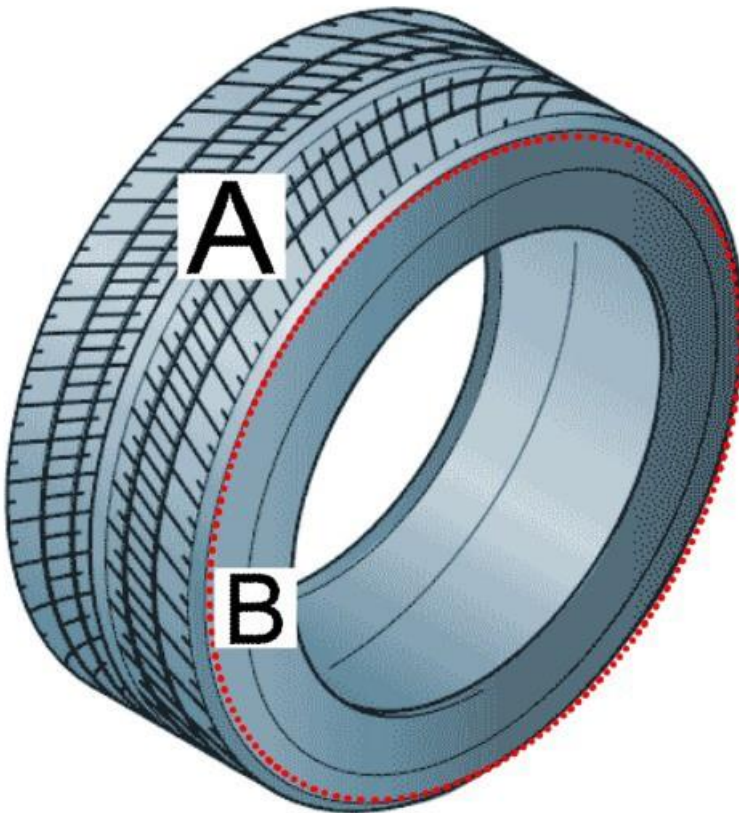
Referring to Figure 3

- Tyres will require replacement if cracks and/or signs of wear are found on or around the tread pattern (Point A)
- In the event that cracks and/or signs of wear are found on the sidewall (Point B) or at (Point A and B) the operative **MUST** raise a technical DISS query ensuring clear photographs and information detailing customer usage profile are attached to the DISS query
