Technical product information

Topic	Knock/clunk noise from the rear of the vehicle (Rear axle)
Market area	Australia E04 Bentley rest Asia and Australia (6E04),China 723 Volkswagen (Anhui) Automotive CO (6723),China 796 VW Import Comp. Ltd (Vico), Beijing (6796),Germany E02 Bentley rest Europe (6E02),Japan E03 Bentley Japan (6E03),Korea, (South) E08 Bentley South Korea (6E08),United Arab Emirates E06 Bentley Middle East and Africa (6E06),United Kingdom E01 Bentley UK (6E01),United States E05 Bentley USA and rest America (6E05)
Brand	Bentley
Transaction No.	2064477/5
Level	EH
Status	Released for publishing
Release date	03-Oct-2023

Knock/clunking noise heard from the rear of the vehicle when changing direction at low speed

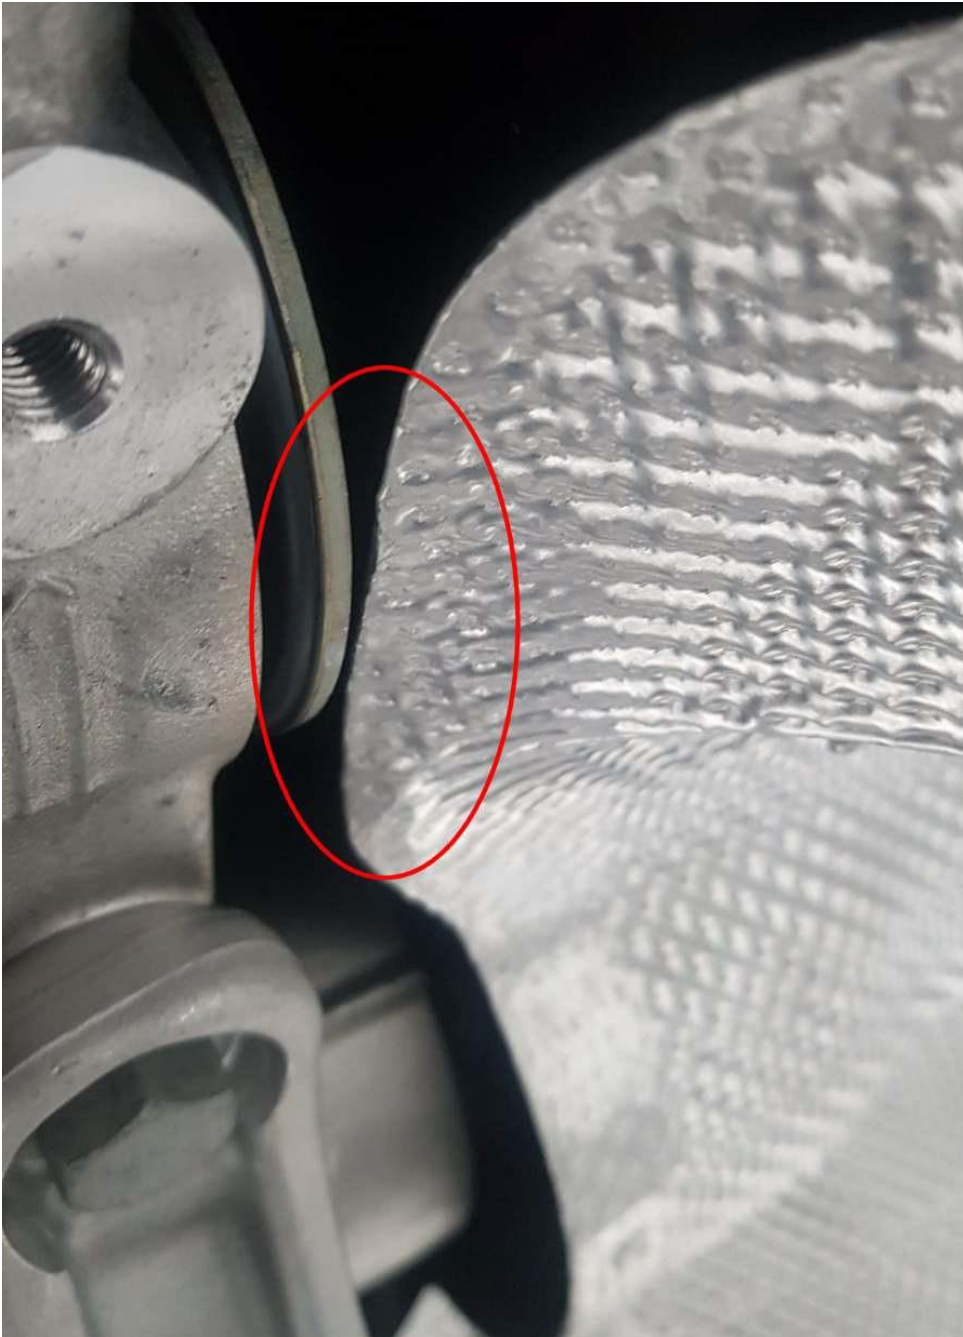
Figure 1

3) Referring to Figures 1 and 2

- Check to confirm the heat shields are not in contact or have witness marks showing evidence of contact with the rear differential and/or surrounding components

NOTE: In the event the issue shown regarding the heatshield is evident, the operative should rectify (relocate the heatshield) and retest
