Technical product information

Topic	Bentayga Hybrid - Emission control system warning lamp illuminated within the DIP - Open circuit DTC's evident
Market area	Australia E04 Bentley rest Asia and Australia (6E04),China 723 Volkswagen (Anhui) Automotive CO (6723),China 796 VW Import Comp. Ltd (Vico), Beijing (6796),Germany E02 Bentley rest Europe (6E02),Japan E03 Bentley Japan (6E03),Korea, (South) E08 Bentley South Korea (6E08),United Arab Emirates E06 Bentley Middle East and Africa (6E06),United Kingdom E01 Bentley UK (6E01),United States E05 Bentley USA and rest America (6E05)
Brand	Bentley
Transaction No.	2065697/3
Level	EH
Status	Released for publishing
Release date	03-Oct-2023

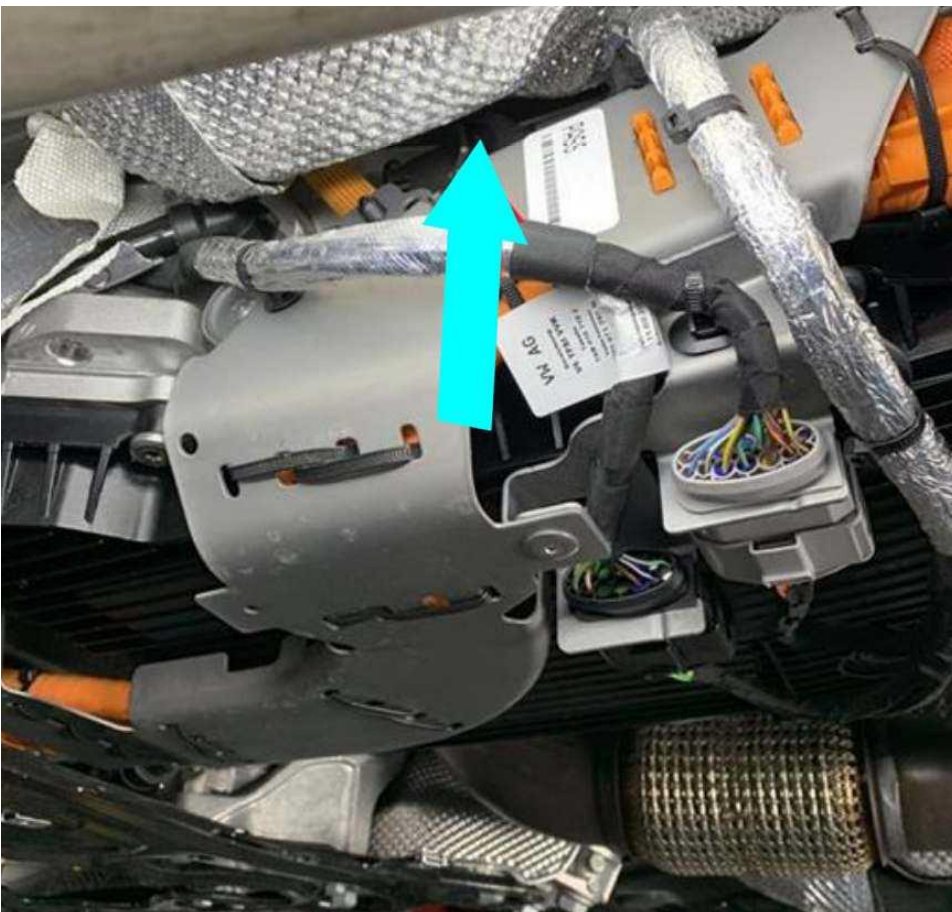
- The operative should identify the location shown in Figure 2 (Left hand side of Transmission)

- Referring back to the fitting location in Figure 2 - Reposition/secure the wiring harness ensuring the wiring harness cannot chaff/contact any of the surrounding components

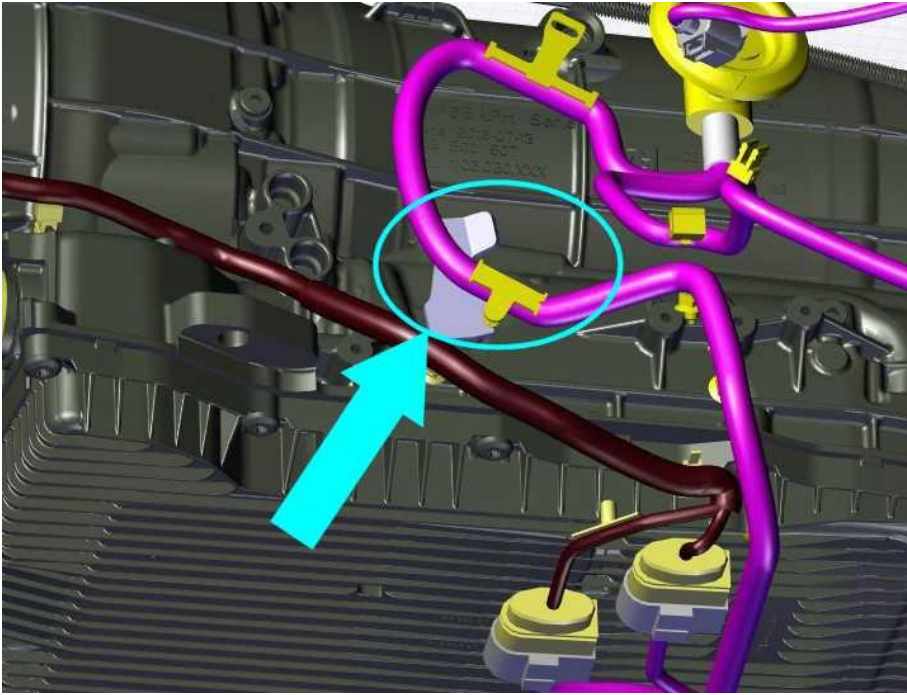
Figure 3

TIP: Referring to Figures 3 and 4 - Consider contact/chaffing between the main body harness and the following components:

- Transmission outer casing webbing
- Floor panel
- Transmission park lock mechanism

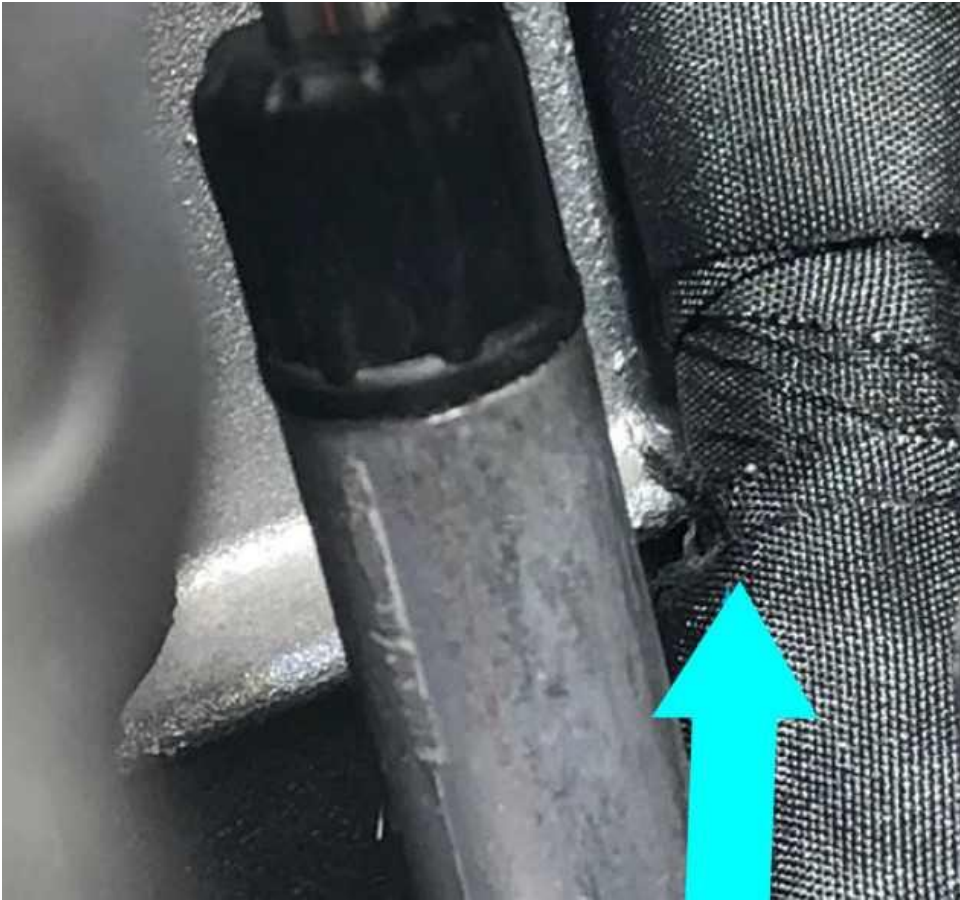
Figure 5

- The actual symptom(s) may be different than described depending on the wire(s) which are damaged/chaffed - Refer to the examples as shown in Figures 5,6 and 7

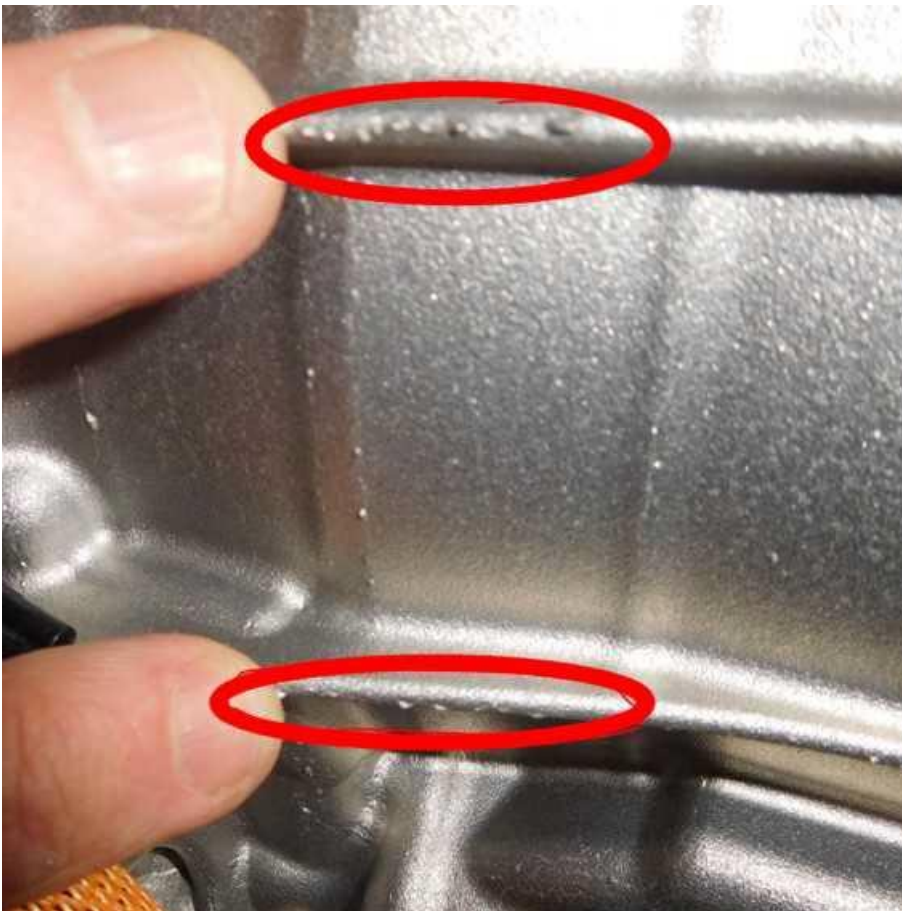
Figure 8

The transmission outer casing webbing (Figure 8)

- In the event that any sharp edges or excess casting spots are evident, the operative should carefully remove any sharp edges with low grade sandpaper for example
