Technical product information

| Topic | Rear Jacking point - Sill damage found during PDI |

Bentayga Series

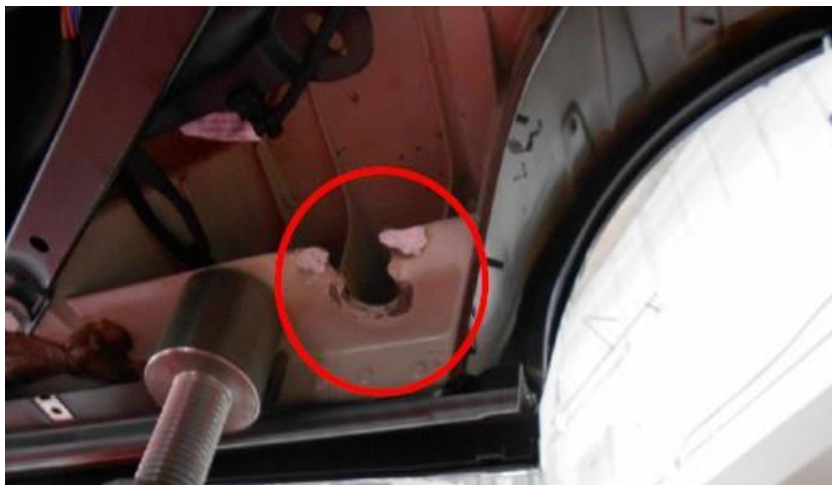
Figure 1

Damage found around the rear sill Jacking point during PDI (Figure 1)

In the event the issue is as described, please raise a technical DISS query ensuring clear photographs are attached

The operative **MUST** await feedback from **Product Support** before conducting any further work
