Technical product information

Topic	Engine coolant - Overheat condition - Warning evident within the DIP - DTC's P2B6500 and P2B8600 are evident
Market area	Australia E04 Bentley rest Asia and Australia (6E04),China 723 Volkswagen (Anhui) Automotive CO (6723),China 796 VW Import Comp. Ltd (Vico), Beijing (6796),Germany E02 Bentley rest Europe (6E02),Japan E03 Bentley Japan (6E03),Korea, (South) E08 Bentley South Korea (6E08),United Arab Emirates E06 Bentley Middle East and Africa (6E06),United Kingdom E01 Bentley UK (6E01),United States E05 Bentley USA and rest America (6E05)
Brand	Bentley
Transaction No.	2066669/3
Level	EH
Status	Released for publishing
Release date	28-Sep-2023

W12 - New Continental GT/GTC & New Flying Spur

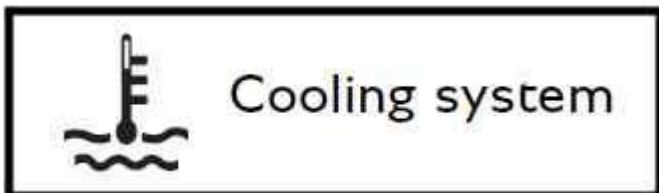
- Warning light in Drivers Information Panel (DIP) as Figure 1

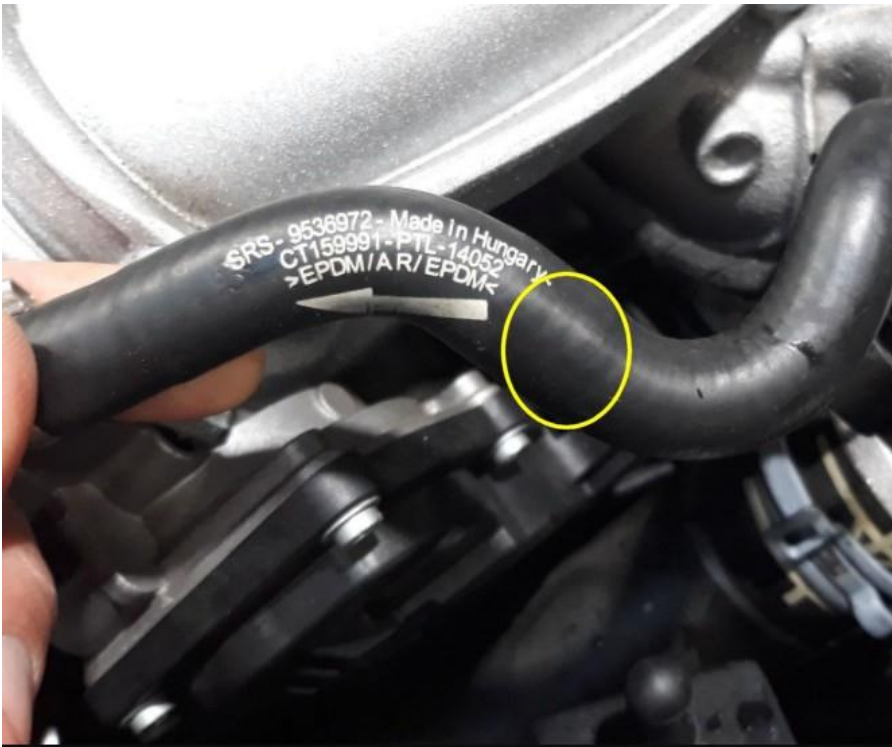
- The vent hose has an internal check valve, the valve is positioned within the vent hose at the location shown in Figure 3 (Circled)

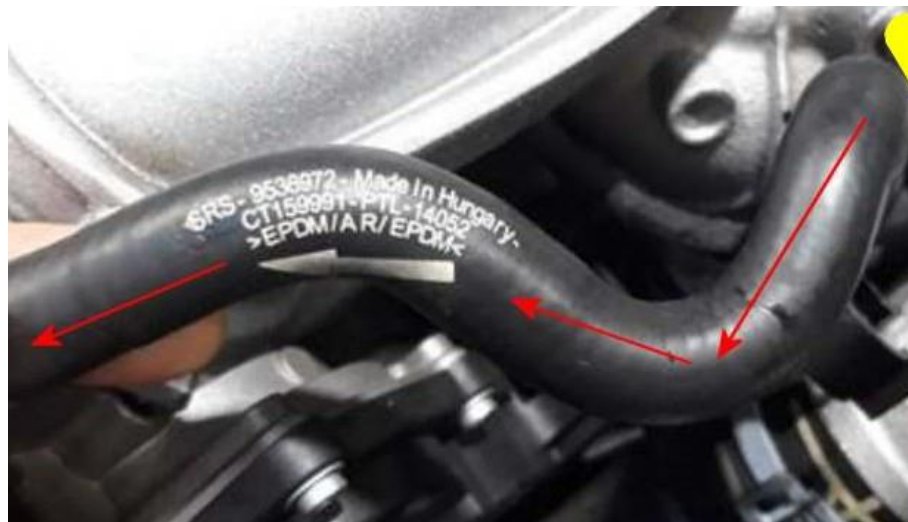
- Referring to Figure 4 - The coolant flows in the direction shown (Arrows) in the event the internal check valve is faulty the flow of the coolant will be restricted (***Causing the symptoms described within the customer findings/workshop findings section***)

4) Replace the vent line

- Once the vent line has been replaced - Referring to Rep.Gr 19 - Bleed the coolant system
- Erase all applicable DTC's
- Conduct a road test - On return check to confirm that no coolant related DTC's are evident

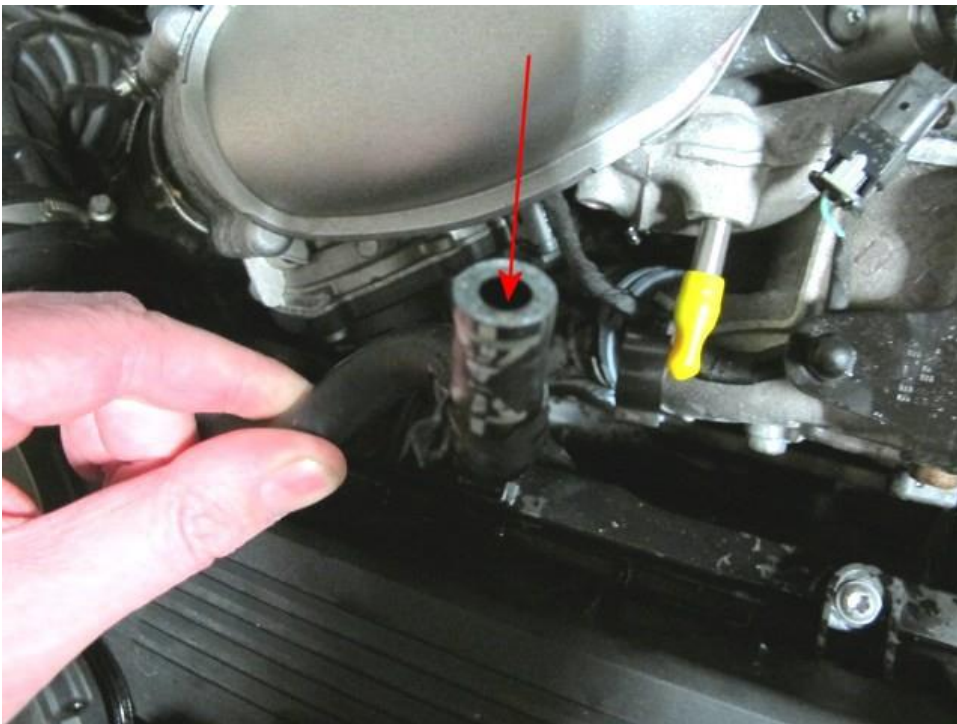
Does the air flow through the vent line without any restrictions?

5) Referring to Figure 8 - Apply light air pressure into hose (Arrow)

No - Go to step 4

Yes - Raise a DISS query and await feedback before conducting any further work
