Technical product information

Topic	"Drive System Fault" warning present within the DIP - Under full throttle conditions
Market area	Australia E04 Bentley rest Asia and Australia (6E04),China 723 Volkswagen (Anhui) Automotive CO (6723),China 796 VW Import Comp. Ltd (Vico), Beijing (6796),Germany E02 Bentley rest Europe (6E02),Japan E03 Bentley Japan (6E03),Korea, (South) E08 Bentley South Korea (6E08),United Arab Emirates E06 Bentley Middle East and Africa (6E06),United Kingdom E01 Bentley UK (6E01),United States E05 Bentley USA and rest America (6E05)
Brand	Bentley
Transaction No.	2067483/4
Level	EH
Status	Released for publishing
Release date	28-Sep-2023

New Continental GT(C) and New Flying Spur - V8 Kovomo

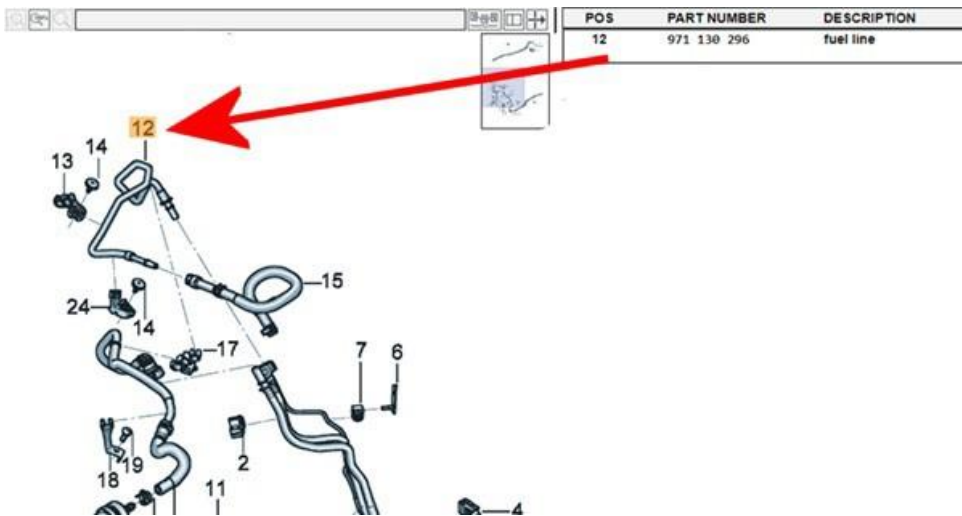
3) Referring to Figure 2 (Item 12) remove the fuel line shown

- In the event the fuel line is blocked/restricted - Replace the fuel line as shown in Figure 2 (item 12) ensuring all Rep.Gr guidelines are strictly adhered to

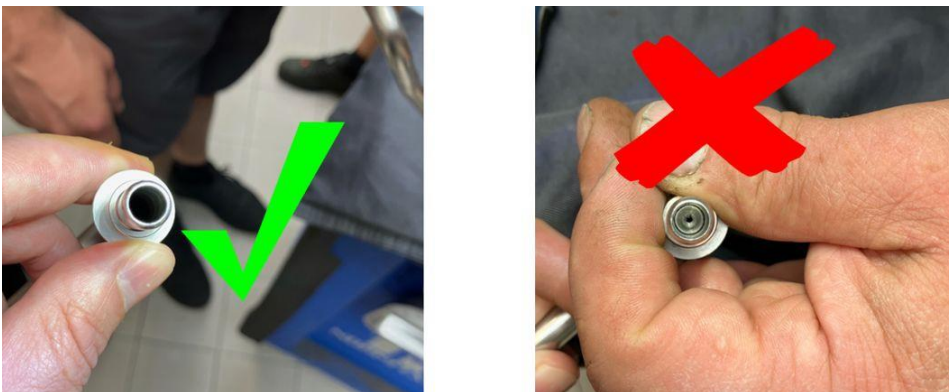
4) Referring to Figure 3 - Check to confirm if the fuel line is blocked/restricted

- In the event the fuel line is not blocked/restricted the operative should refer to Rep.Gr 20 and conduct the Low pressure fuel system - to test and provide feedback via a new or existing DISS query
