Technical product information

Topic	New Continental GT and GTC - Window drop glass operation
Market area	Australia E04 Bentley rest Asia and Australia (6E04),China 723 Volkswagen (Anhui) Automotive CO (6723),China 796 VW Import Comp. Ltd (Vico), Beijing (6796),Germany E02 Bentley rest Europe (6E02),Japan E03 Bentley Japan (6E03),Korea, (South) E08 Bentley South Korea (6E08),United Arab Emirates E06 Bentley Middle East and Africa (6E06),United Kingdom E01 Bentley UK (6E01),United States E05 Bentley USA and rest America (6E05)
Brand	Bentley
Transaction No.	2070497/4
Level	EH
Status	Approval
Release date

Retailer glass reset procedure for GT/GTC

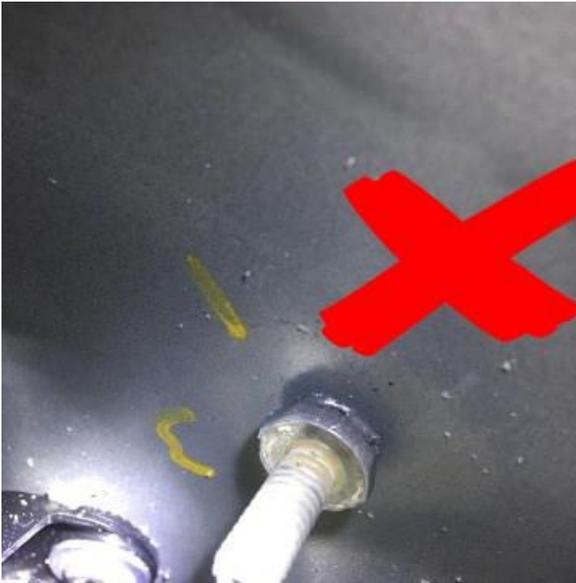
- Earth point 736 RHR and Earth point 738 LHR
- Check for cleanliness and security of both earth points Figure 7 shows an example of a contaminated earth point (dirt/paint/debris)

- Remove any dirt/paint/debris from the earth points using suitable abrasives/wire brush ensuring no damage is caused to the earth stud threads as shown in Figure 8

- Secure the earth point fixings (9 Nm)

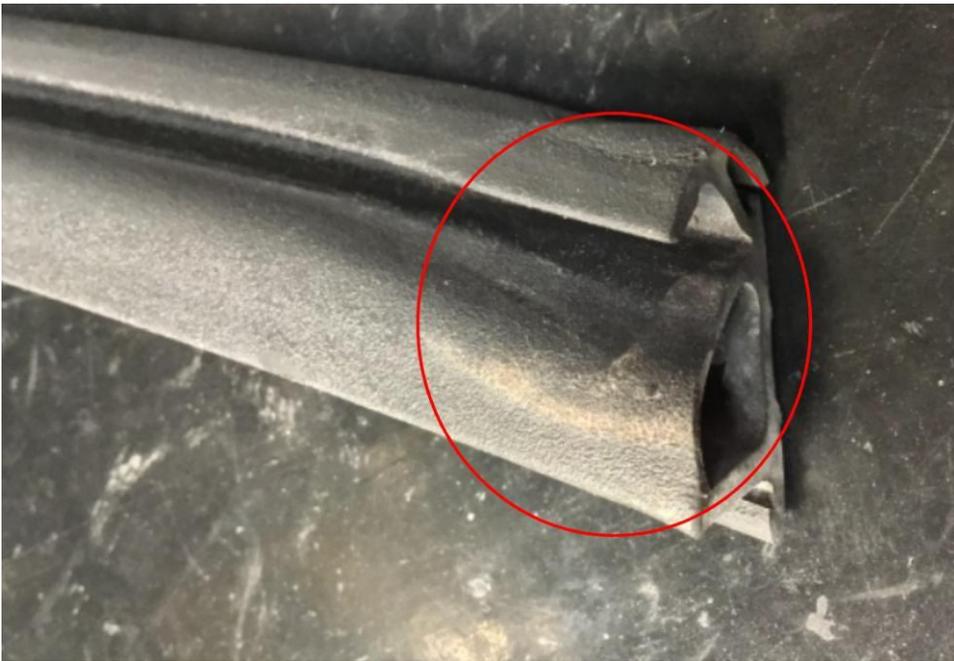
Figure 9

- Damage
- Splits
- Tears
- Misalignment
- Incorrectly fitted/located
- Drop glass seal deformation (see Figures 9 and 10 as examples)

NOTE: Any issues found with the window seals must be rectified before conducting the remaining steps

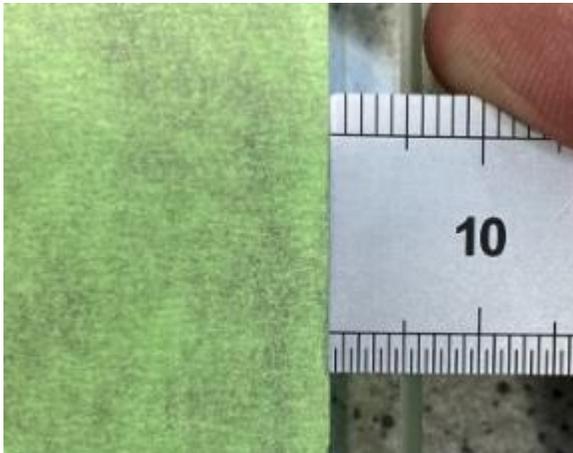
Example of incorrect fitment:
10mm intrusion into division bar seal not achieved. Only 6mm seen, front and rear side glasses will be too far rearwards, potentially clash condition between rear of rear glass and cant rail/roof seals

When reinstalling front drop glass ensure tape is applied at 10mm from front edge and align this with the previously set quarter glass division bar.

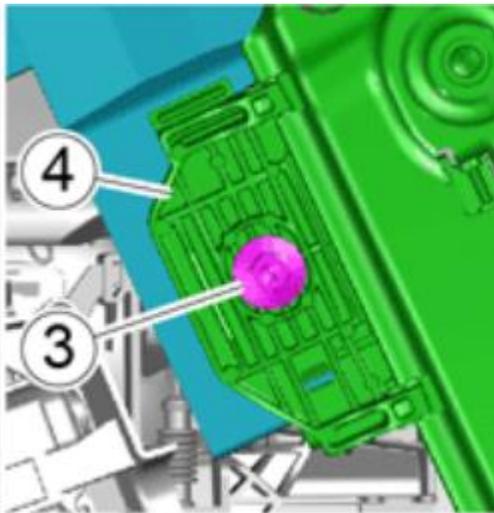
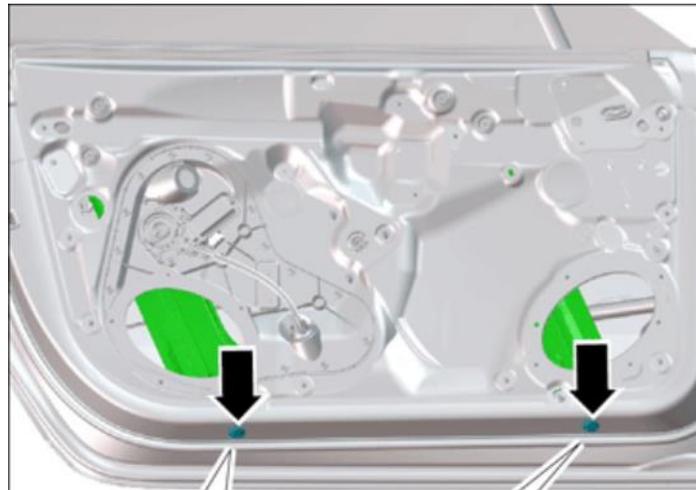
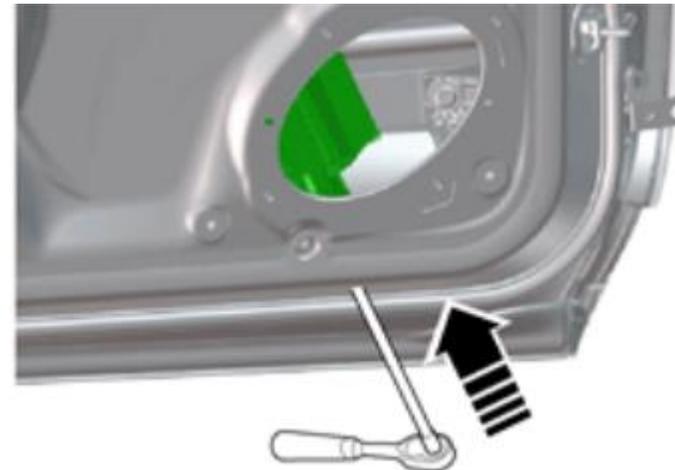
Example: Front drop glass Z axis not adjusted correctly. Bottom of tape was level with waist rail seal, after slackening pinch bolt (3 in bottom left image) front drop glass lowered 14mm to where pen marked line is.

Z-axis adjusters (bottom middle and right images) had not been used, pinch bolt had been slacked and glass lifted out of the regulator to achieve specification. This has a knock on effect of altering the 10mm division bar intrusion seen in previous slide as glass is loose and can be accidentally moved in X-axis.

This also creates a risk that the window will bottom out on the cant rail seals rather than the regulator bump stops meaning that the glass can raise further as the seals soften over time and affect end stop learning.

Z-Axis height should only be adjusted by the 4mm Allen key adjusters as per ELSAPRO

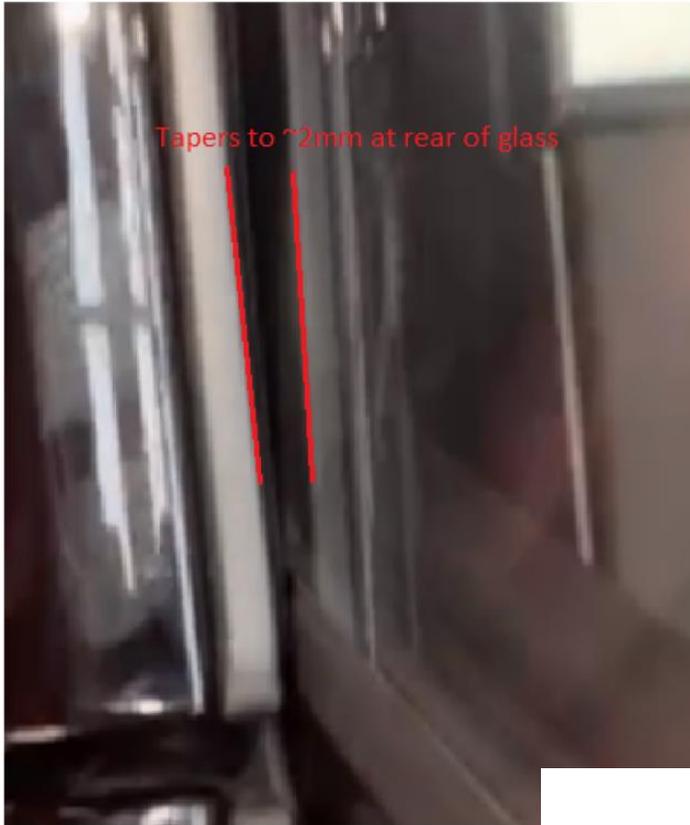
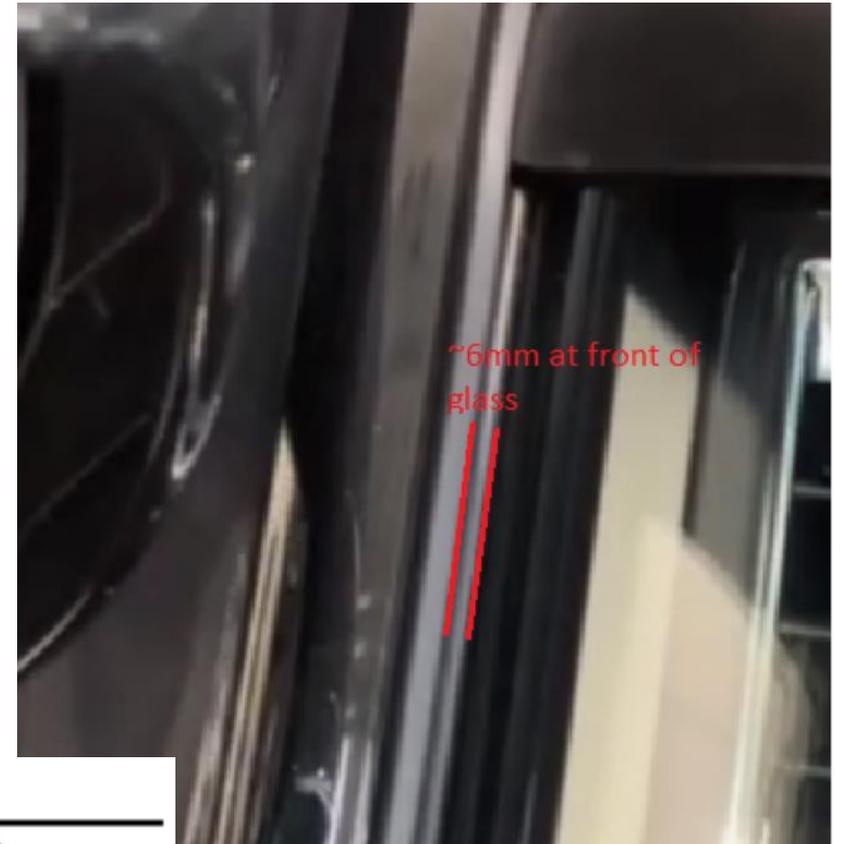
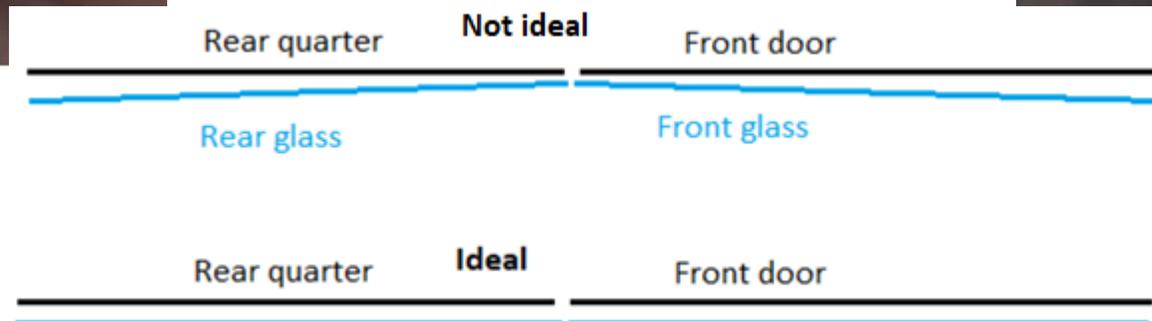
Images show a poor setting.
Circa 6mm at front edge (near wing mirror)
closing up to 2mm at the rear edge.

2mm at rear edge would have been set to achieve specified flush/2mm underflush profile condition between front and rear glasses, the rear quarter glass mirrors this taper condition. This potentially increases the risk of false anti trap as rear window/seal does not engage with front window at the correct angle. Suggested to set to specification on problem vehicles as per next slide. If both windows are set between 4-6mm then the flush/2mm underflush profile can be easily achieved.

Set waist rail gapping to between 4-6mm as mentioned in Glass setting guide videos on E-Academy and also check for parallelism along front and rear windows to door/quarter. 50mm from edge of Waistrail seal, roughly underneath the Bentley wings.

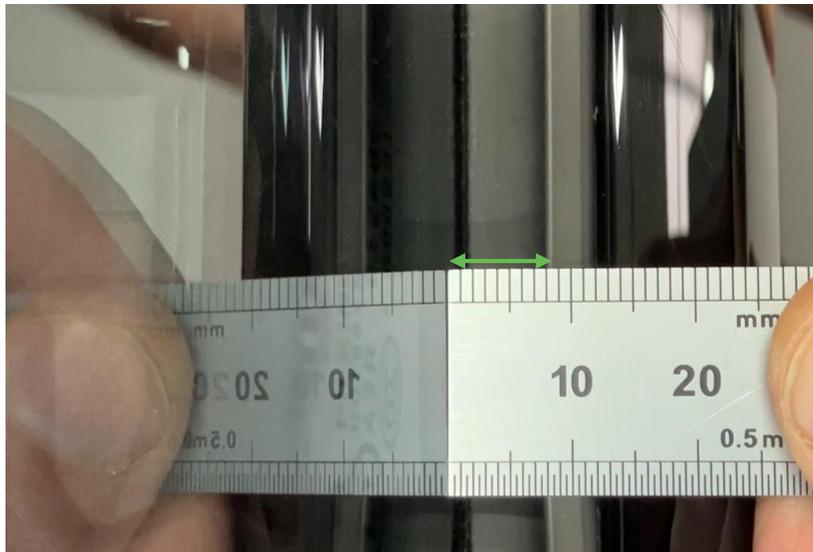
RHF window, front window closed, rear window open. Note gap

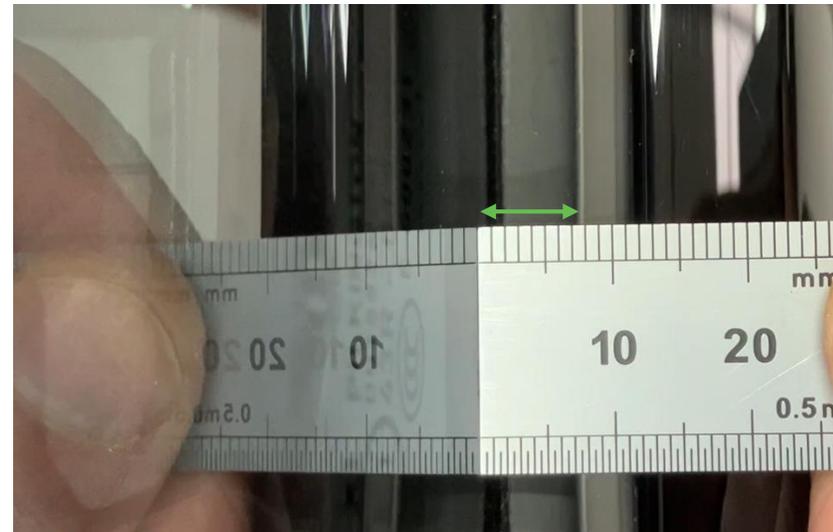
RHF window, front window closed, rear window closed. Note gap, over 0.25mm outboard movement, this is incorrect

There does need to be some tension between the front and rear glass to seal against the drop glass seal, zero mm of movement is best.

If more tension is required to resolve a wind noise or water ingress then aim for no more than 0.25mm of outboard movement.

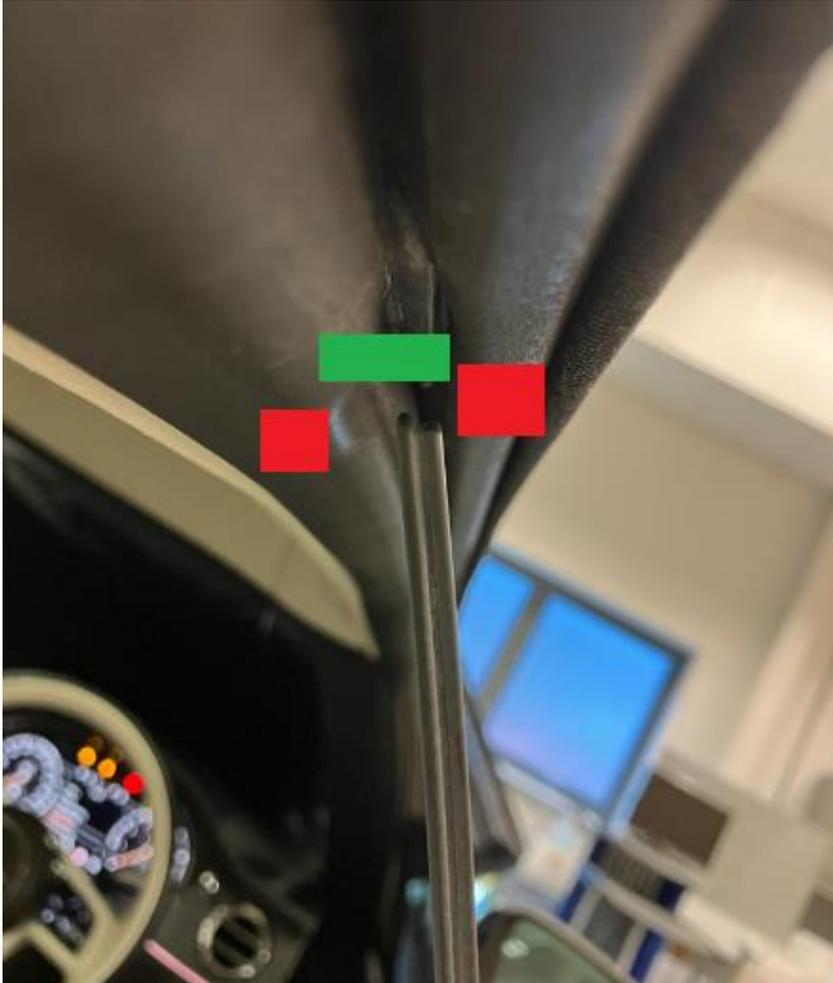
Window entry into cant rail/convertible roof seal

Windows should enter cant rail seal smoothly, making contact with inboard edge first and then be pushed outboard (green square).

Too far inboard increases the risk of the cant rail seal pinching, too far outboard will clash with cant rail brightware (red squares). For front door, poor door profile is a major contributing factor here and should be checked/adjusted if window found to be entering seal incorrectly.
