Technical product information

Topic	Flying Spur Hybrid - Engine warning lamp evident within the DIP - DTC U041100 and/or P0A2E00 is evident
Market area	Australia E04 Bentley rest Asia and Australia (6E04),China 796 VW Import Comp. Ltd (Vico), Beijing (6796),Germany E02 Bentley rest Europe (6E02),Japan E03 Bentley Japan (6E03),United Arab Emirates E06 Bentley Middle East and Africa (6E06),United Kingdom E01 Bentley UK (6E01),United States E05 Bentley USA and rest America (6E05)
Brand	Bentley
Transaction No.	2071458/1
Level	EH
Status	Approval
Release date

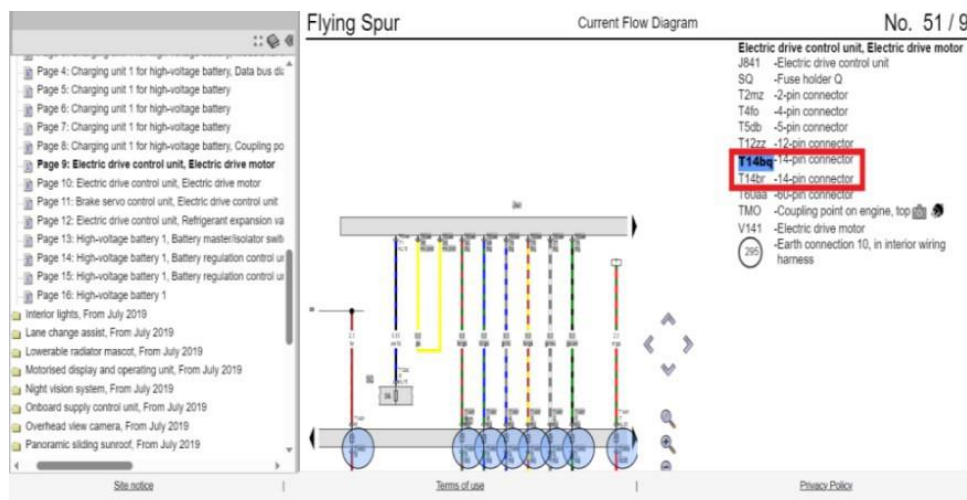
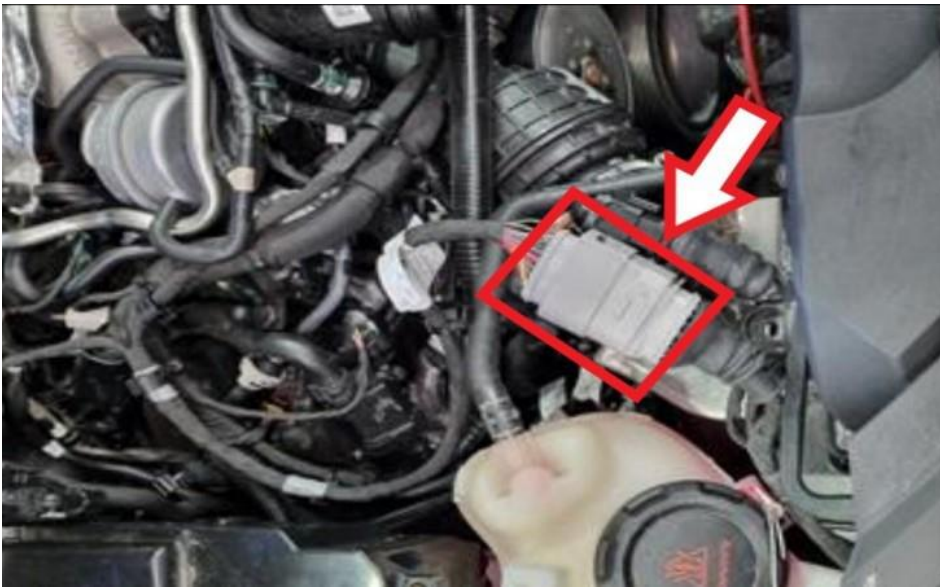
1) Referring to Figures 1 and 2 - Locate interconnect T14bq/br
