## Technical product information

<b>Topic</b>	V8 Kovomo - DTC - P025C00: Fuel Pump Module Control Circuit Low logged in 0001
<b>Market area</b>	Australia E04 Bentley rest Asia and Australia (6E04),China 796 VW Import Comp. Ltd (Vico), Beijing (6796),Germany E02 Bentley rest Europe (6E02),Japan E03 Bentley Japan (6E03),Korea, (South) E08 Bentley South Korea (6E08),United Arab Emirates E06 Bentley Middle East and Africa (6E06),United Kingdom E01 Bentley UK (6E01),United States E05 Bentley USA and rest America (6E05)
<b>Brand</b>	Bentley
<b>Transaction No.</b>	2071674/2
<b>Level</b>	EH
<b>Status</b>	Approval
<b>Release date</b>

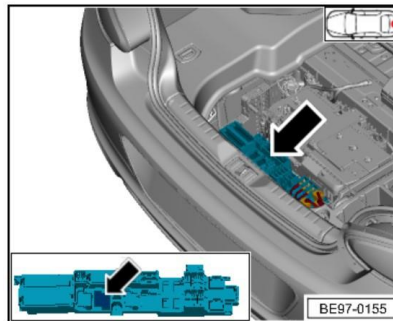
Figure 1

1) Referring to Figures 1 and 2 - Locate (J17) fuel pump relay

- Fuel pump relay -J17-

- Remove (J17) from the carrier

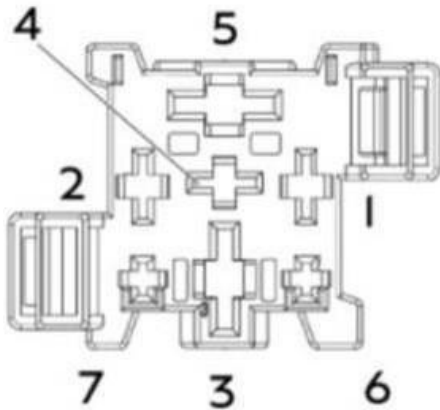
2) Referring to Figure 3 - Once removed conduct a visual check of all carrier terminals, check for the following:

- Loose terminals within the carrier
- Terminals which have spread (poor connection)
- Terminals which are damaged (poor connection)

4) Referring to Rep.Gr 97 - Wiring harness repairs - Renew the applicable terminals using the VAS 1978B wiring repair kit
