Technical product information

New Continental GT/GTC and New Flying Spur

Clicking noise from the front wheels when conducting a static lock to lock steering manoeuvre

TPI 2060446/8

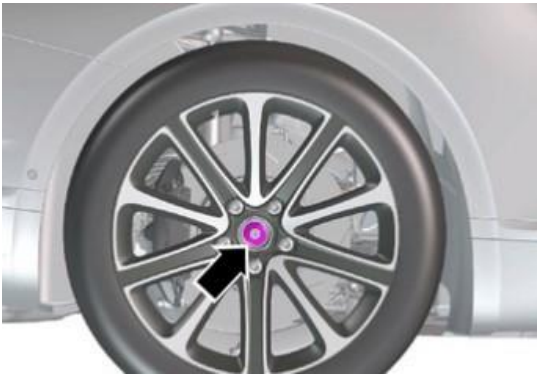
Clicking noise from the front wheels whilst performing a static lock to lock steering manoeuvre

5) Referring to Figure 1 - Remove and discard the left and right front hub retaining nuts - Refer to Rep.Gr 40 Front wheel bearing housing - To remove and fit

6) Install new the left and right front hub retaining nuts - Refer to Rep.Gr 40 Front wheel bearing housing - To remove and fit
