Technical product information

| Topic | Water ingress onto the front reading light |

Bentayga Series

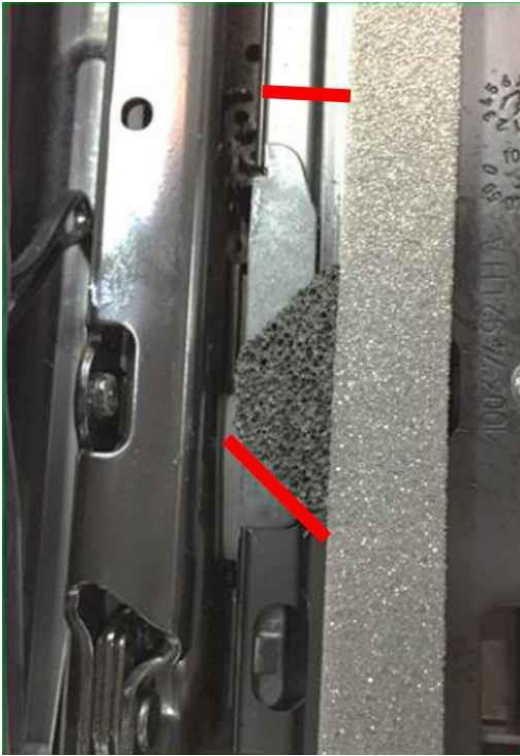
Figure 2

A water drop can get onto the guide rail instead of the water flow area of the guide rail. The water runs forwards to the guide tube of the operating cable and from there onto the electric drive.

2) Figures 2 (red lines) and 3 show the areas in which the adhesive beads have to be applied.

The marked areas (red lines shown in Figure 2) have to be carefully cleaned with isopropyl D 009.401.04.
