Technical product information

Topic	Driver/Passenger door/s creak on close - Bentayga
Market area	Australia E04 Bentley rest Asia and Australia (6E04), China 723 Volkswagen (Anhui) Automotive CO (6723), China 796 VW Import Comp. Ltd (Vico), Beijing (6796), Germany E02 Bentley rest Europe (6E02), Japan E03 Bentley Japan (6E03), Korea, (South) E08 Bentley South Korea (6E08), United Arab Emirates E06 Bentley Middle East and Africa (6E06), United Kingdom E01 Bentley UK (6E01), United States E05 Bentley USA and rest America (6E05)
Brand	Bentley
Transaction No.	2061582/8
Level	EH
Status	Approval
Release date

Driver and/or Passenger door creak during the "Power close" function

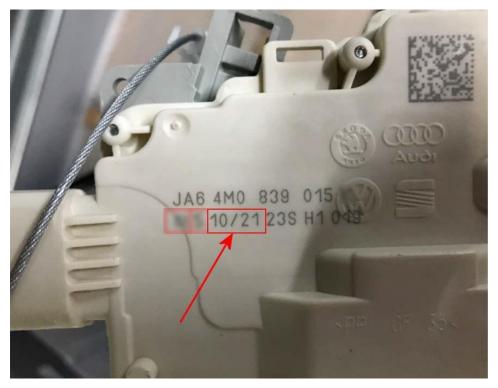
Figure 2

Latch manufacturing date code prior to 10/21

Latch manufacturing date code post 10/21

• Conduct the onward rework process (Step 4) on all latches which have a date code prior to 10/21 regardless if the creaking noise is evident or not

- · Conduct the onward rework process (Step 4) only on latches which exhibit the creaking noise
- 4)) Referring to Figure 3 Apply Dow corning Molycote 33 extreme Low temperature grease to the inner cable
