Technical product information

Topic	Brake noise identification
Market area	Australia E04 Bentley rest Asia and Australia (6E04),China 723 Volkswagen (Anhui) Automotive CO (6723),China 796 VW Import Comp. Ltd (Vico), Beijing (6796),Germany E02 Bentley rest Europe (6E02),Japan E03 Bentley Japan (6E03),Korea, (South) E08 Bentley South Korea (6E08),United Arab Emirates E06 Bentley Middle East and Africa (6E06),United Kingdom E01 Bentley UK (6E01),United States E05 Bentley USA and rest America (6E05)
Brand	Bentley
Transaction No.	2052785/8
Level	EH
Status	Approval
Release date

Object of complaint	Complaint type	Position
running gear -> brakes, brake control -> service brake	noise, vibration -> noise

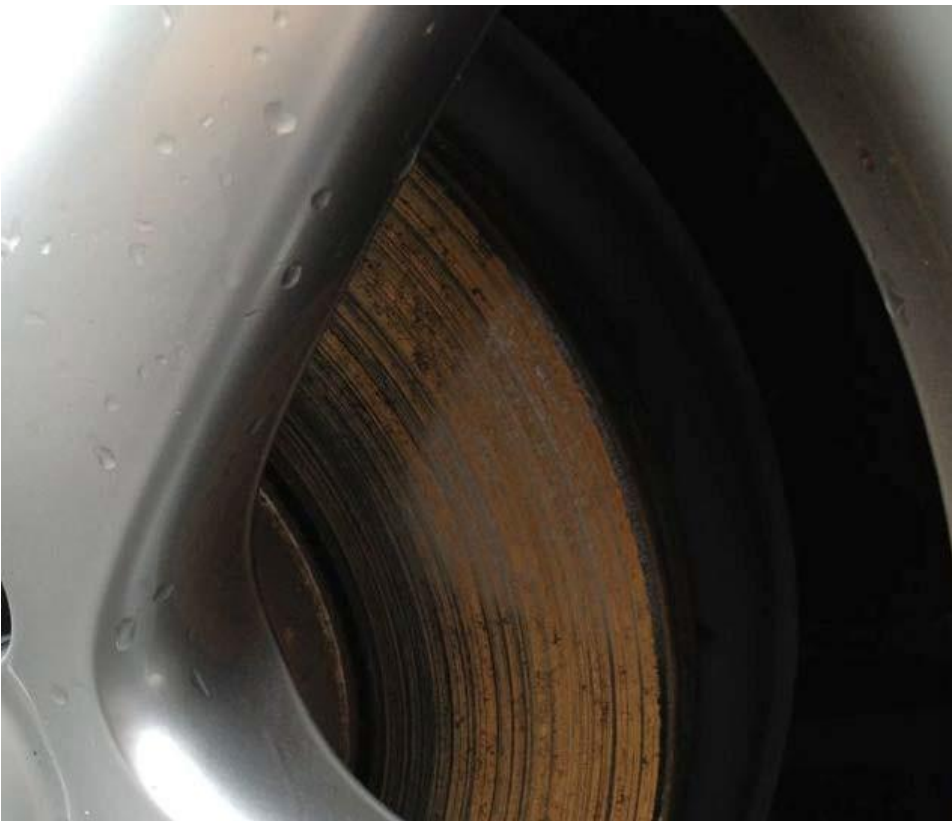
Figure 1

- Brake discs or pads are close to their wear limit
- New brake pads and/or discs have not been properly bedded in after installation
- Aftermarket pads or discs are installed
- There is debris such as small stones, grit, road salt or sand between the brake disc and pad
- Discs are covered in rust. Rust can form when the vehicle has been stationary for long periods of time (Figure 1)

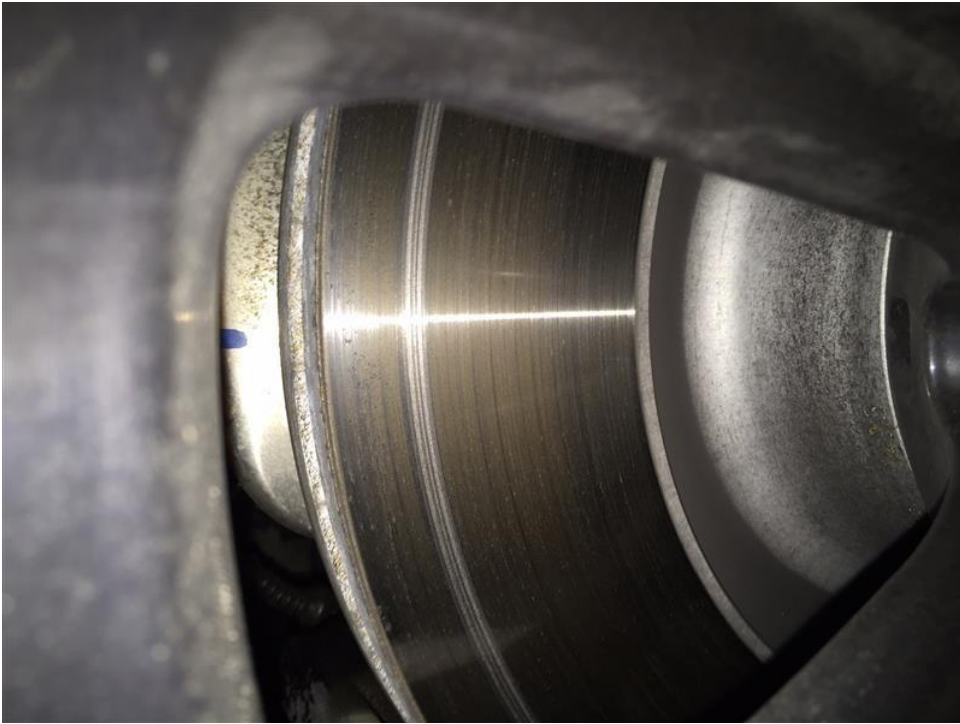
Figure 2

- Discs have a groove in them (Figure 2)

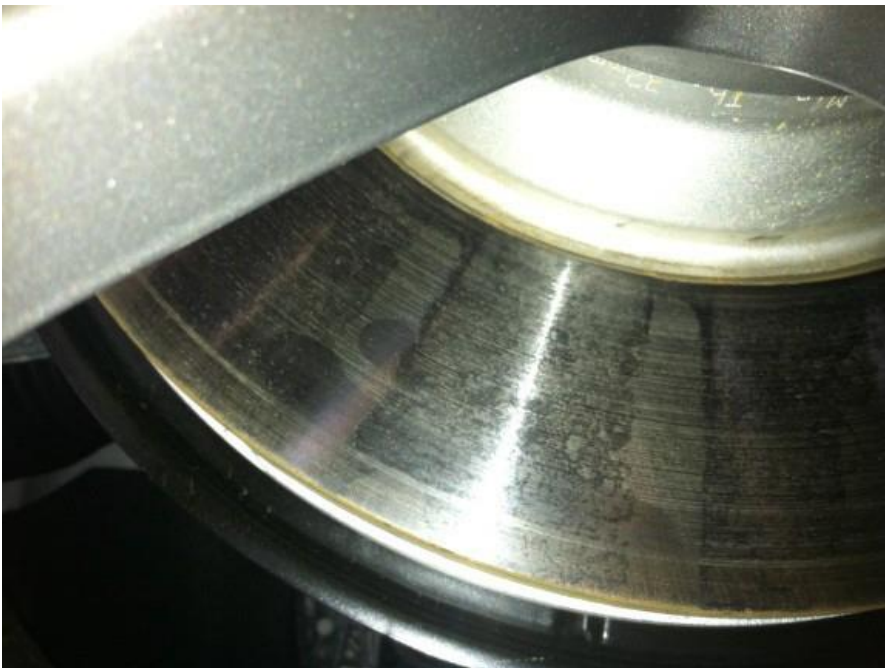
Figure 3

- There is chemical contamination on the braking surface of the disc due to a wheel or tyre cleaner being sprayed directly onto the disc (Figure 3)

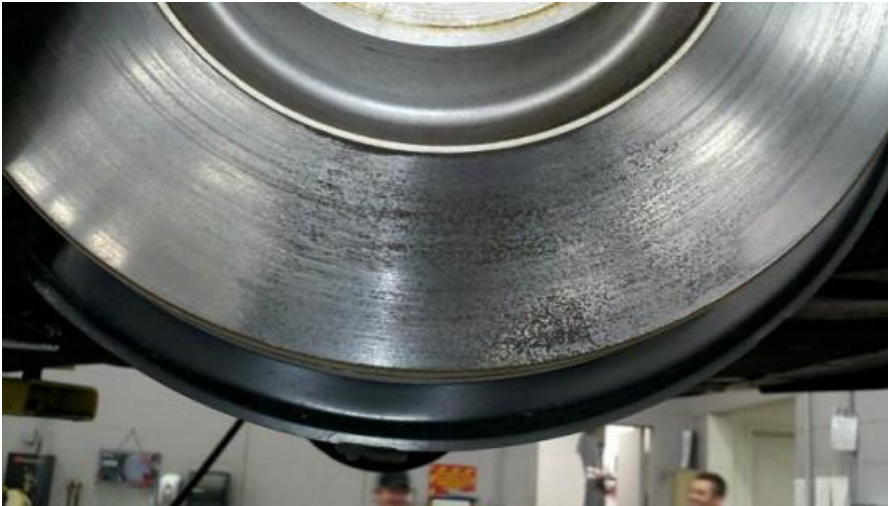
Figure 4

- There are 'pad marks' on the brake disc as a result of the brake pad material transferring to the discs. This can occur when a vehicle has been stood for long periods of time in a wet or snowy environment (Figure 4)

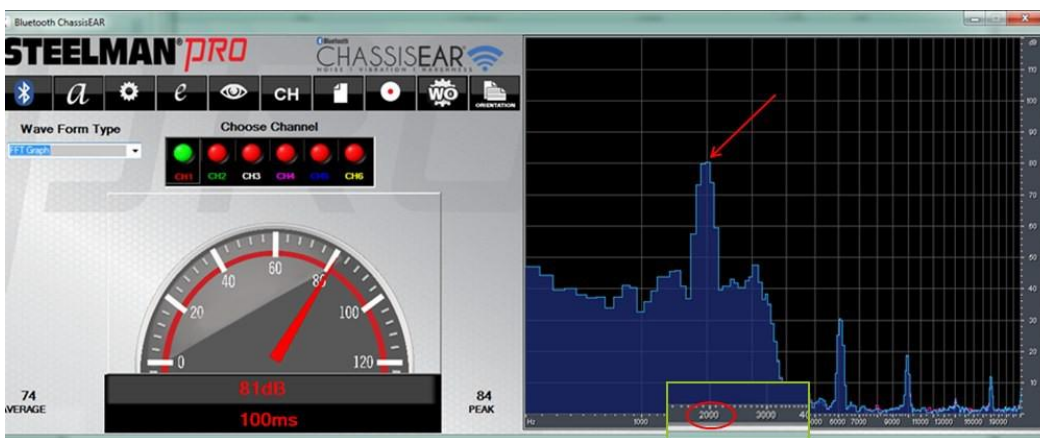
Select 'FFT Graph' as **Wave Form Type** and read the peak achieved during the recording as highlighted in the example above (in this case brake squeal peak frequency is 2000Hz)
