# Technical product information

<b>Topic</b>	DTC B101C29 and/or DTC B101D29 evident within the airbag control unit (J234)
<b>Market area</b>	Australia E04 Bentley rest Asia and Australia (6E04),China 723 Volkswagen (Anhui) Automotive CO (6723),China 796 VW Import Comp. Ltd (Vico), Beijing (6796),Germany E02 Bentley rest Europe (6E02),Japan E03 Bentley Japan (6E03),Korea, (South) E08 Bentley South Korea (6E08),United Arab Emirates E06 Bentley Middle East and Africa (6E06),United Kingdom E01 Bentley UK (6E01),United States E05 Bentley USA and rest America (6E05)
<b>Brand</b>	Bentley
<b>Transaction No.</b>	2071047/2
<b>Level</b>	EH
<b>Status</b>	Approval
<b>Release date</b>

DTC B101C29 and/or DTC B101D29 evident within the airbag control unit (J234)

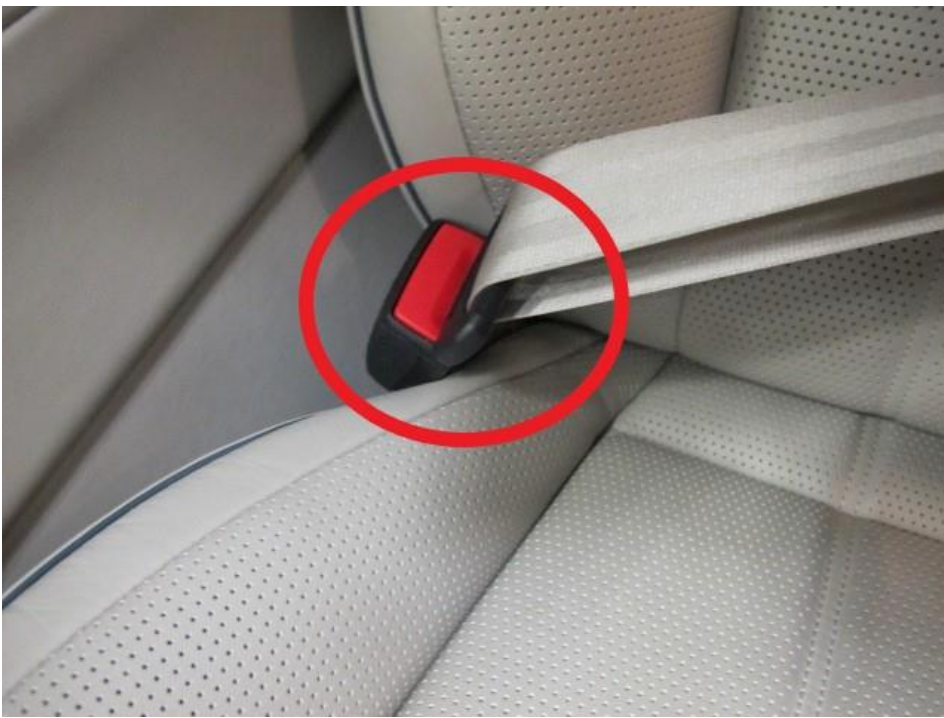
Figure 1

- 1) Insert the drivers side seatbelt tongue into the seatbelt buckle (Figure 1)
- 2) Referring to TPI 2071131/- Measured values - Cycle recording instructions - Record MVB IDE01193 (Drivers side) whilst manoeuvring the seatbelt buckle assembly - Reference the Bentley Hub TPI 2071047/- (Video 1)

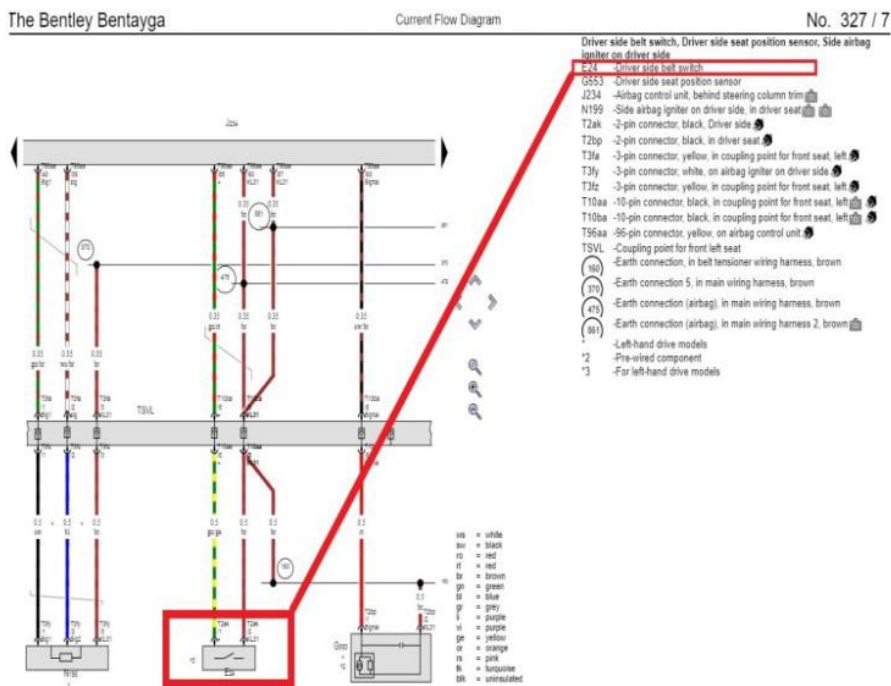
Figure 2

4) Referring to the applicable wiring diagram/Figure 2 - Locate E24

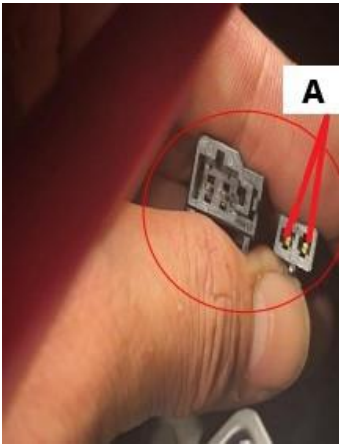
5) Referring to Figure 3 - Disconnect the E24 connection (circle)

**Hint: The next part of the procedure requires the resistance of the seat belt buckle harness to be measured. The resistance measurement must be taken at the location shown in Figure 3 (Point A) The operative must take care not to damage the terminals shown at point A when taking the resistance measurements**

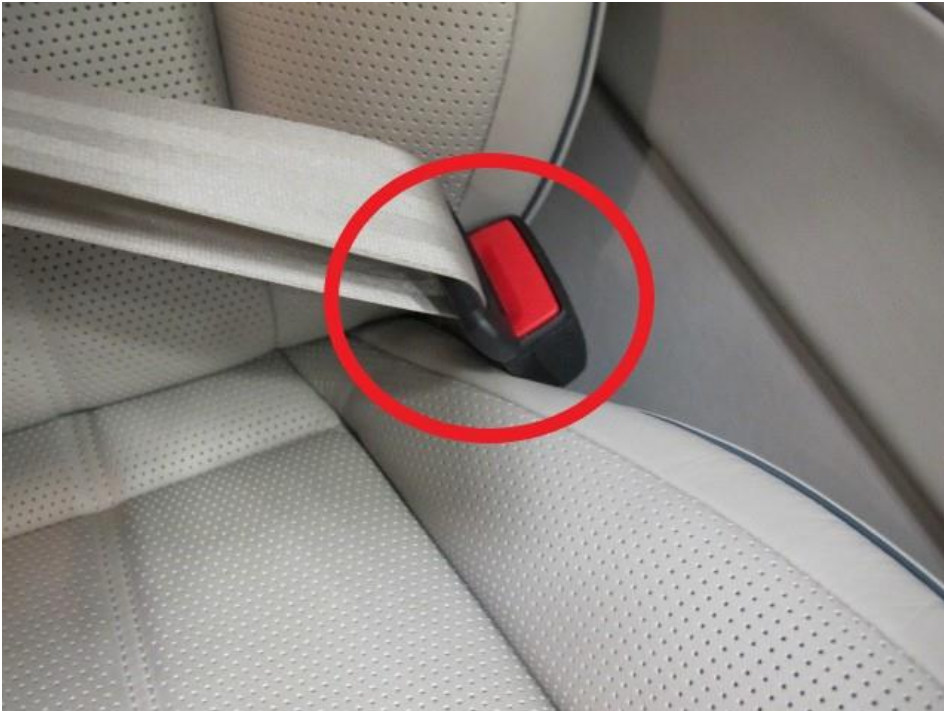
- 1) Referring to Figure 4 - Insert the passenger side seatbelt tongue into the seatbelt buckle
- 2) Referring to TPI 2071131/- Measured values - Cycle recording instructions - Record MVB IDE01194 (passenger side) whilst manoeuvring the seatbelt buckle assembly - *Reference the Bentley Hub TPI 2071047/- (Video 1)*

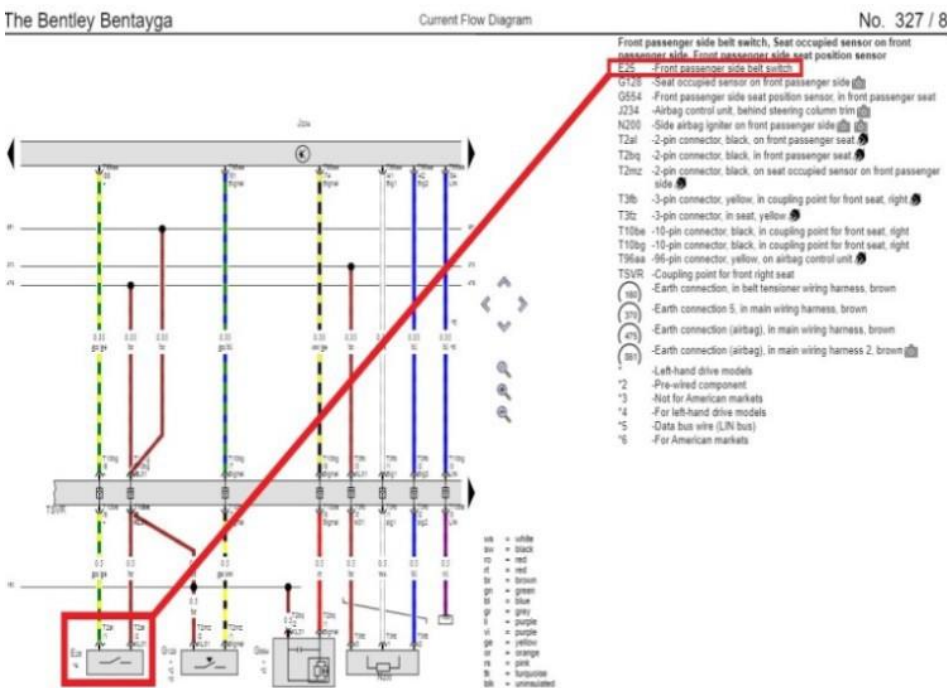
Figure 5

- 3) Referring to TPI 2071131/- Measured values - Cycle recording instructions - Record MVB IDE01194 (passenger side) whilst installing and removing the seatbelt tongue from the buckle the seatbelt buckle assembly - *Reference the Bentley Hub TPI 2071047/- (Video 2)*
- 4) Referring to the applicable wiring diagram/Figure 5 - Locate E25

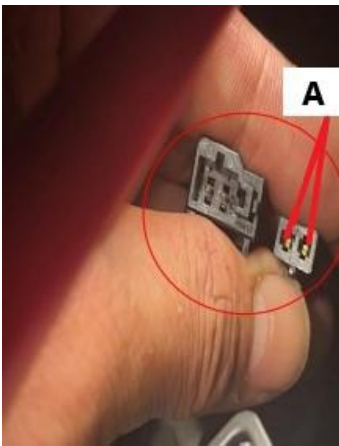
- 5) Referring to Figure 6 - Disconnect the E25 connection (circle)
