# Technical Information

105/23 ENU WPJ7

## WPJ7 - Re-Routing Wiring Harness in Transmission (Workshop Campaign)

Vehicle Type: 991 GT3 (992) / 991 GT3 Touring (992) / 991 GT3 RS (992)

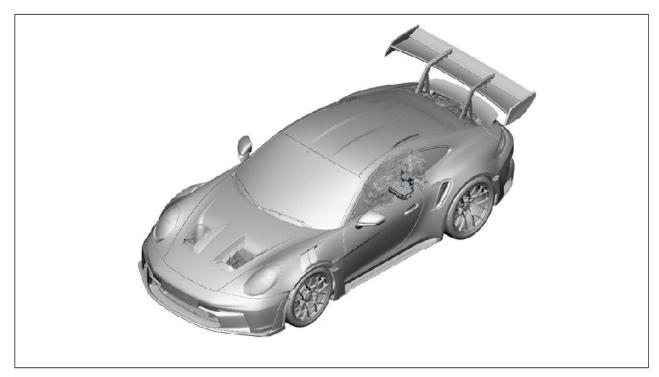
Installation position

Cause: There is a possibility that the wire harness in the transmission was not routed according to

specifications on the affected vehicles.

If this is the case, damage to the line insulation cannot be ruled out over the service life of the vehicle. As a result, a yellow warning message "Transmission faulty – reverse gear not available" would be displayed

on the instrument cluster. A reduced onward trip would also be possible in the event of an error.

Action: Re-route wire harness in transmission.
