WPK3 - Checking Wire Harness for Rear Lid and Reworking if Necessary (Workshop Campaign)

Model Line: **Panamera (971)**

Model Year: **2023**

Concerns: **Wire harness for rear lid**

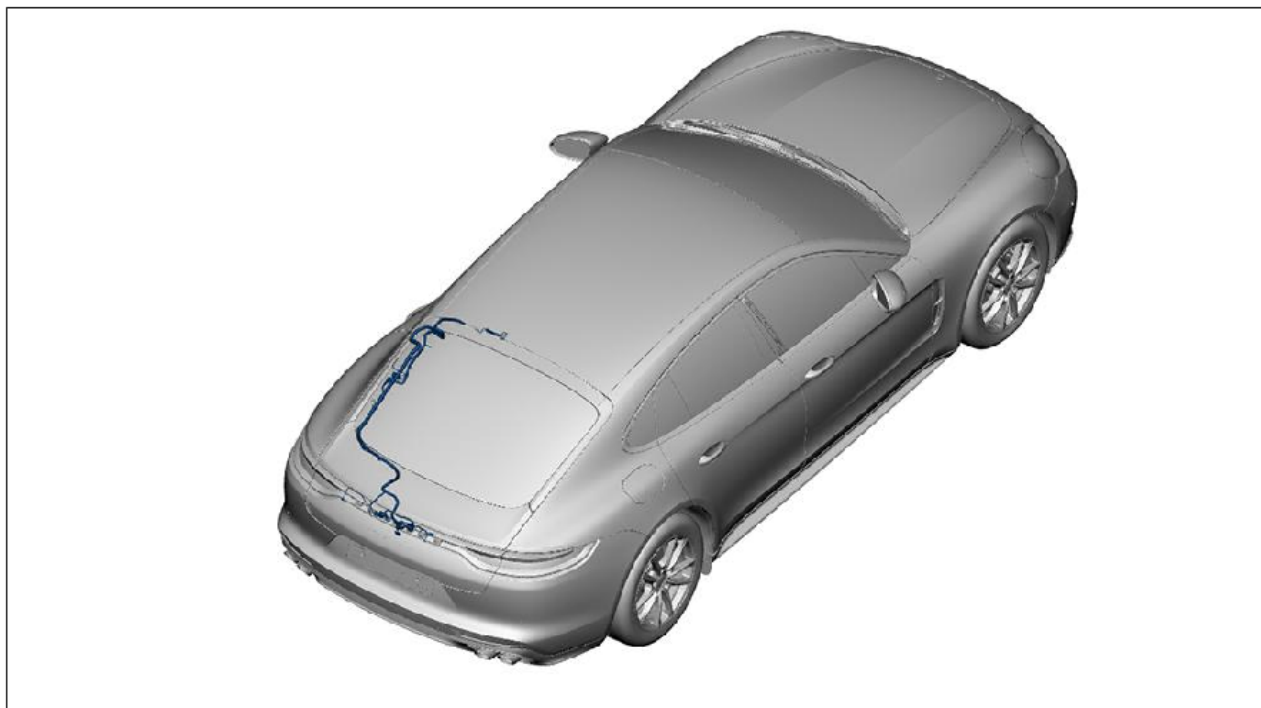
Installation position of wire harness for rear lid

Cause: **There is a possibility that a condenser in the wire harness for the rear lid was not installed according to specifications on the affected vehicles due to a manufacturing error.**
 If this is the case, it can lead to a malfunction of the heated rear window as well as signal disturbances to radio reception.

Action: Check wire harness for rear lid and rework if necessary.

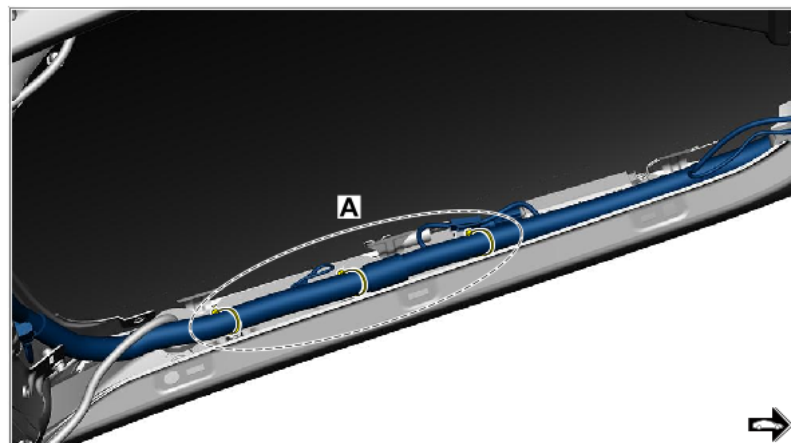
Installation position of condenser

The work area is located in the rear lid on the left window frame. The condenser to be tested is on the left in the marked area of the wire harness ⇒ *Installation position of condenser -A-* :

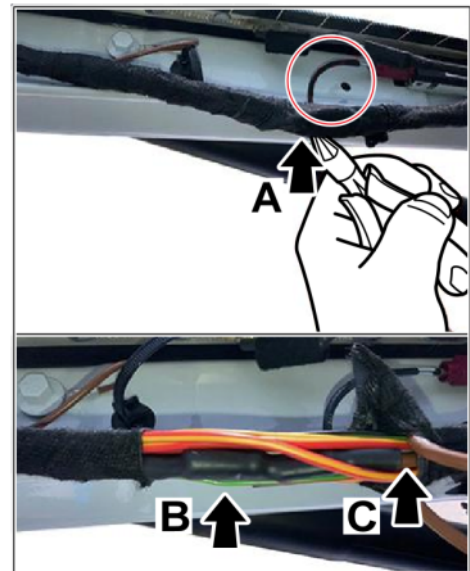
Expose wire harness

- 3 Starting with a side cutter at the level of the antenna line ⇒ *Expose wire harness -Arrow A-*, separate textile adhesive tape in both directions until the condenser ⇒ *Expose wire harness -Arrow B-* and the end of the shrink tube become ⇒ *Expose wire harness -Arrow C-* visible. Make sure the seal ⇒ *Expose wire harness -Circle-* is not damaged while doing this.
- 4 Check installation direction of condenser in wire harness for rear lid.

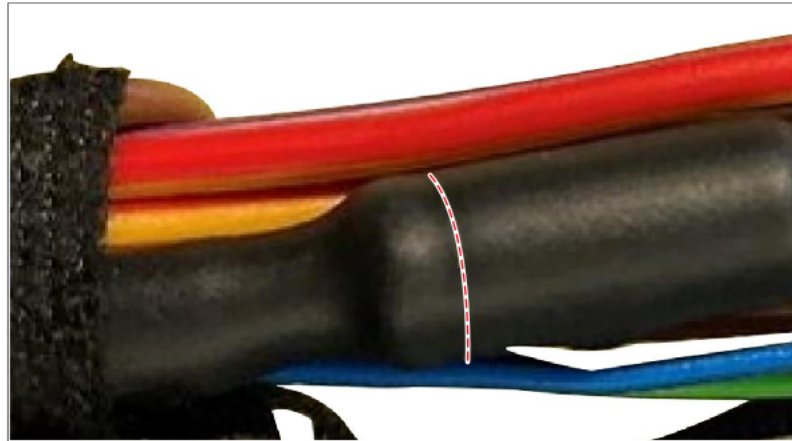
Condenser circumferential indentation

A circumferential indentation ⇒ *Condenser circumferential indentation -Dashed line-* can be seen under the shrink hose. This marks the **positive** side of the condenser.

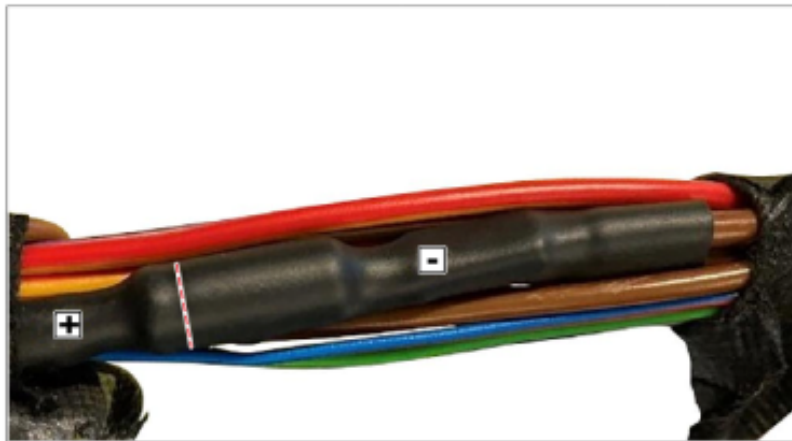
Installation direction for condenser OK

Assessment		Action
(✓)	The circumferential indentation (positive side of condenser) is on the side of the red/yellow line.	Wire harness for rear lid does not need to be reworked. Continue with Step 5. Invoicing for Scope 1
(✗)	The circumferential indentation (positive side of condenser) is on the side of the brown line.	Wire harness for rear lid must be reworked. Continue with ⇒ <i>Technical Information '709219 reworking wire harness for rear lid'</i> Invoicing for Scope 2
