Macan /Cayenne – Front Window Motor Without Function

Vehicles Affected

Models	Model Year	Model Type	VIN Range	Vehicle-Specific Equipment
Macan	2020 - 2023	95B	N/A	N/A
Cayenne	2020 - 2023	9YA, 9YB	N/A	N/A

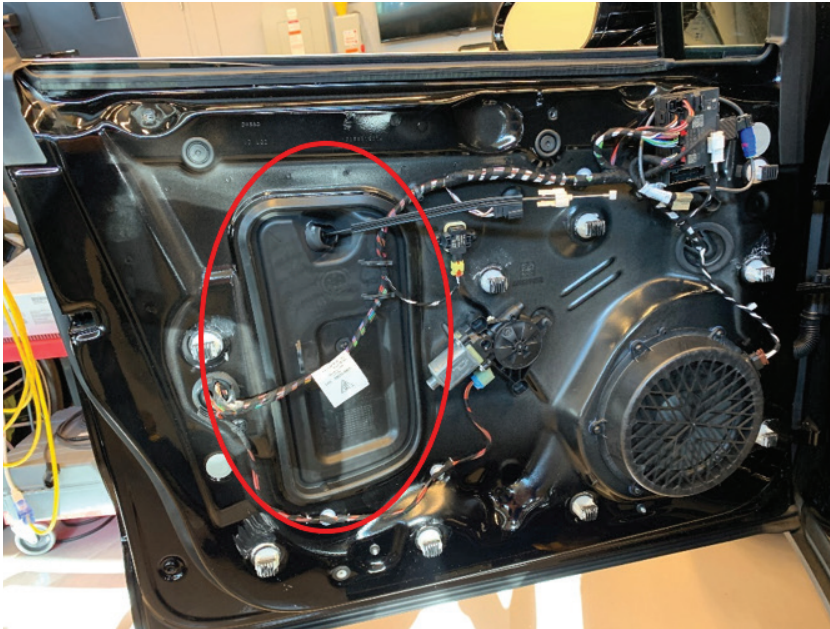
Figure1

5. Remove the large rubber cover towards the rear of the door to gain access to the rear part of the window regulator mechanism.

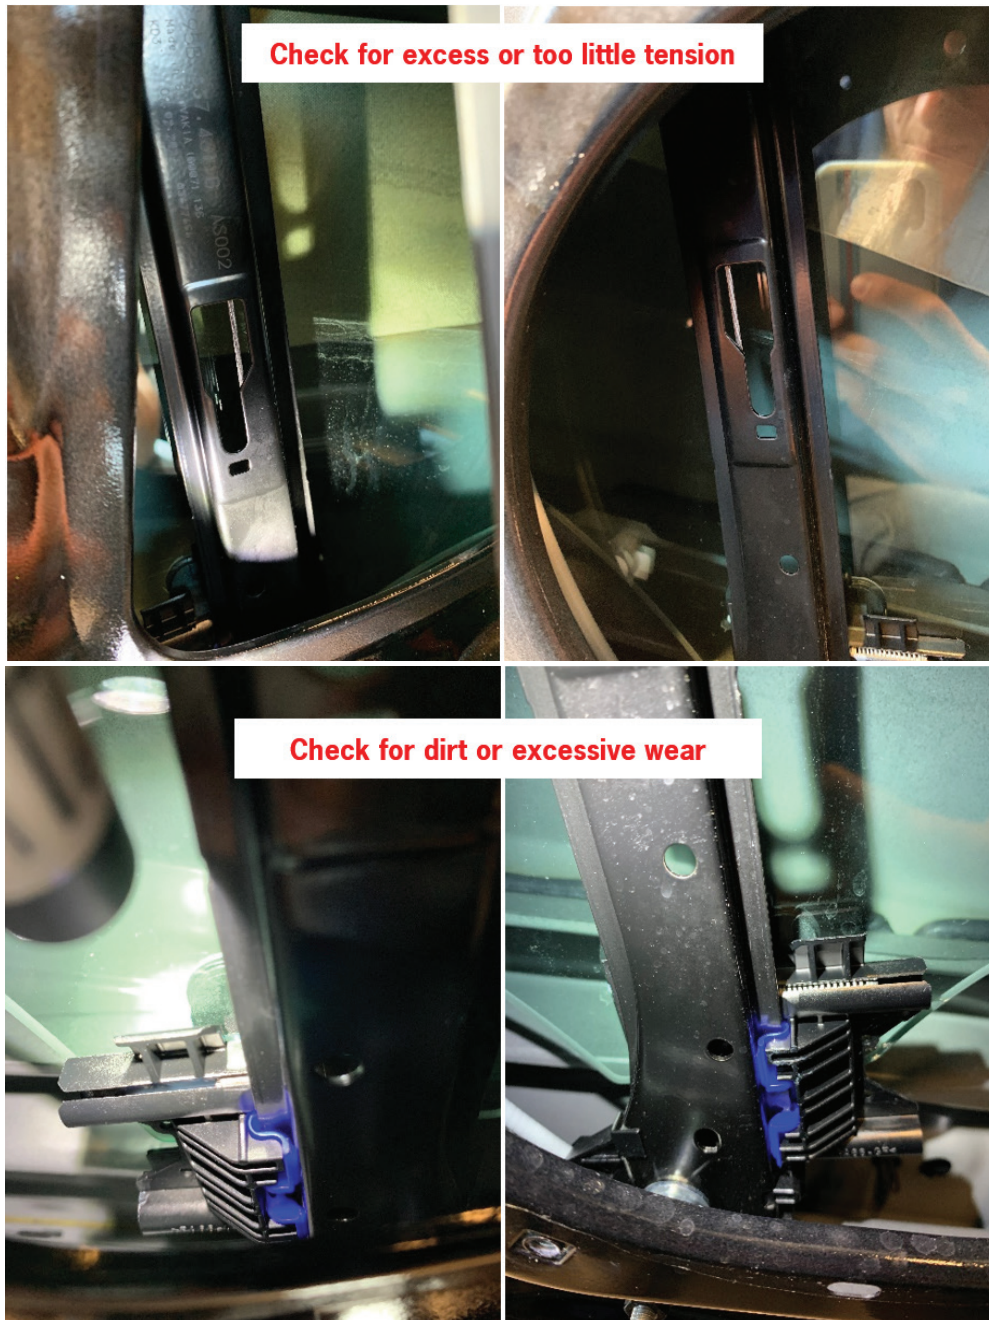
Figure 2

8. Inspect the window regulator mechanism and the window motor for excess tension, dirt, or wear. Ensure that the window regulator mechanism is easy to move. Clean the window regulator mechanism as needed.

9. If there are no faults in the window guide seals or the window regulator mechanism, the window regulator motor must be replaced per *WM 645419 – Removing and installing window regulator motor*.
10. Please completely document the findings to all above steps in the PCSS job.
