46-003: 579EV and 520EV Battery-Electric Vehicle R5 Software System Operation Impact

10/31/2023

46-003

579EV and 520EV Battery-Electric Vehicle R5 Software System Operation Impact

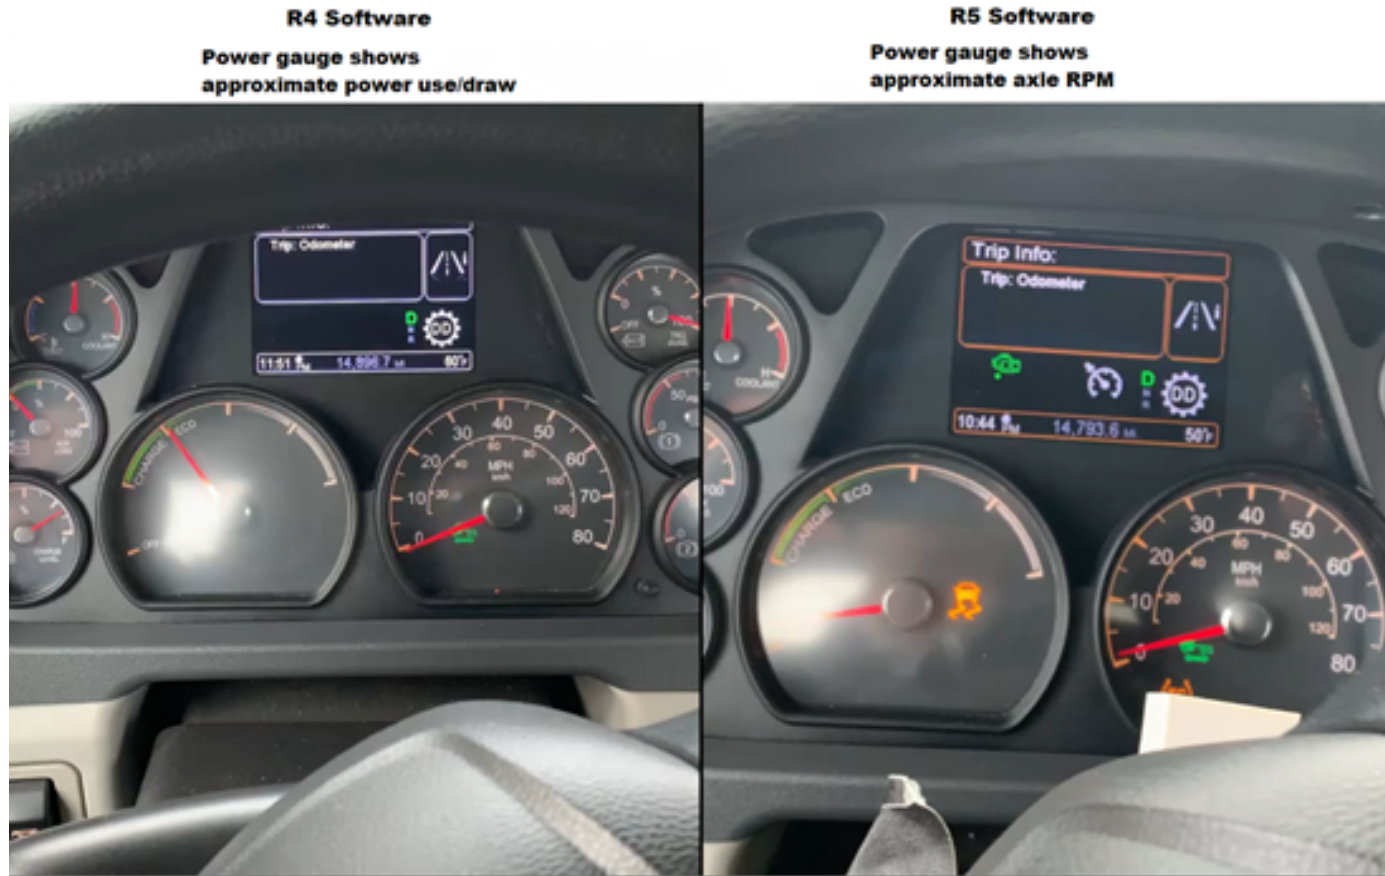
1. The power gauge displays axle RPM instead of power draw. This is not an accurate representation of power draw and could lead to incorrect

estimations of power usage.

- All other gauges will continue to operate normally.

For 579EV only -This repair involves replacement of the Bendix ABS ECU with an updated version and a software update to R5.00_003.

520EV without ESP will only receive a software update to R5.00_003 – (software part number: SCM_1p5_BC_R5p00_003.)
